**Nechako Sturgeon Spawning Gravel
September 2012 Substrate Assessment**

**Ministry of Forests, Lands and
Natural Resource Operations
4051 18th Avenue
Prince George, BC
V2N 6H2**

**NHC 300115
Final Report
February 27, 2013**

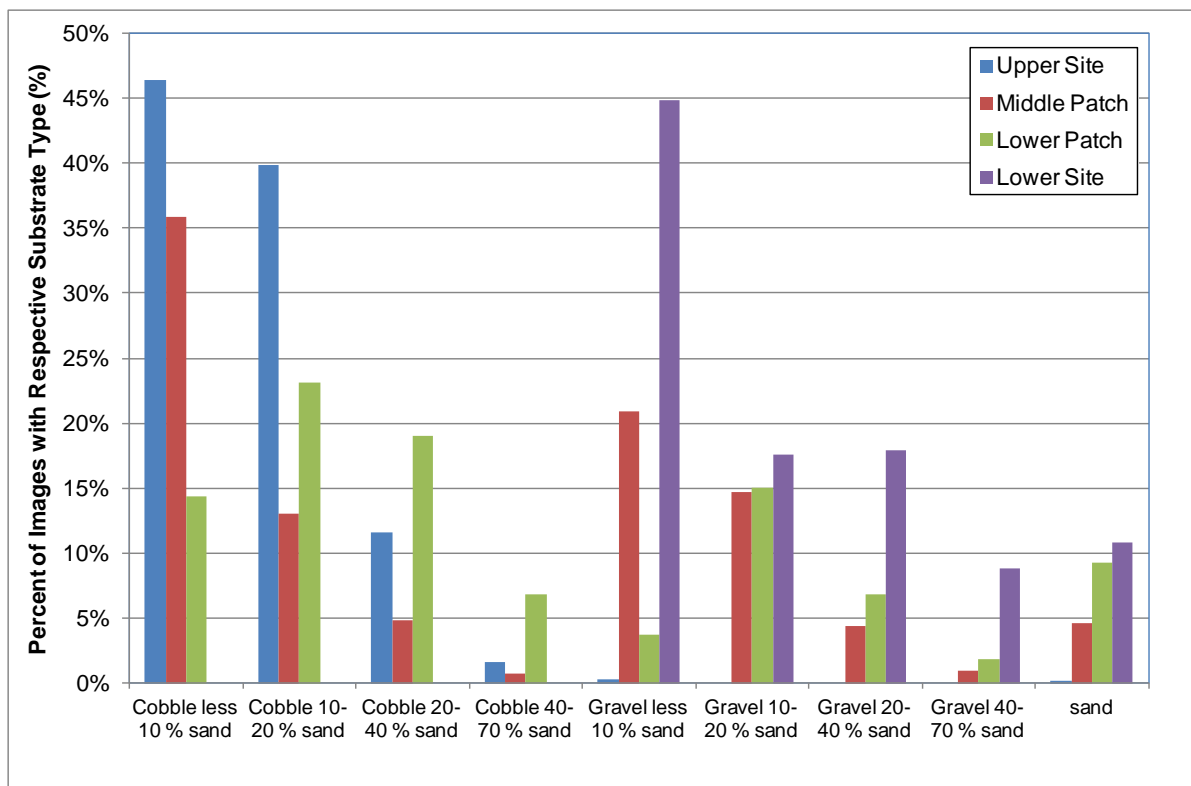
Figure 3: Substrate classification results for each site based on underwater images.

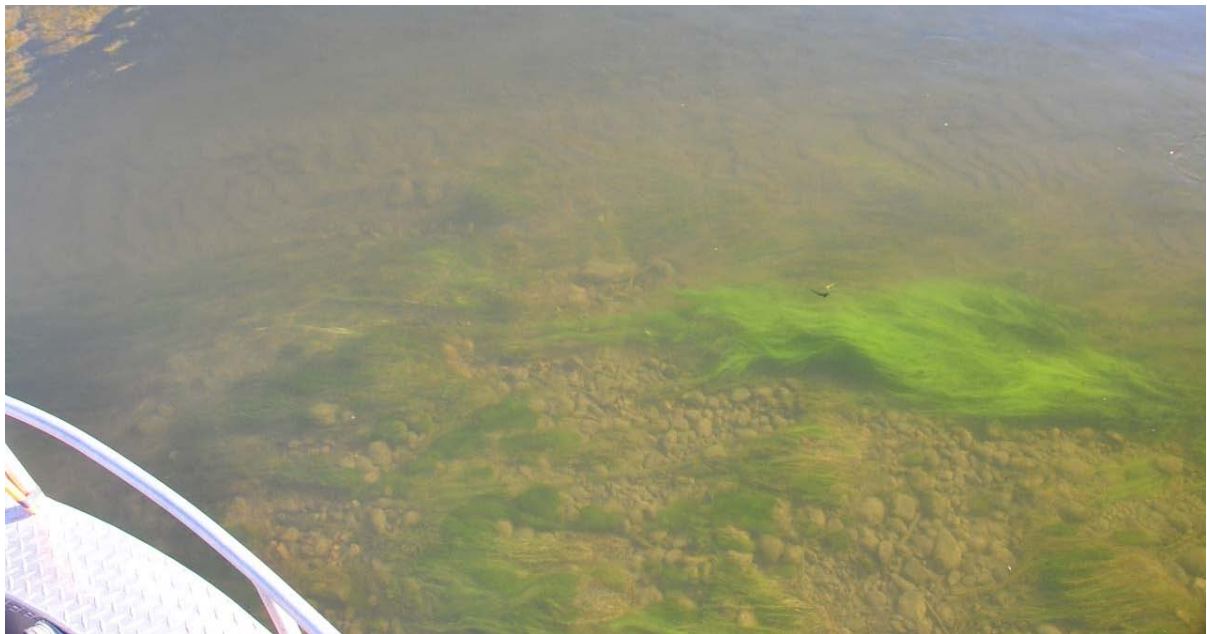
Overall the quality of the substrate at the Middle Patch appears to have degraded slightly since last year as there appeared to be more fine sediment in some areas. Nevertheless, there were still areas dominated by cobble substrate that were clear of fine sediment to some depth. This is particularly the case at the downstream end of the patch. There were no indications that the placed substrate moved, and it did not appear imbricated, which suggests that flood conditions during 2012 were well below the threshold of motion for the placed cobbles.

Photo 5: Filamentous algae growing on placed substrate. Note sand dunes moving along edge of placed substrate. Photo from upper stream end of Middle Patch.

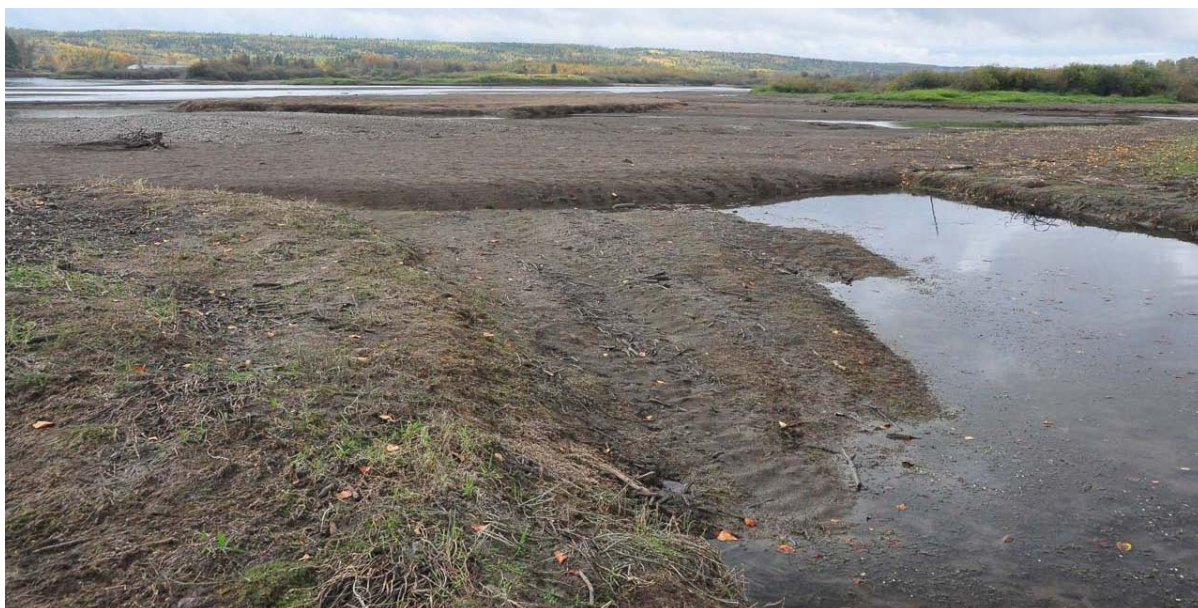
A visit to the outlet of Murray Creek indicates that it is not a significant source of medium to coarse sand (the material infilling the placed substrate). At the time of the visit Murray Creek was blocked off by a sand bar that has migrated down the Nechako River from the island group and appears incapable of moving significant quantities of bedload. The bed of Murray Creek at the confluence is predominantly silt and fine sand.

Photo 10: Outlet of Murray Creek blocked by a sand bar that has washed in from upstream.

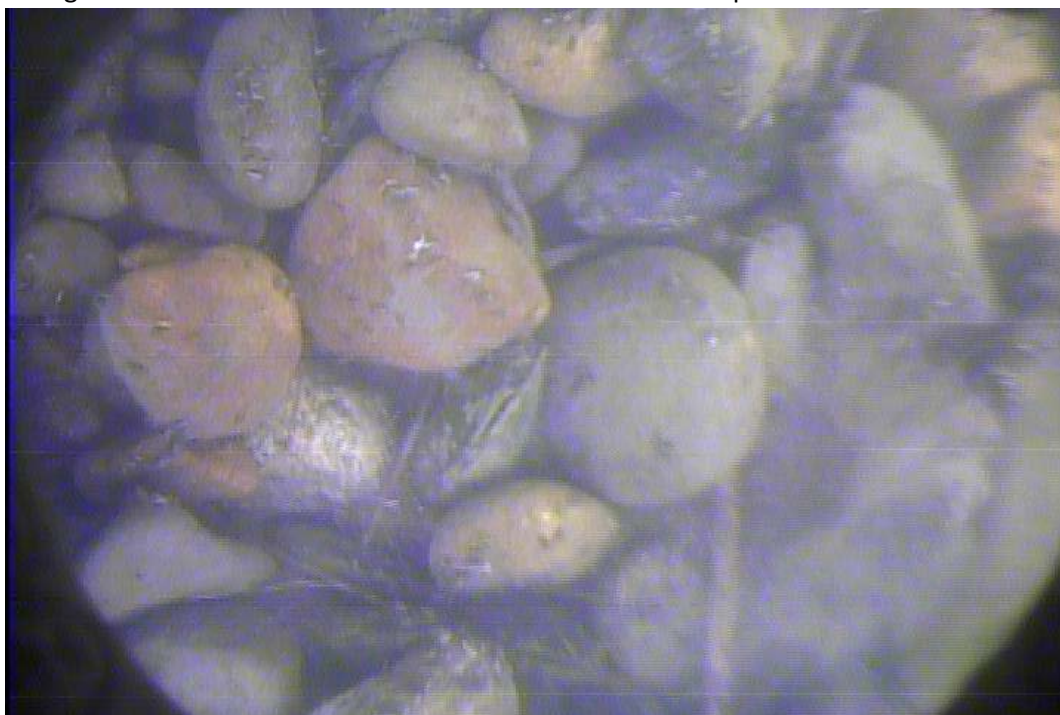
Photo 11 and Photo 12 are two representative underwater photos from the Lower Patch that show high quality substrate that is free of fines. In contrast, Photo 13 shows a patch of placed substrate infilled with fine gravel and sand. During 2012 much more high quality substrate like that shown in Photo 11 and Photo 12 was observed compared to 2011. This observation suggests that either the 2011 sampling did not cover the areas of cleaner substrate (due to the deeper waters and lower quality underwater images) or fine substrate was flushed out by the 2012 freshet. . Map 3 illustrates the sampling results from the underwater images and shows that the deeper areas along the left bank commonly have less than 10 % sand while the shallow areas on the inside bend of the river were generally infilled with fines. This pattern is typical of river meanders as bedload often moves along the inside edge of bends, and the higher velocities on the outside of the bend keep mobile sediments moving.

Photo 11: Underwater photo of substrate from Lower Patch, note mussels in image.

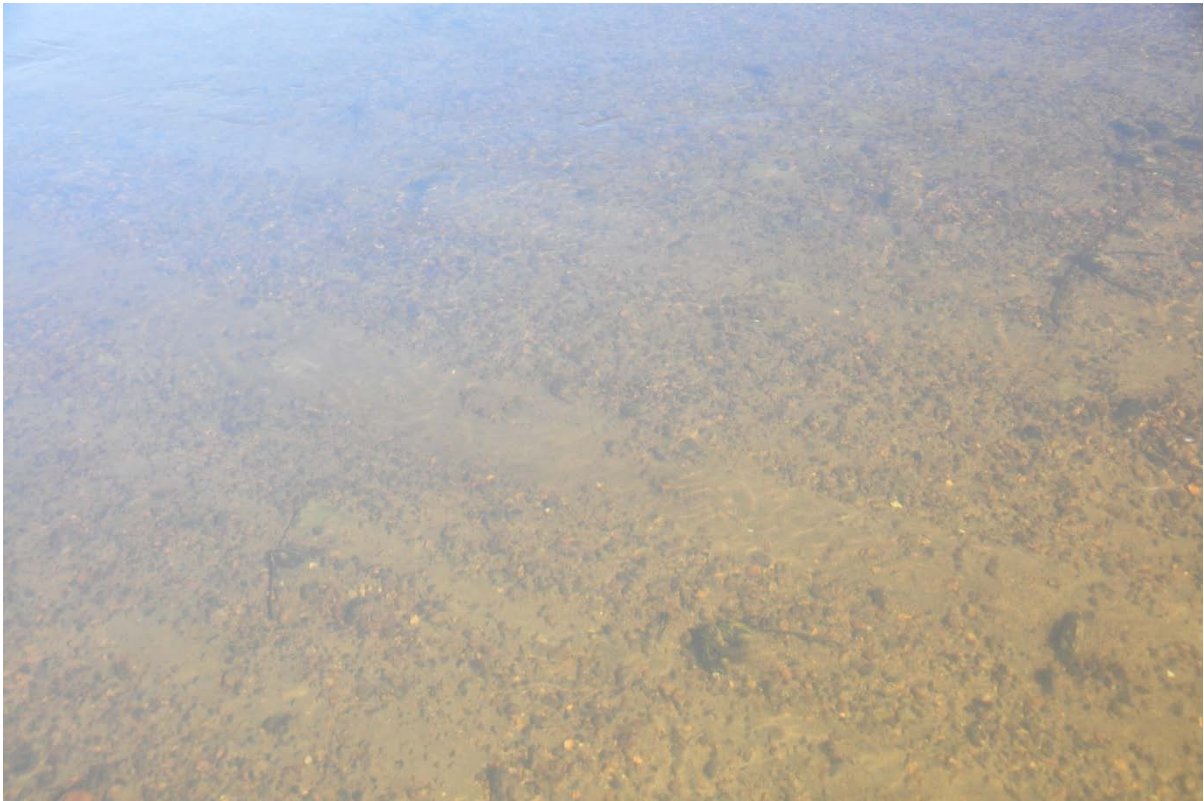
Photo 16: Photo of river bed at lower site illustrating strips of sand overtop of gravel.

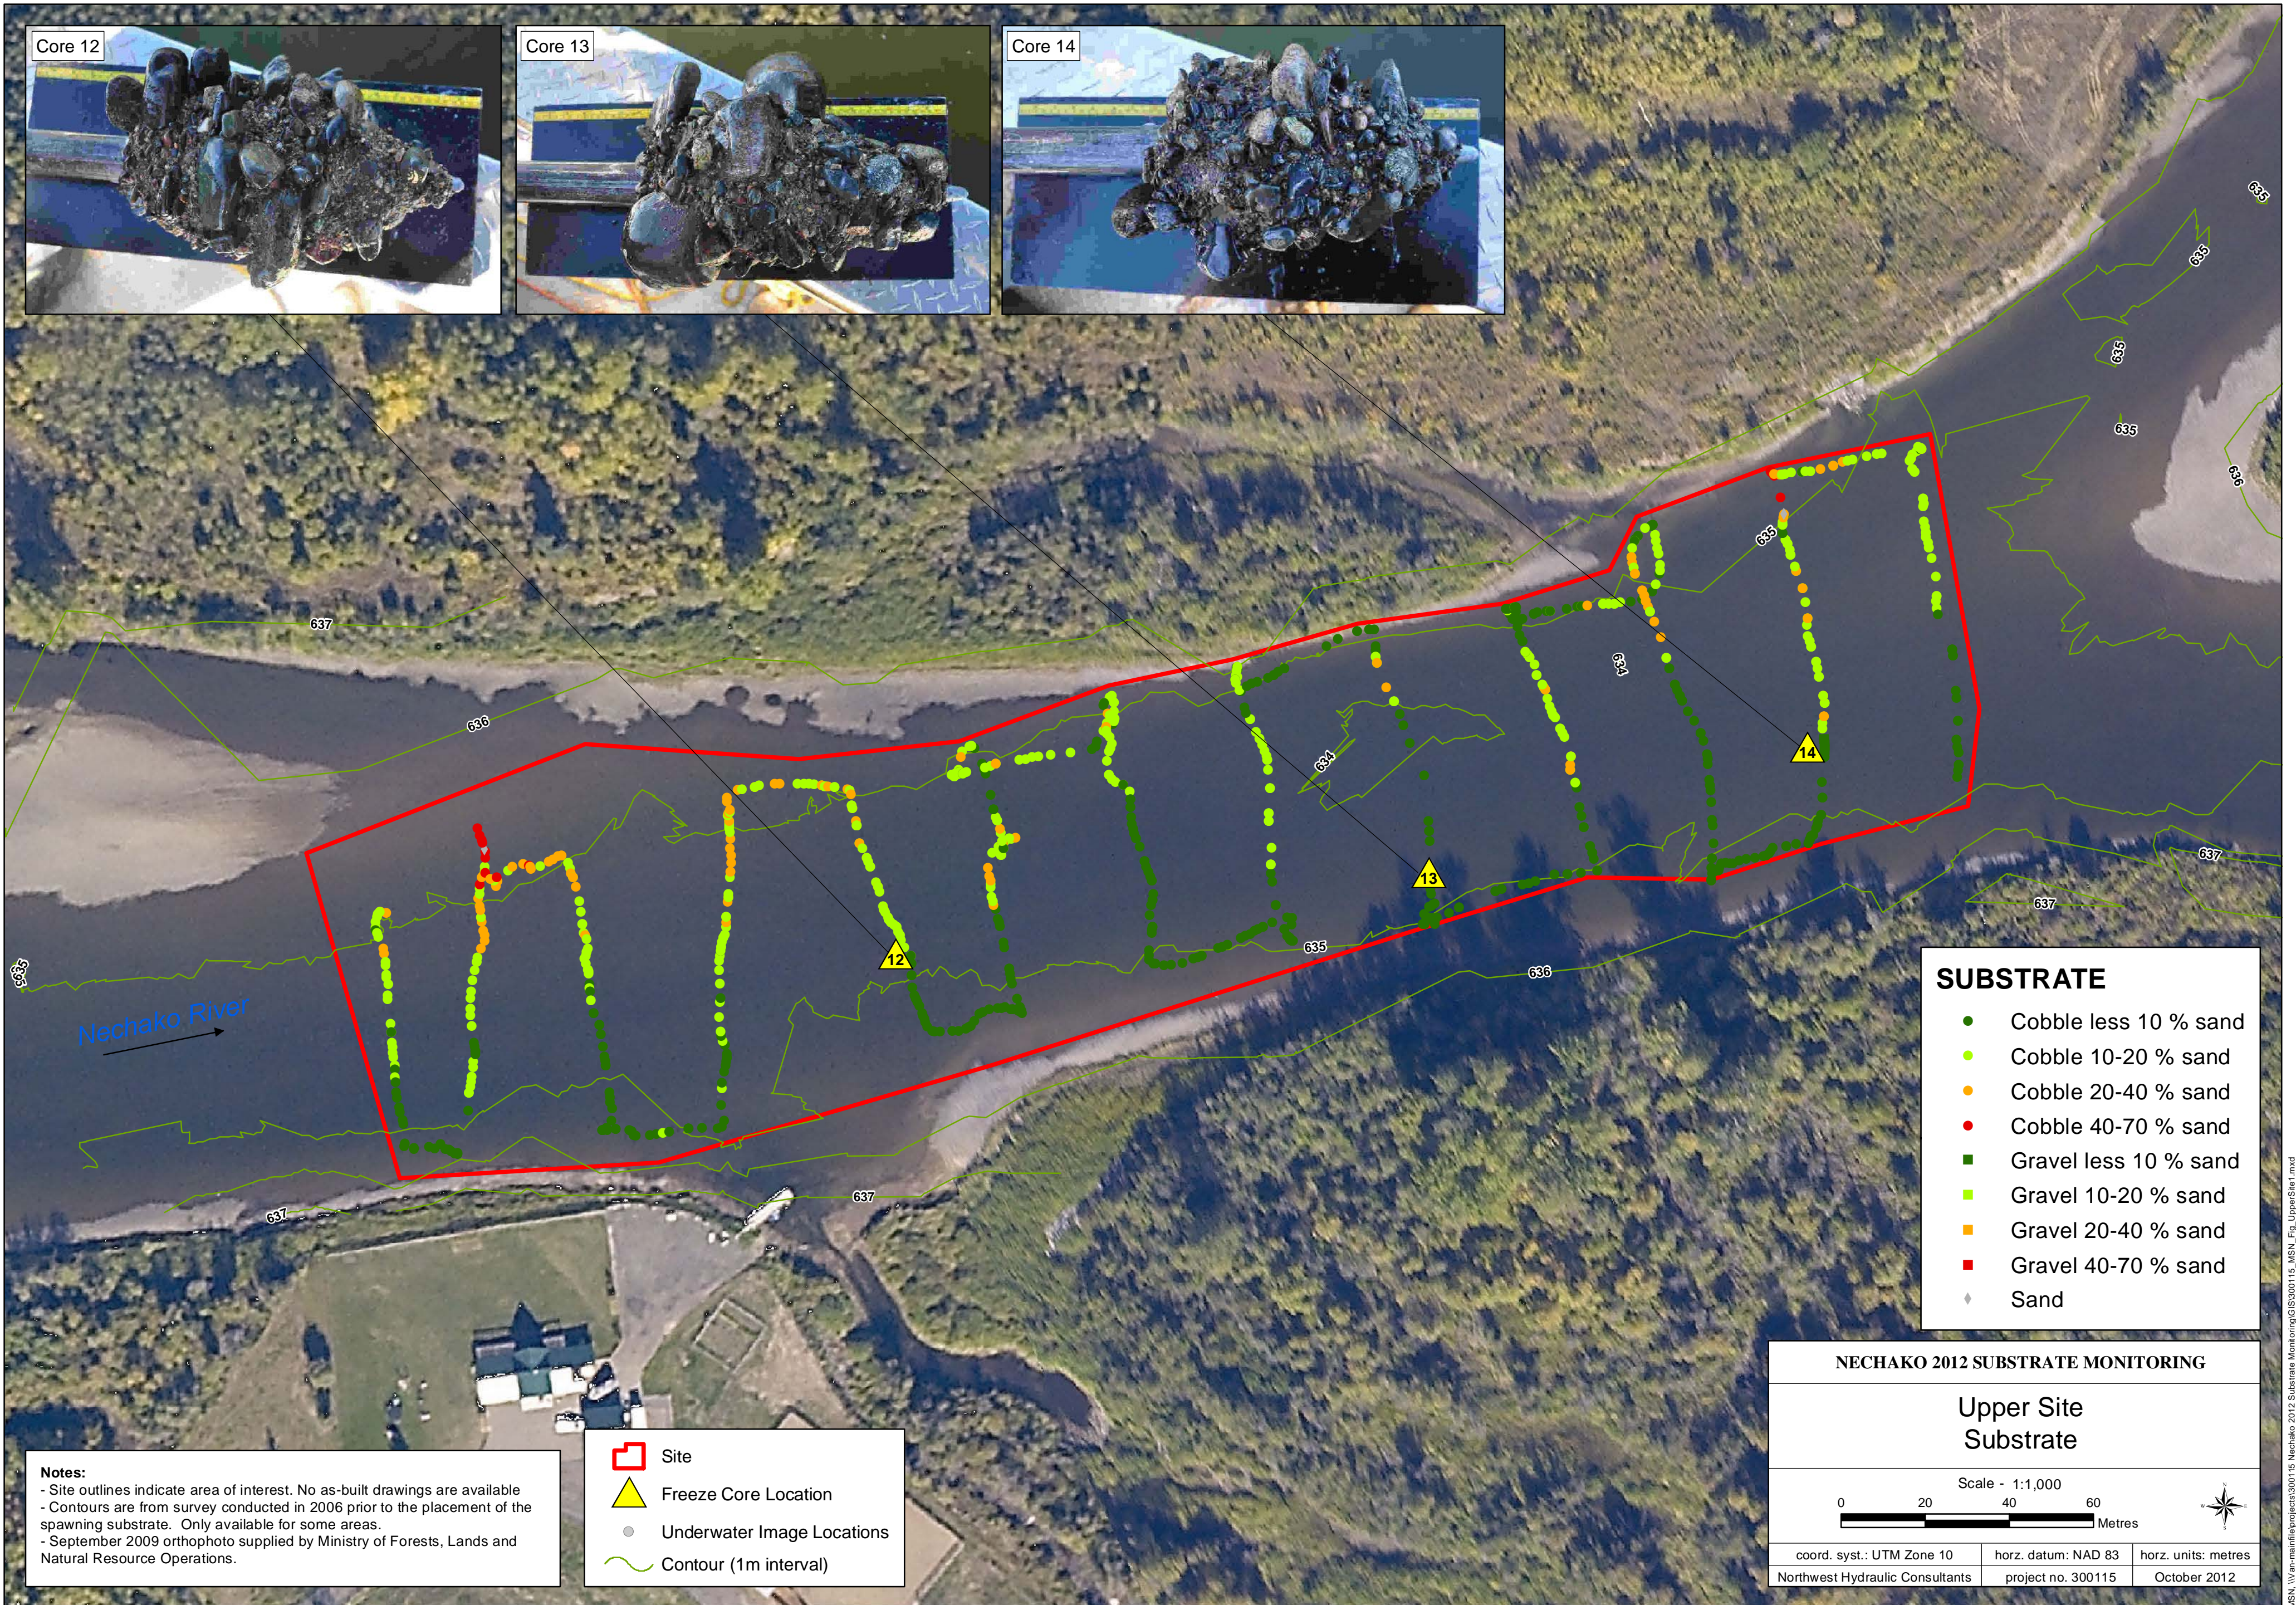
The three freeze cores from the site show a gravel-cobble substrate with a limited amount of interstitial space (Map 1 and Table 2). Compared to the other sites, the native substrate is larger at this site and relatively close packed.

Overall the upper site appears to have areas of moderately high quality substrate that are stable and free of surface sand. Some sand moves through the site, but it is not retained within the surficial interstitial spaces. At depth sand fills the pore spaces and prevents eggs from being deposited at any great depth. Site conditions could only be improved by having a greater depth of open interstitial spaces, which could possibly be done by hydraulically loosening up the sediment and flushing fines. Such an approach would require further development and some testing.

The site furthest upstream is the only one with naturally occurring cobble substrate and the substrate is quite imbricated. There does not appear to be sufficient energy to move these cobbles to the downstream areas. It is possible that hydraulically loosening up the cobbles and flushing some of the fines from the bed could improve the substrate quality at the Upper Site.
