**NECHAKO RIVER WHITE STURGEON
2020 SPAWNING SUBSTRATE RESTORATION AND MONITORING**

FINAL REPORT

15 March 2021

NHC Ref No. 3005659

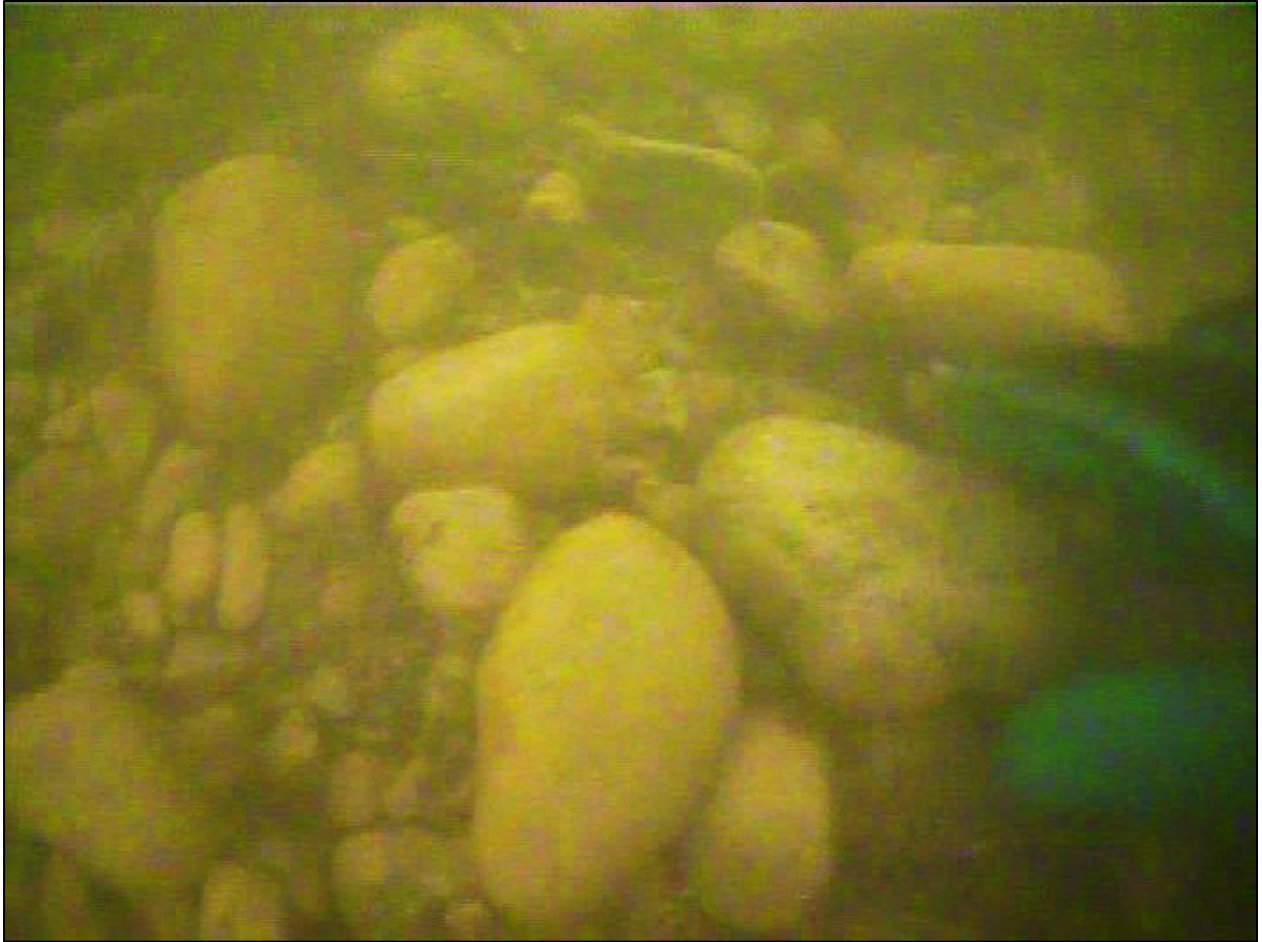
Photo 3.2 Pre-existing substrate observed on the Middle Patch showing coarse bed of placed cobbles and gravels with a minor to moderate amount of infilled sand.

Immediately prior to the spawning period (May 6, 2020), the substrate on the Middle Patch was observed to be generally composed of clean cobbles and gravels, with a limited amount of surficial sand deposited between the coarser grains (Photo 3.2). This observation is consistent with previous studies (NHC, 2012, 2013, 2014) finding that only a limited amount of infilling has occurred on the spawning pad since placement in 2011. Although some spatial variability was observed, where certain areas had up to moderate amounts of surficial sand cover, the general condition of the substrate appeared to be relatively coarse with clean interstitial voids between the top layer of grains (to a depth of one or two grains thick).

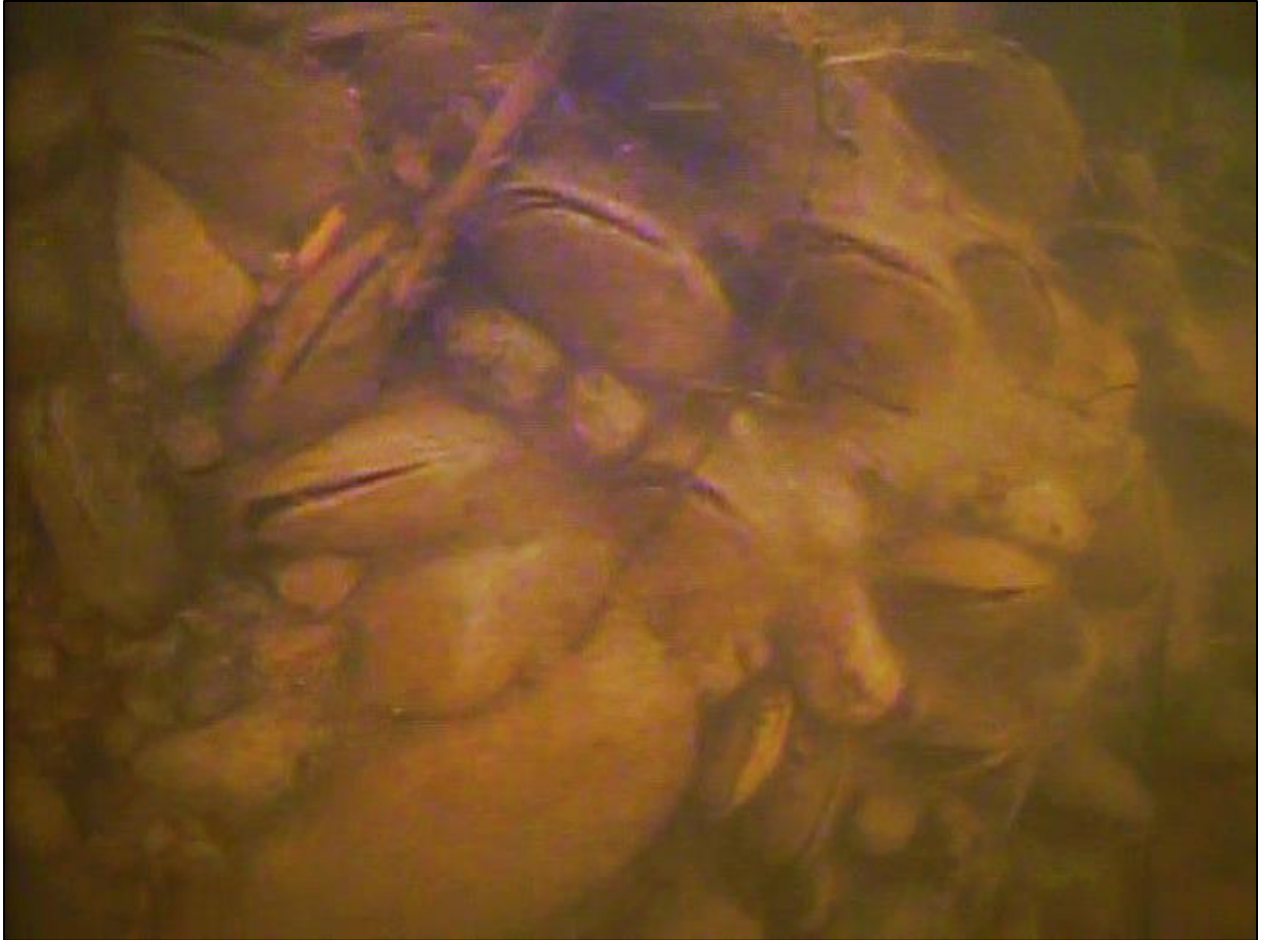
Photo 3.4 High density of mussels embedded within the cobbles of the Lower Patch upstream of the selected cleaning site.

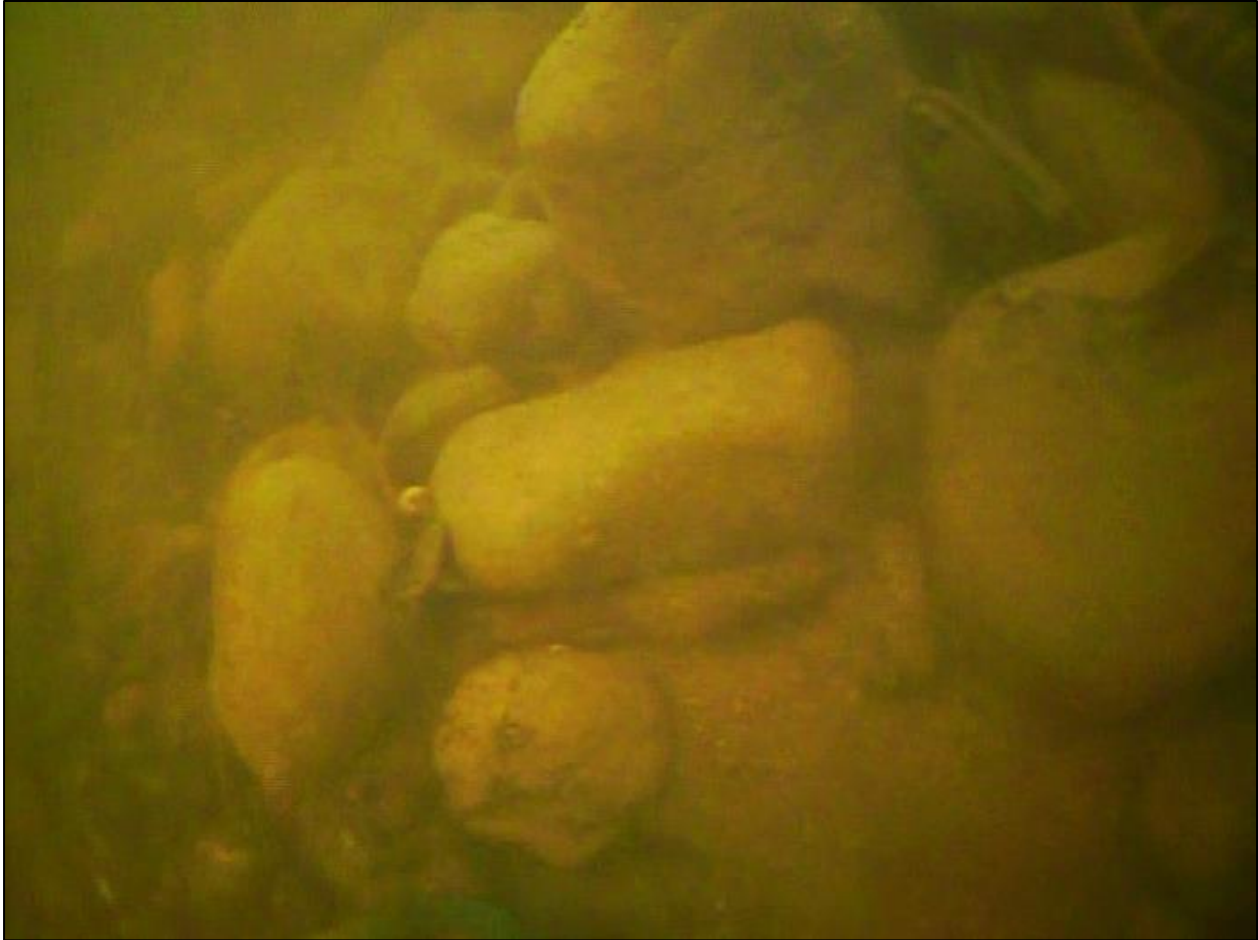
Photo 3.5 shows the typical substrate observed on the Lower Patch prior to the cleaning operation, consisting of a mix of large cobbles and gravels typically overlaying a base of sand. However, the composition of the existing substrate, including the amount of surficial sand, varied spatially over the area. Several sites were found to have a coarse cobble substrate protruding above the bed. These sites appeared to provide large interstitial voids (perhaps too large for larvae to find velocity refuge) between the protruding cobbles, although interstitial space at-depth appeared limited by a base of sand and gravel.

Photo 3.5 Typical substrate at the Lower Patch cleaning site prior to hydraulic jetting showing a mix of large cobbles and gravels overlaying a base of sand.

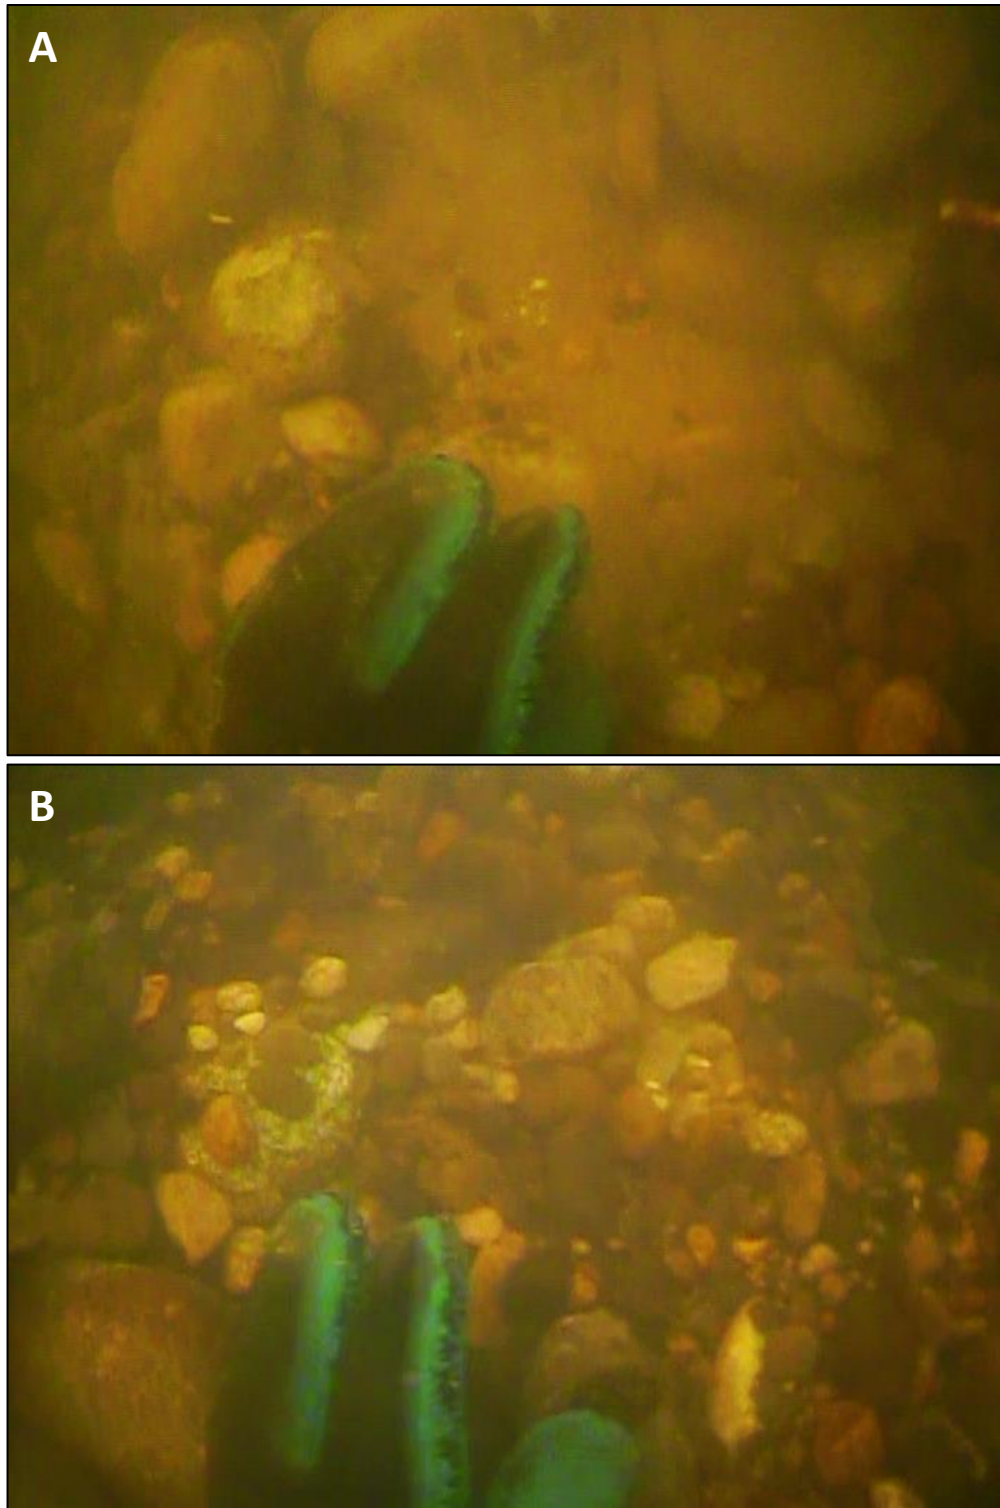
Figure 3.1 Pre- and post-operation substrate condition at the Lower Patch cleaning site; A) pre-existing substrate showing embedded cobbles and gravel with surficial sand deposition and B) cleaned substrate showing recently mobilized gravels.

The substrate on the northwestern portion of the Lower Patch consisted of a mix of large cobbles and gravels, generally infilled with sand. However, the amount of surficial sand did vary across the area, and several sites were found to have a coarse cobble substrate protruding above the bed with only a minor amount of sand infill (Photo 4.1). These observations show that, while there may not be extensive areas of high quality substrate, local areas do appear (from the surface) to provide a coarse substrate with interstitial voids. That said, the quality of the habitat provided by these large, protruding cobbles may be limited despite the lack of surficial sand due to other reasons (e.g. not enough interstitial spaces, voids are too large for larvae to maintain their position due to turbulent fluctuations, etc.). In comparison, the cleaned substrate is expected to have provided high quality interstitial habitat during the spawning period due to the loose mixture of cobble- and gravel-sized particles (Figure 3.1).

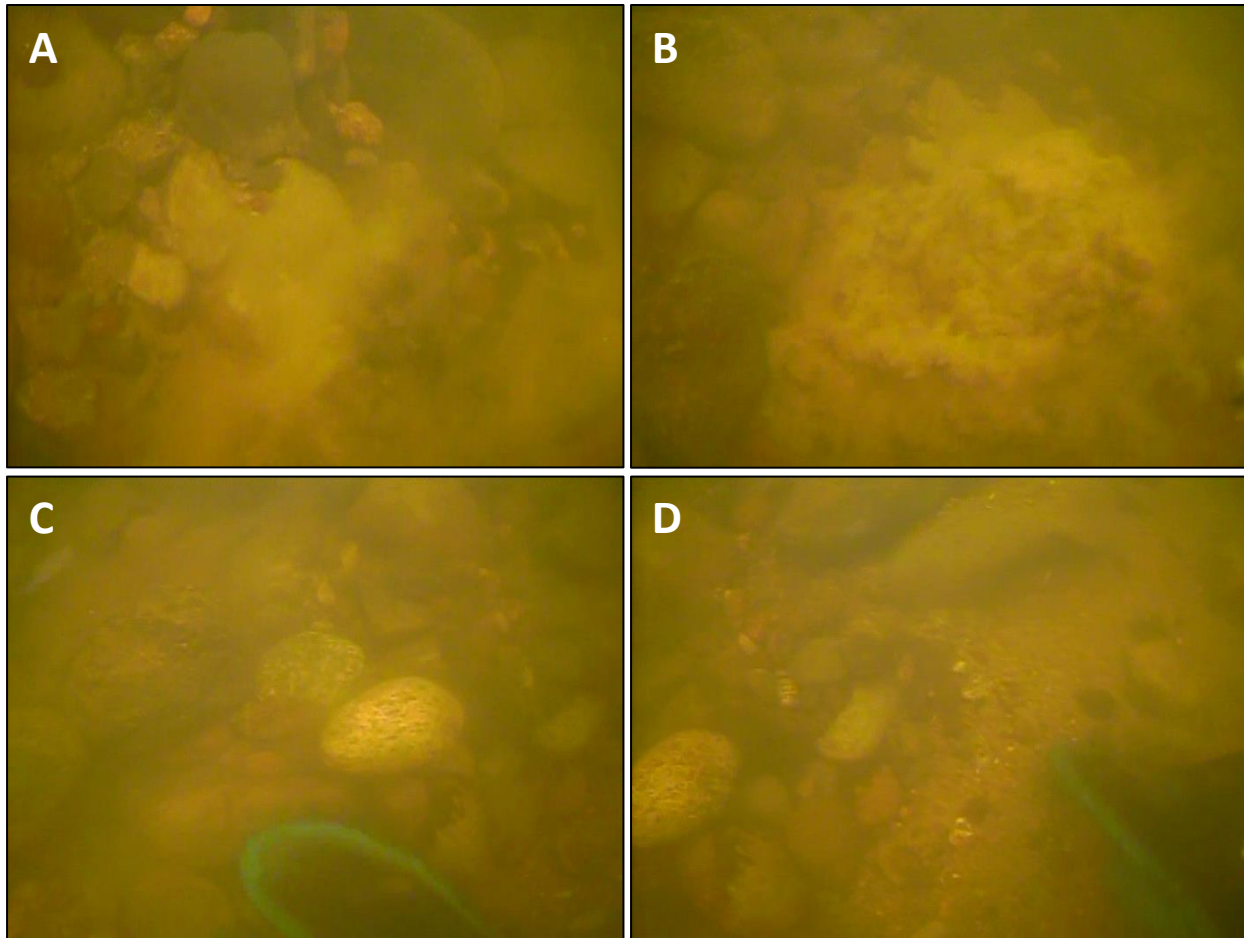
Figure 3.2 Overview of the substrate cleaning process using the hydraulic jet at the Lower Patch; A) pre-existing substrate composed of cobbles and gravels on base of compacted sand, B) hydraulic jet mixing substrate and bringing underlying sand and silt into suspension, C) substrate after jetting showing layer of loosely deposited gravels and cobbles with minimal surficial sand and D) redeposition of sand approximately 0.5 m downstream of cleaned substrate.

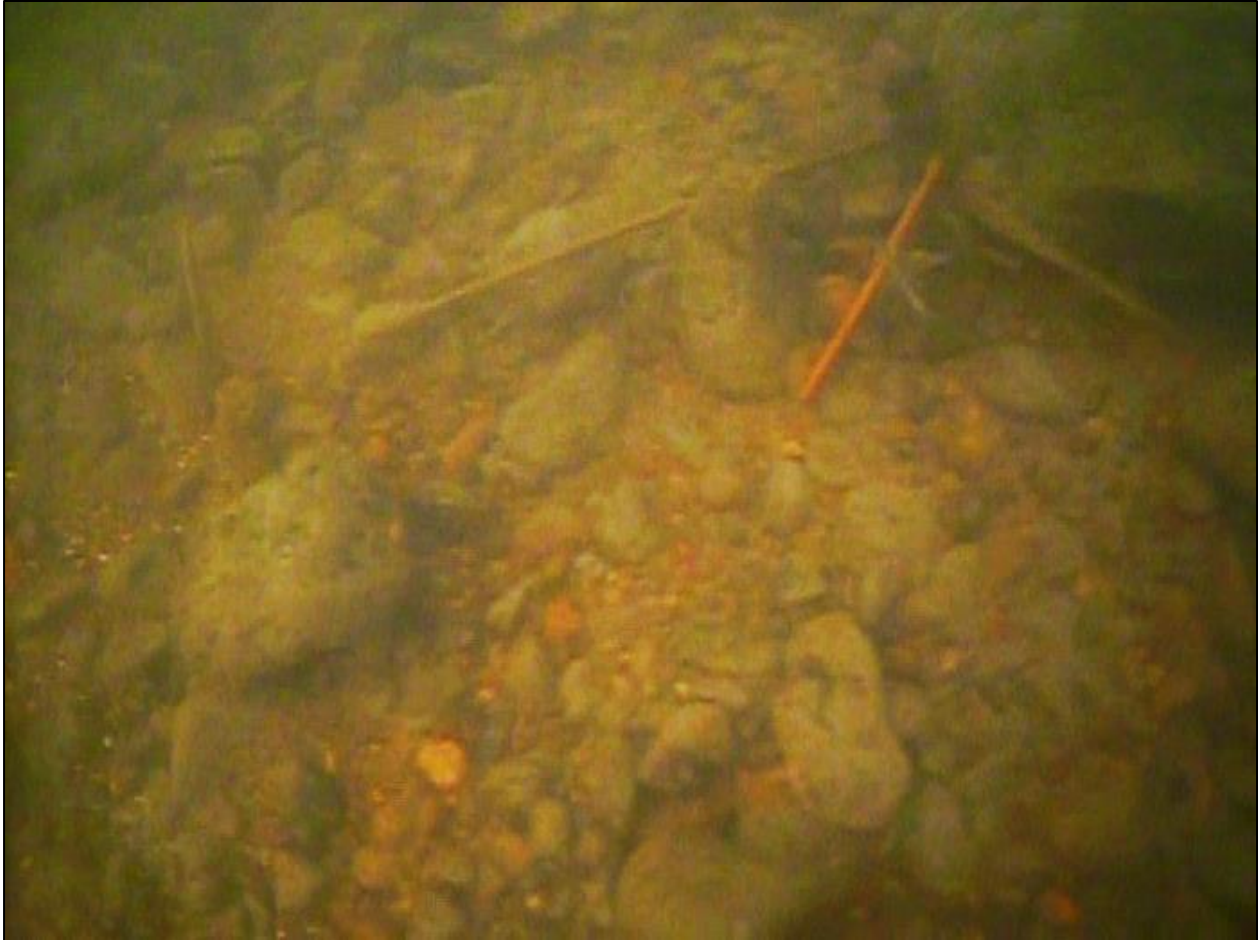
Photo 3.6 Pre-existing substrate observed at the Lower Site cleaning area showing infilled gravels with trace cobbles.

The pre-existing substrate at the Lower Site cleaning area was predominantly composed of small to large gravels with granules and scattered cobbles (Photo 3.6). Similar to the Lower Patch, the degree of embeddedness and amount of surficial fines was found to vary spatially, where some areas were found to have a substrate composed predominately gravels and granules with minor surficial sand. Although the cleaned site contained a lesser proportion of cobbles compared to the Lower Patch, the cleaned substrate is expected to have provided high quality larval habitat during the spawning period in the form of small- to medium-sized interstitial voids found throughout the loose gravel deposit to a depth of up to several grains thick (Section 3.2.3).

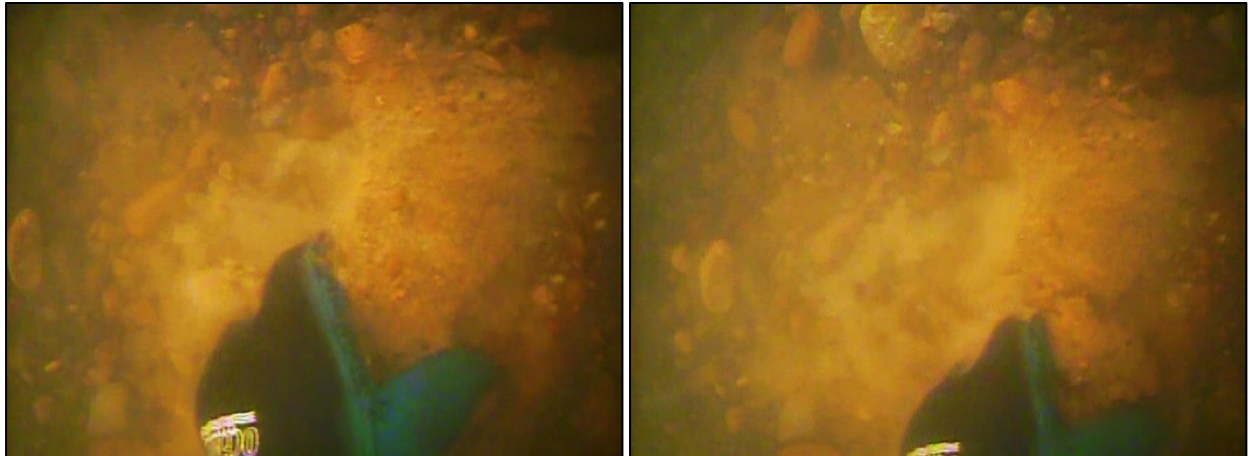
Figure 3.3 Consecutive photos showing the diver breaking off a piece of compacted fine sediment found to underly the substrate in portions of the Lower Site cleaning area.

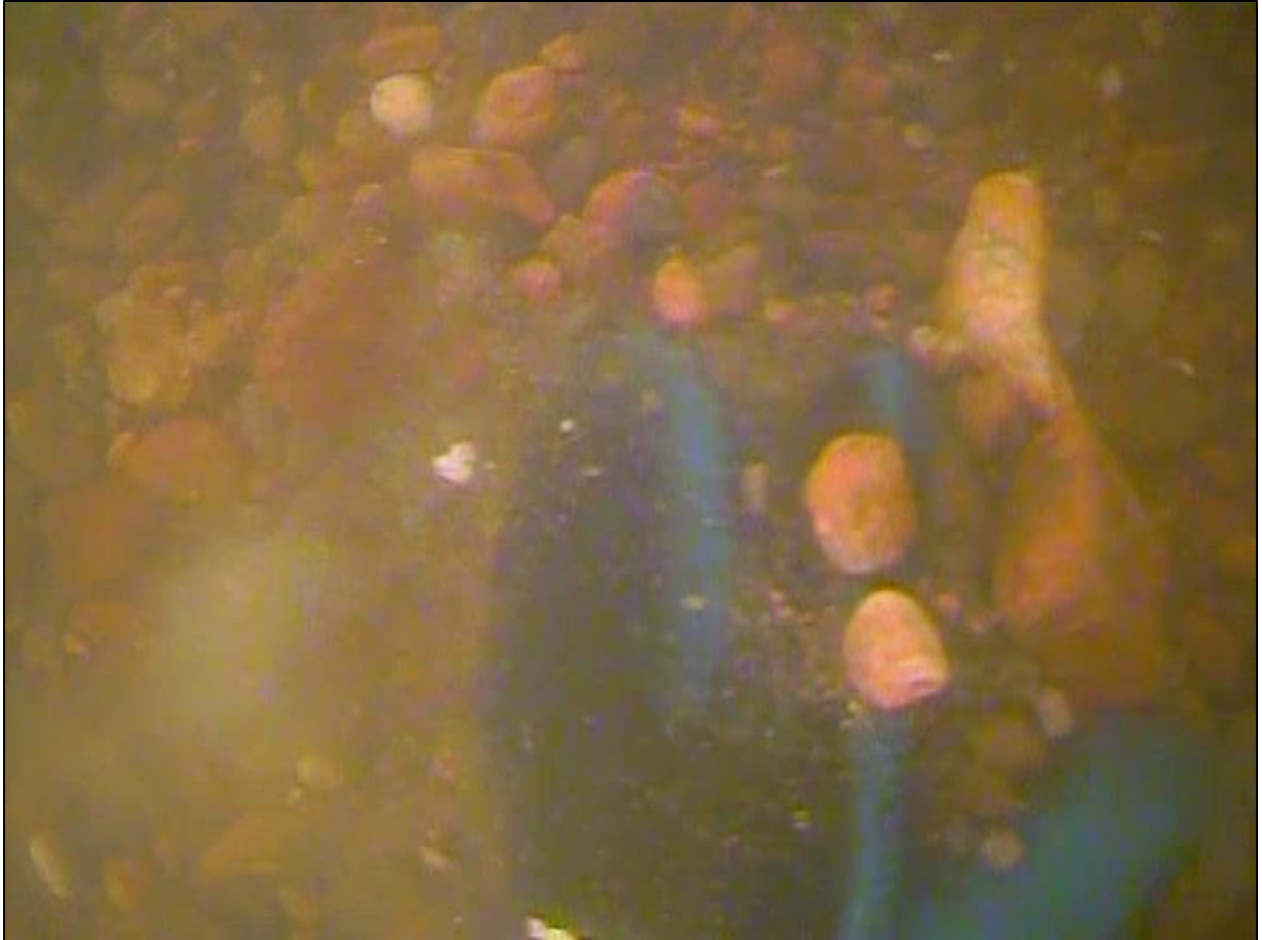
Photo 3.10 Post-cleaned substrate containing only a small amount of fine sediment, as evidenced by the small plume of suspended sediment (as opposed to a large plume) produced as the diver pushes piles of cleaned gravels.

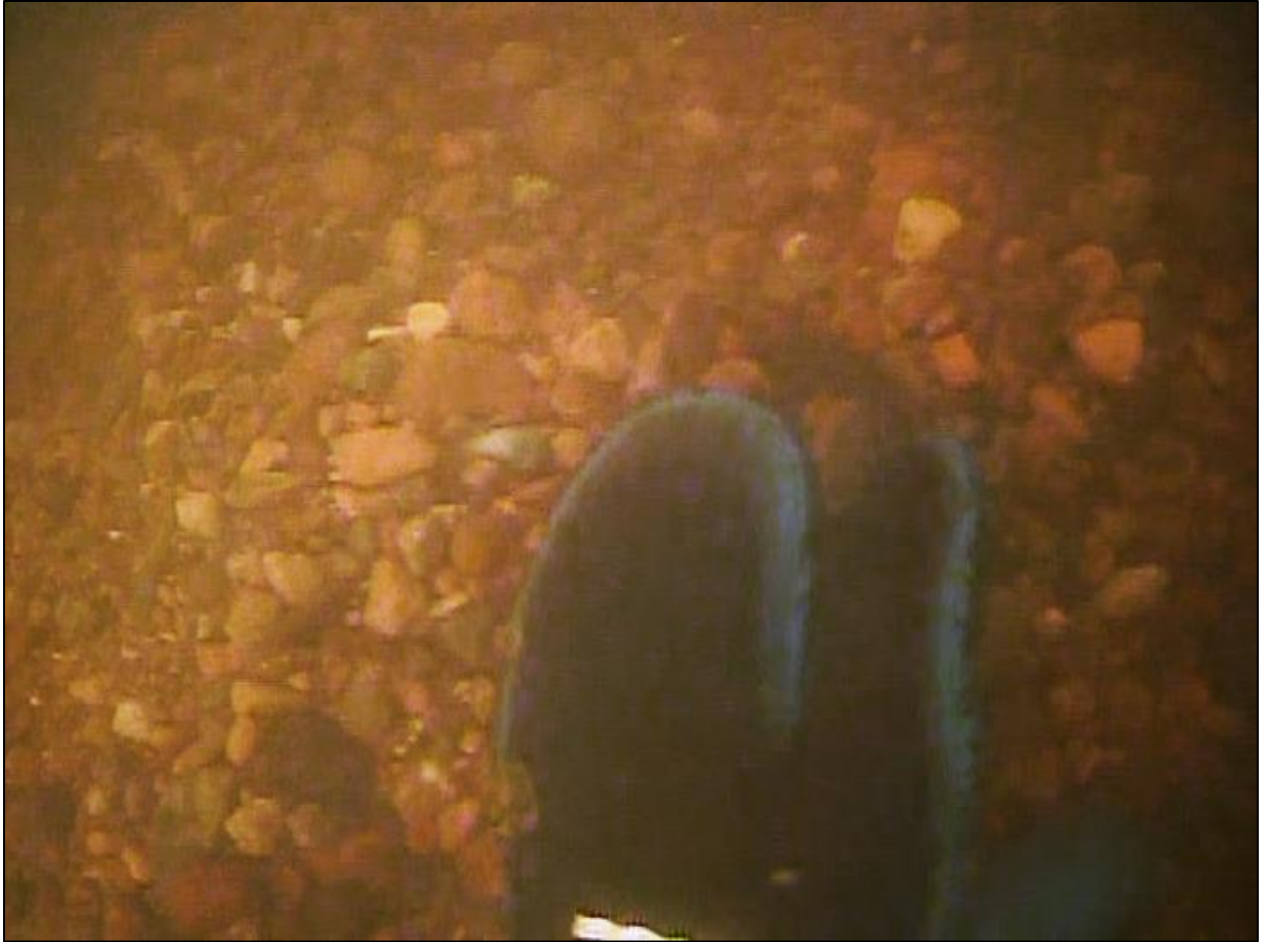
Photo 3.11 Cleaned substrate near the downstream end of the Lower Site treatment area showing a greater proportion of finer gravels compared to upstream.

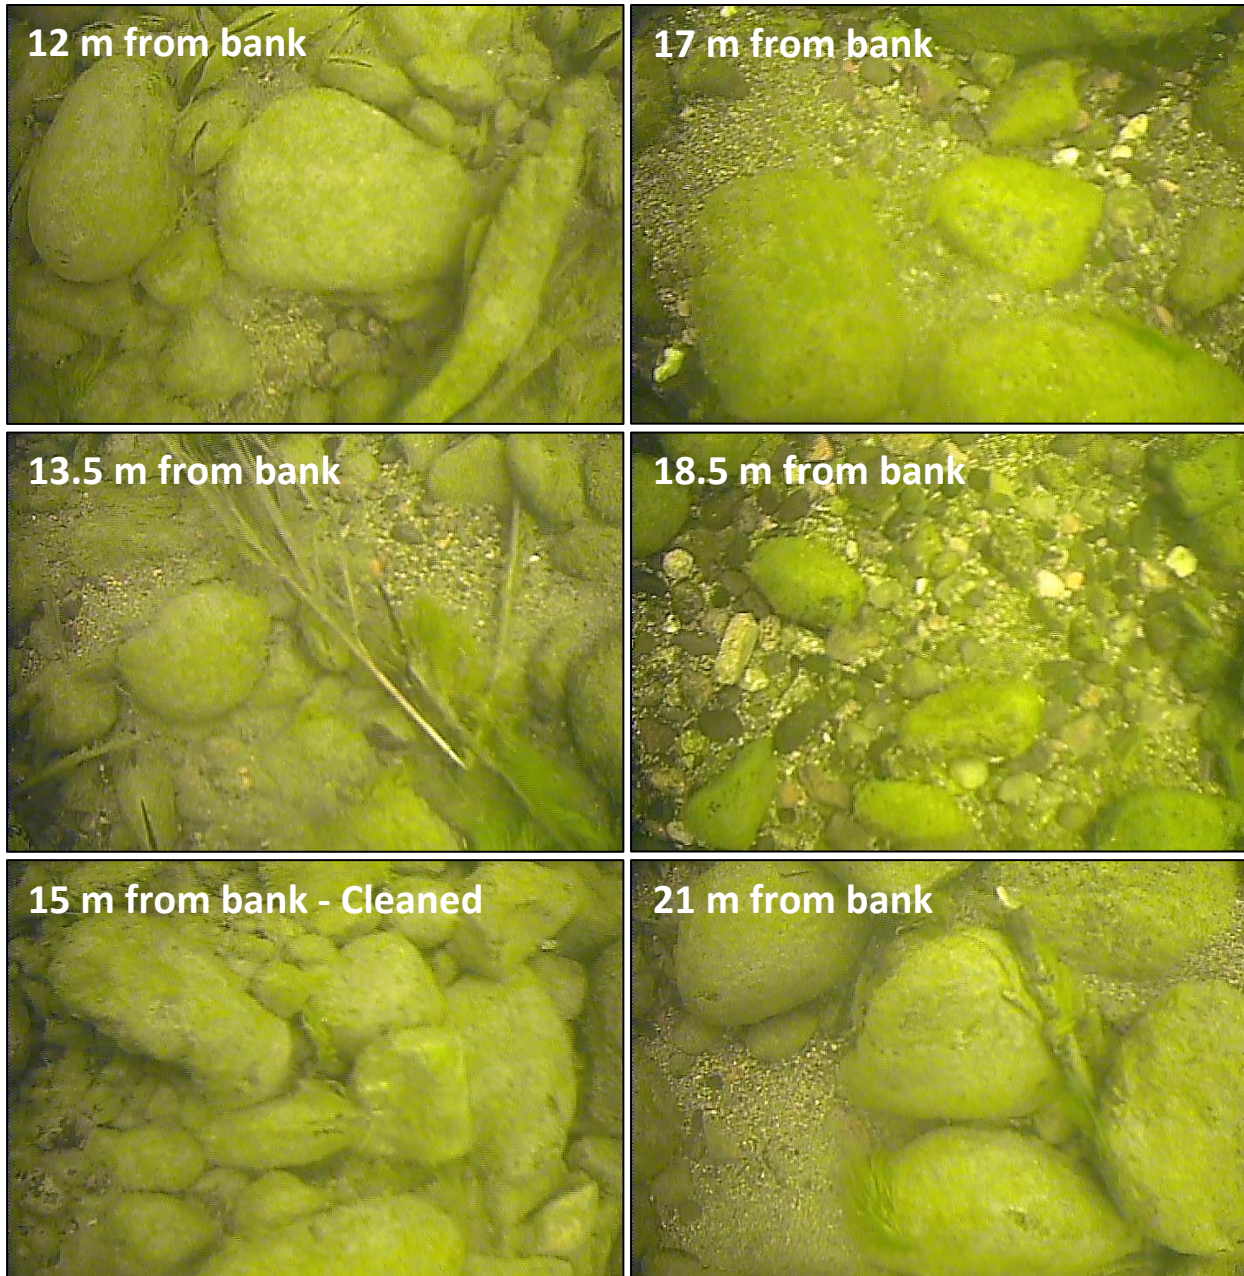
Figure 3.6 Substrate photos taken along a transect crossing the cleaned area of the Lower Patch on June 22, 2020.

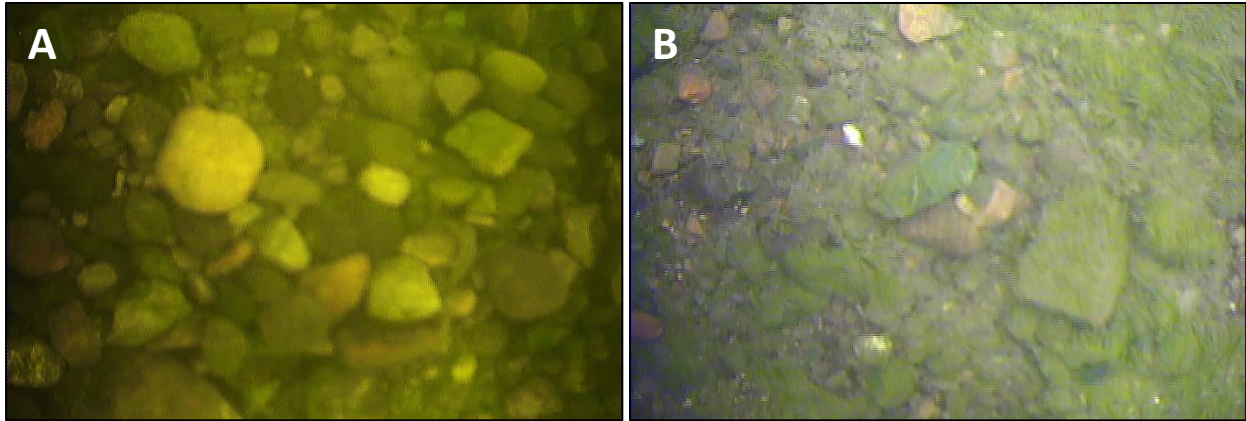
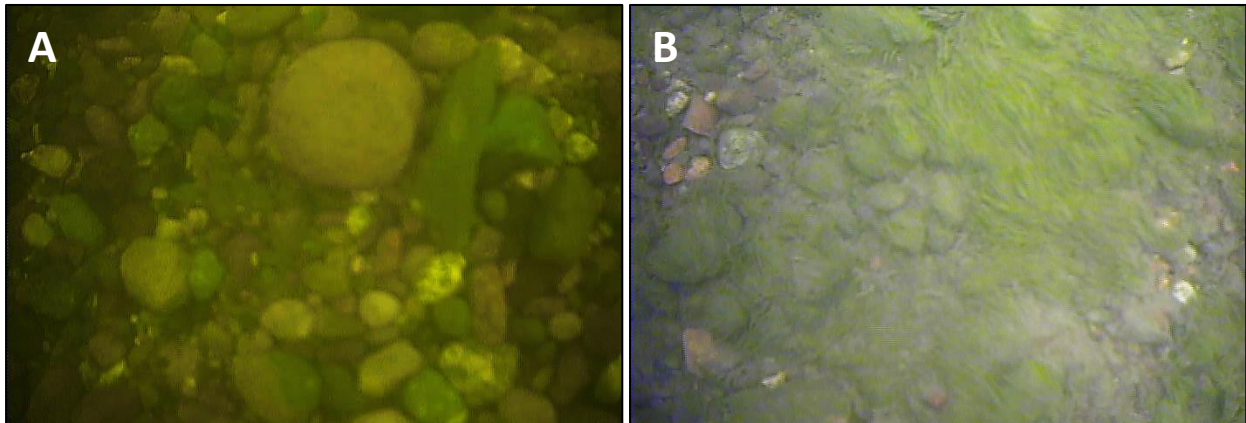
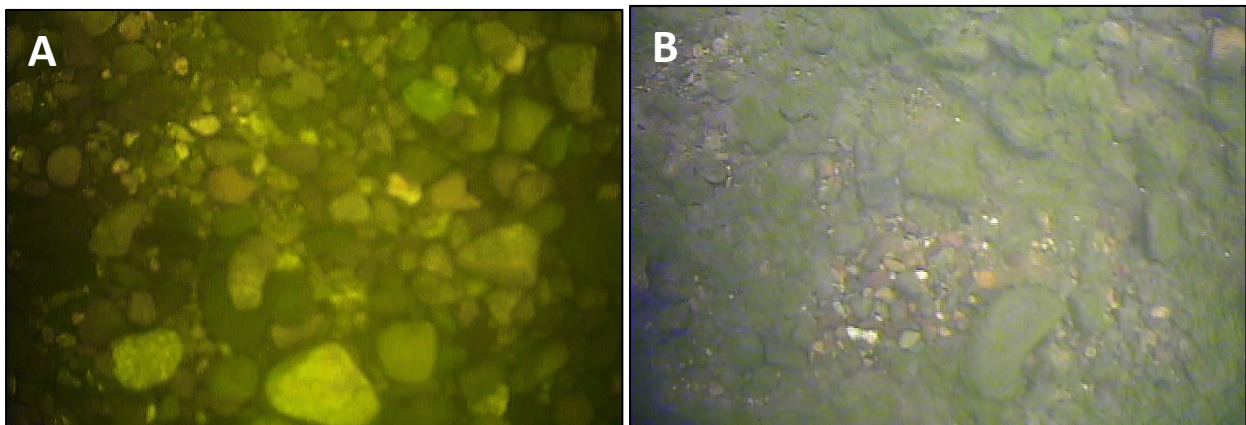
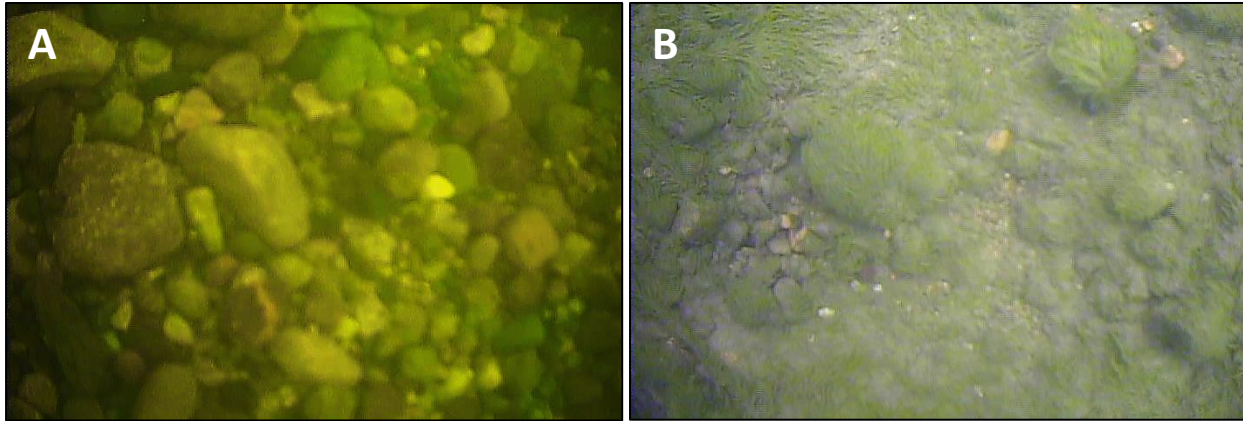
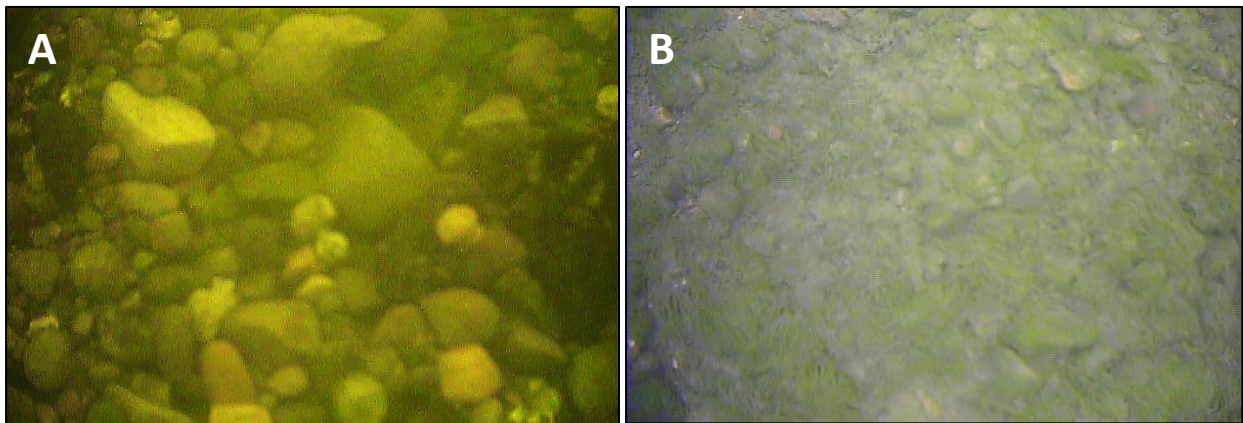
Substrate monitoring photos were taken at 5 specific locations within the Lower Site treatment area (Figure 3.7). Photo comparisons of the substrate during the pre- and post-spawning period are provided below (Photo 3.13 – Photo 3.17); however, it is important to note that the scale in the May and June images is not the same, since, in May, the camera mount settled deeper within the newly cleaned deposits of loose gravel, thus magnifying the appearance of the gravels.

Firstly, it is important to note that the growth of macrophytes within the entire area rendered detailed observations of the underlying substrate difficult. That said, the condition of the cleaned substrate at Sites 1, 2 and 3 appears to have been somewhat maintained over the monitoring period, as the gravels still protrude above the bed and are not embedded in sand; this is particularly the case at Site 3, where a pocket of clean gravel is clearly visible which closely resembles the cleaned substrate. Sites 4 and 5 appear to have undergone greater siltation over this period, as the follow-up imagery taken in late-June shows a general cover of grey material, which is assumed to be very fine sediment. These two sites are located nearer to the bank, where siltation may be greater due to lower flow velocities, further exacerbated by the macrophytes which can reduce near-bed velocity and promote sediment retention.

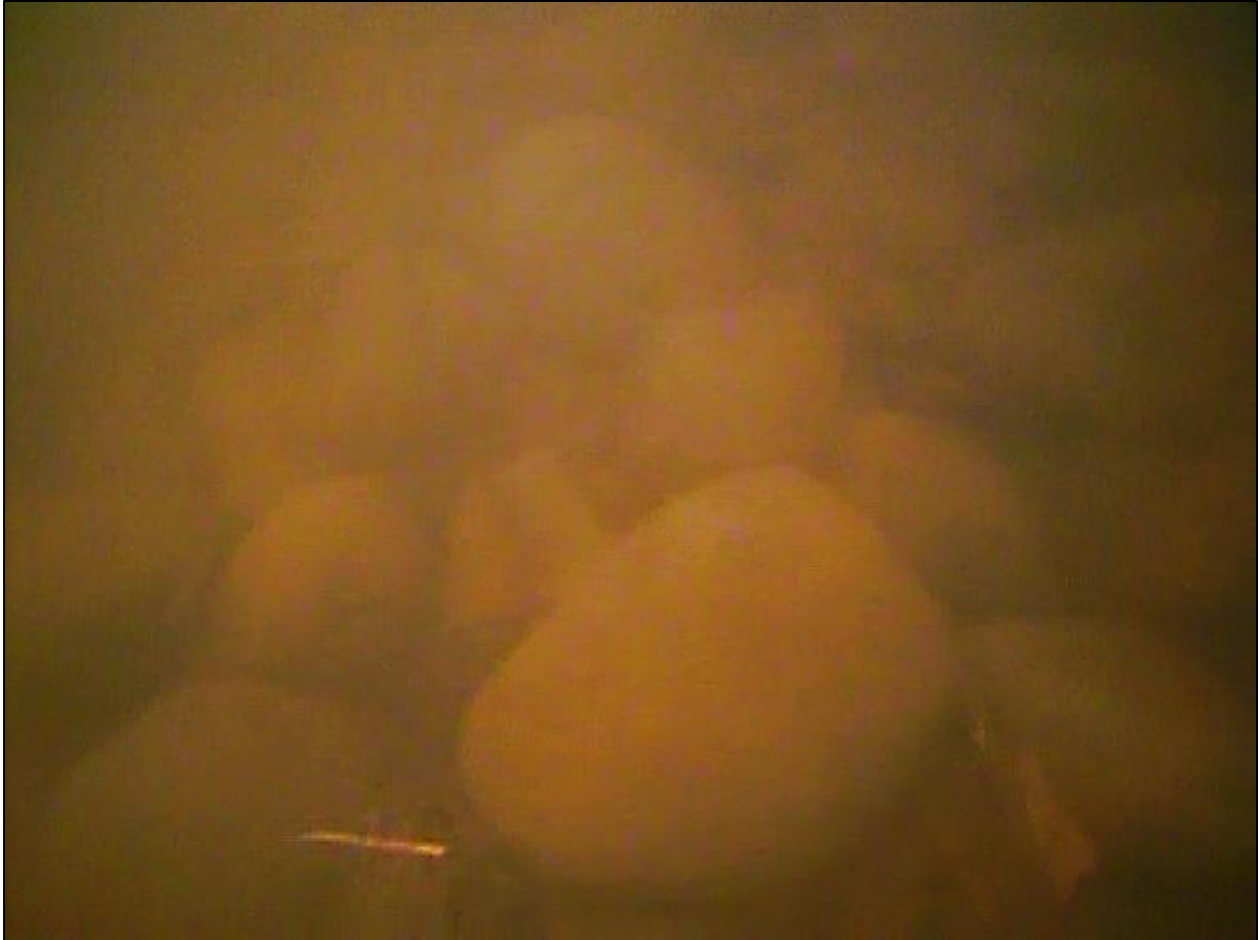
Photo 4.1 Existing substrate observed on the Lower Patch showing large rounded cobbles which may not provide suitable interstitial habitat due to the large size of the voids.
