**Nechako Sturgeon Spawning Gravel
September 2011 Substrate Assessment**

**Ministry of Forests, Lands and
Natural Resource Operations
4051 18th Avenue
Prince George, BC
V2N 6H2**

**NHC 35762
Final Report
March 12, 2012**

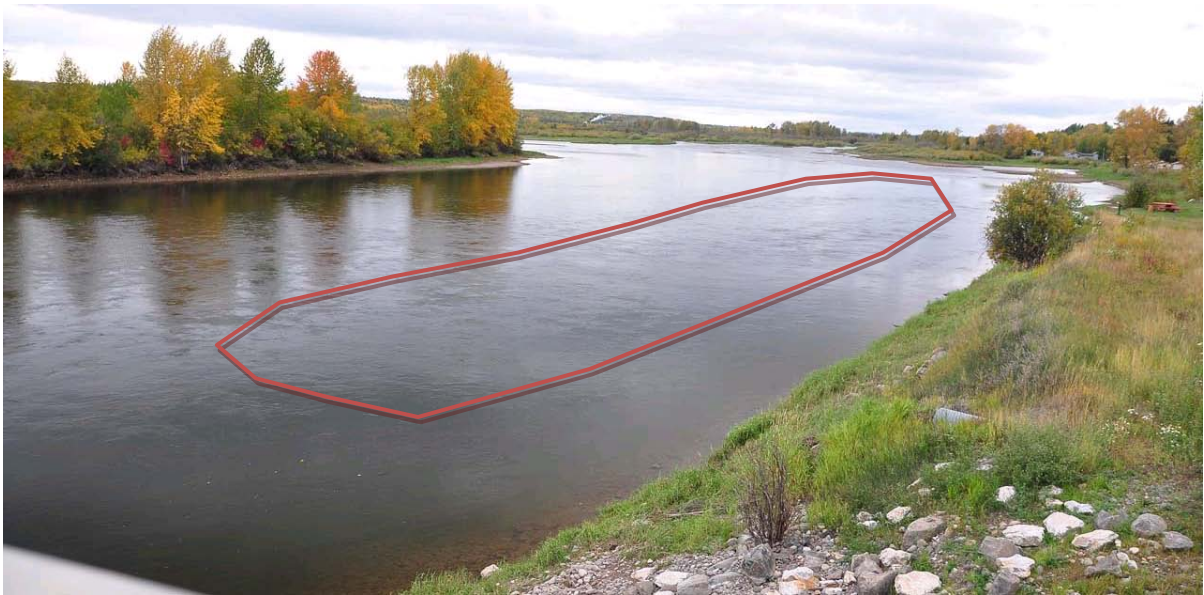
Figure 1: Lower substrate placement location. Substrate was placed in pool on right side of image in the region highlighted by the polygon.

The lower site is visible in Figure 1 and is just downstream of the confluence of the main channel with a number of smaller channels that flow through an island complex. The middle site is on the right bank of the Nechako River and has a tributary enter the site near the top of the site. At both sites water depths varied between about 0.8 and 2 m and were locally deeper at the middle site. During the sampling the discharge in the Nechako River at Vanderhoof was about 100 m³/s (based on preliminary WSC data at the 08JC001 gauge). The placed material was specified to be between 20 and 200 mm, with 20-30 % in the 20-40 mm range and 30-50 % being between 150 and 200 mm.

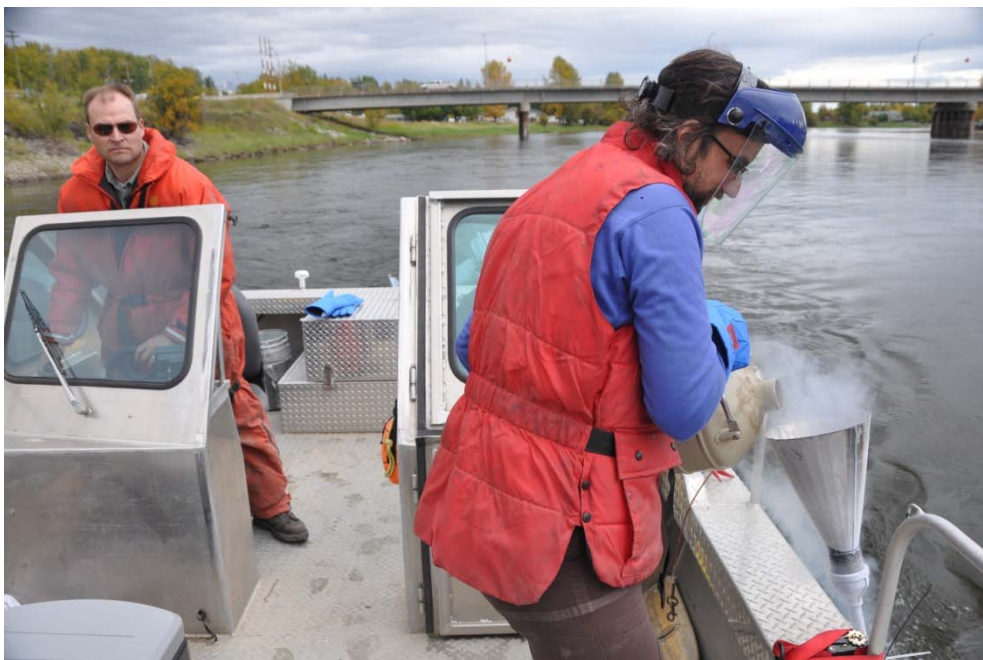
Figure 3: Liquid nitrogen being poured into the funnel that leads into a 20 mm diameter pipe that has an outlet 10-30 cm below the bottom of the core.

To collect samples of the substrate a 2.5 or 3 m long metal pipe was hammered into the bed, and then 5 liters of liquid nitrogen were slowly poured into the pipe (Figure 3). While the liquid nitrogen was evaporating heat was extracted out of the substrate around the core and as a result the substrate became frozen to the core (Figure 4). Once the liquid nitrogen quit evaporating the core was pulled from the bed and the sediment sample inspected. The initial sampling plan was to have 6 high quality cores from each of the pads that were distributed across the pad. In total 15 cores were collected, which required 160 Liters of Liquid Nitrogen (Figure 5).

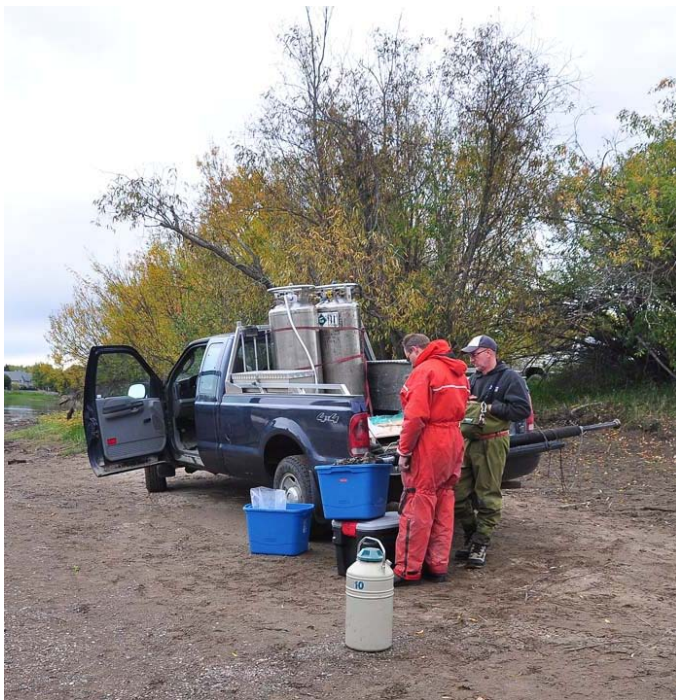
Figure 5: Two 160 Litre dewars of liquid nitrogen are in the back of the truck and a 10 L dewar used to pour liquid nitrogen into the cores is visible in the foreground.

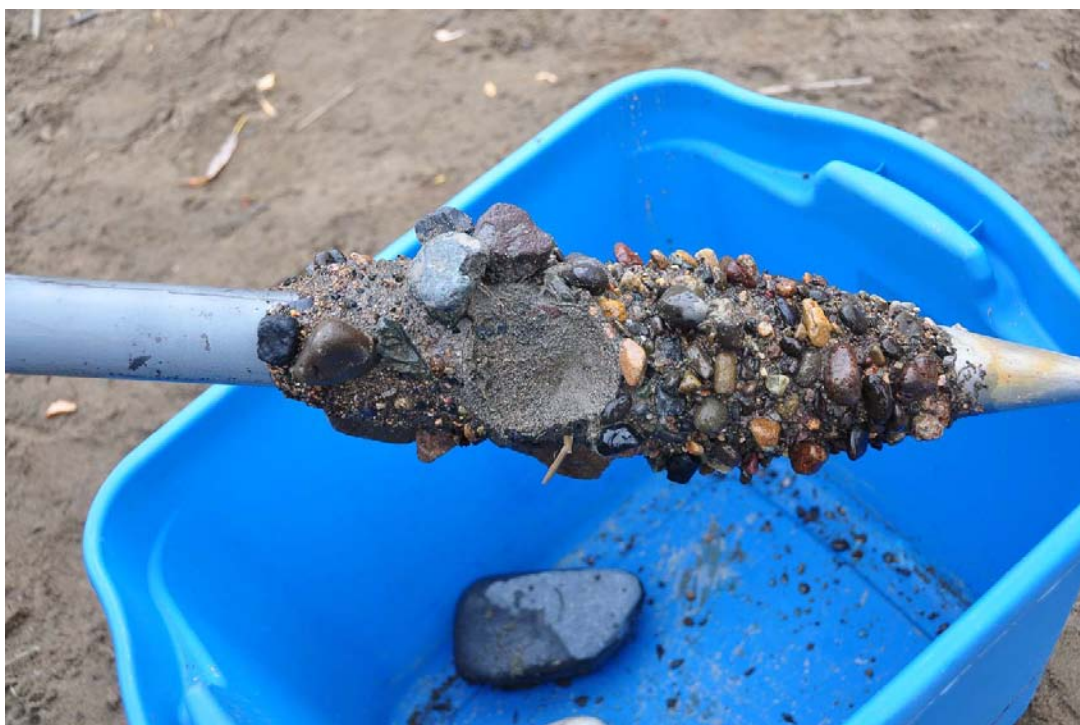
Figure 6: Photo of Core 5 from the lower site. Fine gravel and coarse sand fill the interstitial spaces around the larger placed stones. The substrate below the larger stones is the native material. The native material is composed of clast supported gravels with a sand matrix.

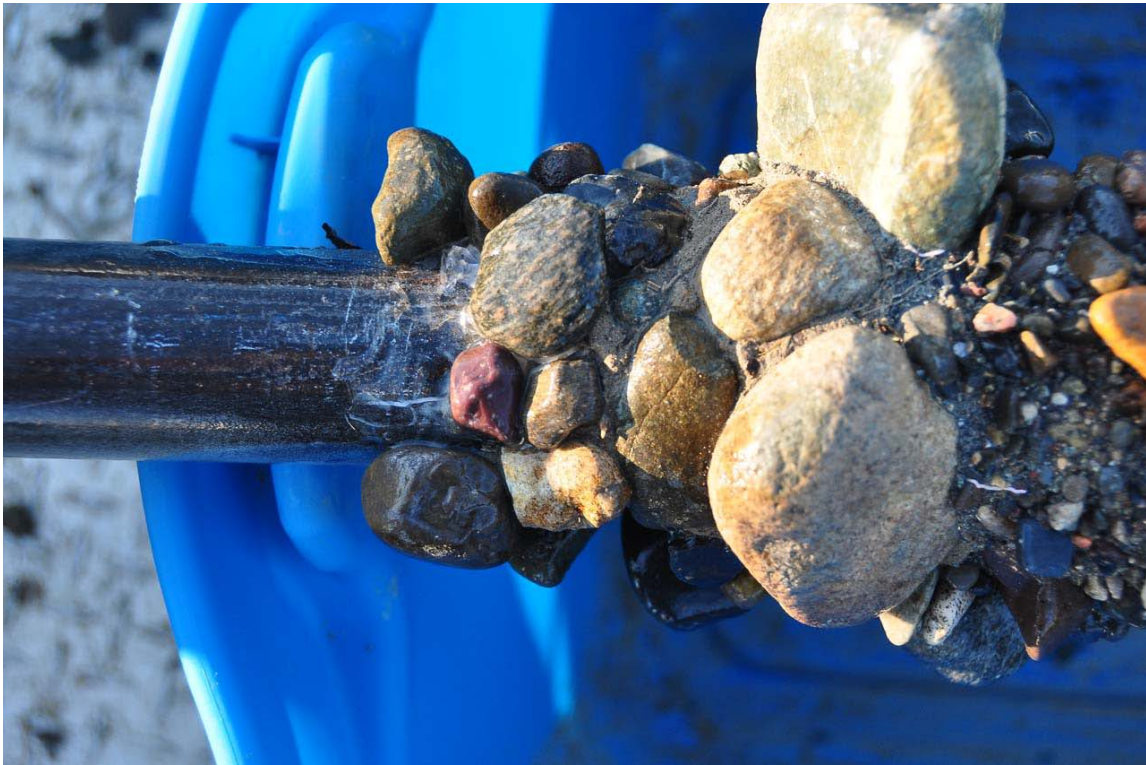
Figure 8: Core 8 from the middle site. The top portion of the substrate has ice filled interstitial spaces while the bottom portion of the substrate has fine to medium sand with organics in the interstitial spaces. Below the placed material the native substrate is similar to the lower site.

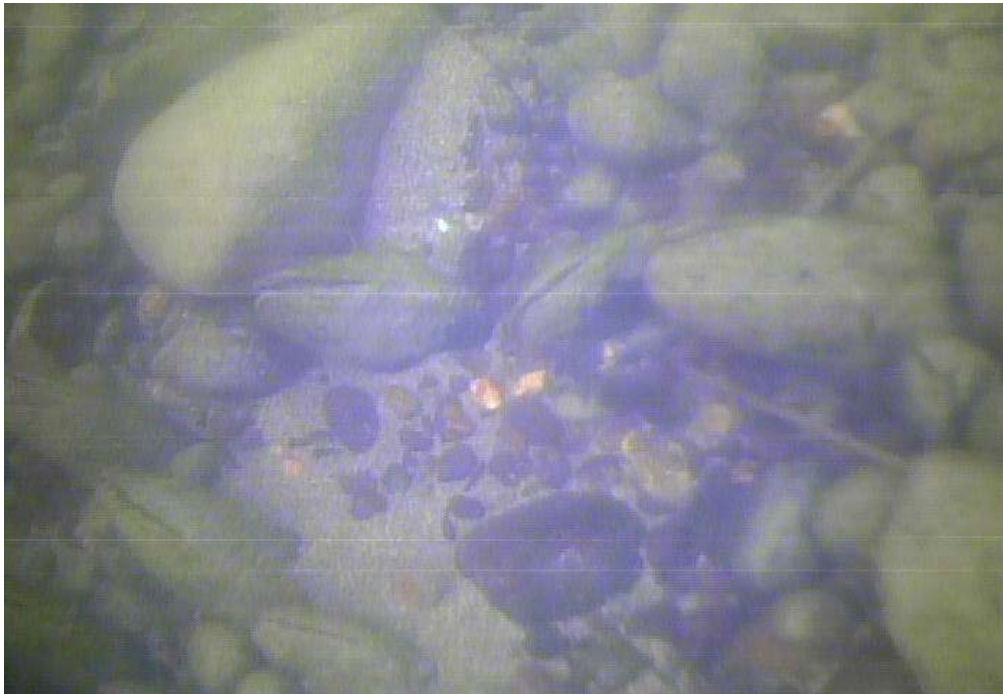
The underwater camera photos from the lower site show that much of the placed substrate had sand and gravel washed in around the placed material (Photo 1). Two of the images at the downstream end of the pad suggest that the interstitial spaces are not completely full of fines; however, these conditions are rare. The underwater images also suggest that freshwater mussels have extensively colonized the pads. Mussels were also collected with the freeze cores.

Photo 1: Image of substrate 46 m upstream of end of downstream placed substrate pad. Fines are visible around most of the large stones. It appears that four mussels have colonized the area in the image.

Despite a two month long freshet with a discharge of 500 m³/s, there are no signs that the transport of sand and gravel became supply limited (Photo 1 and Photo 2 show an abundance of fine substrate in the lee of large cobbles). On account of flow regulation, the inputs from the Cheslatta fan and sediment supply from the upland areas, as well as field observations following the 2011 freshet, it is unlikely that high flows can exhaust the supply of gravel and sand.

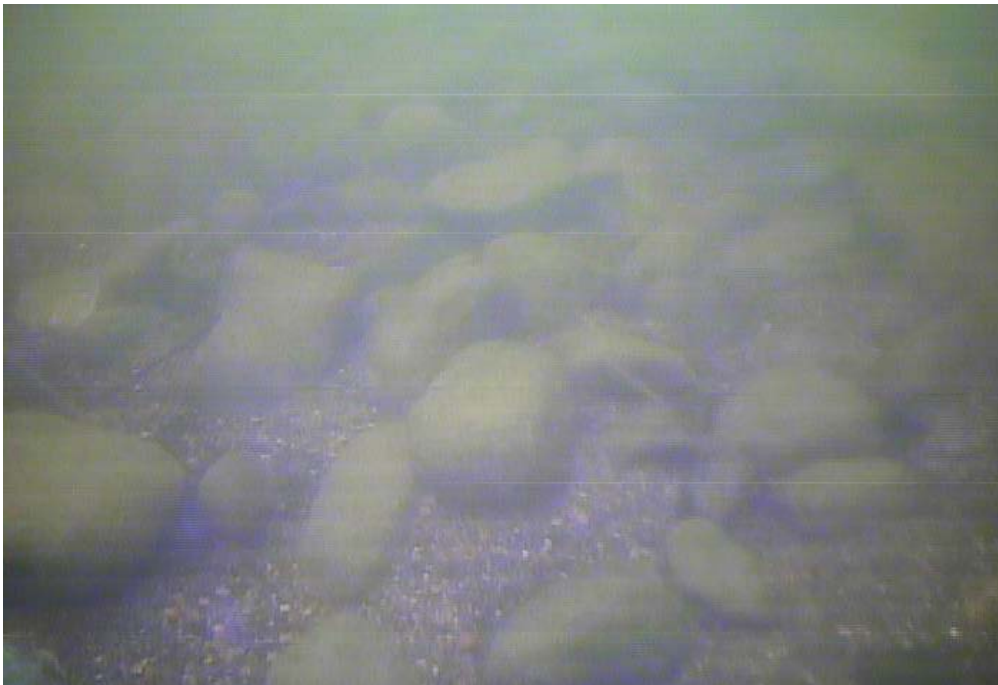
Photo 2: Image of substrate 28 m upstream of end of downstream placed substrate pad. Fine gravel is visible around all of the cobbles.

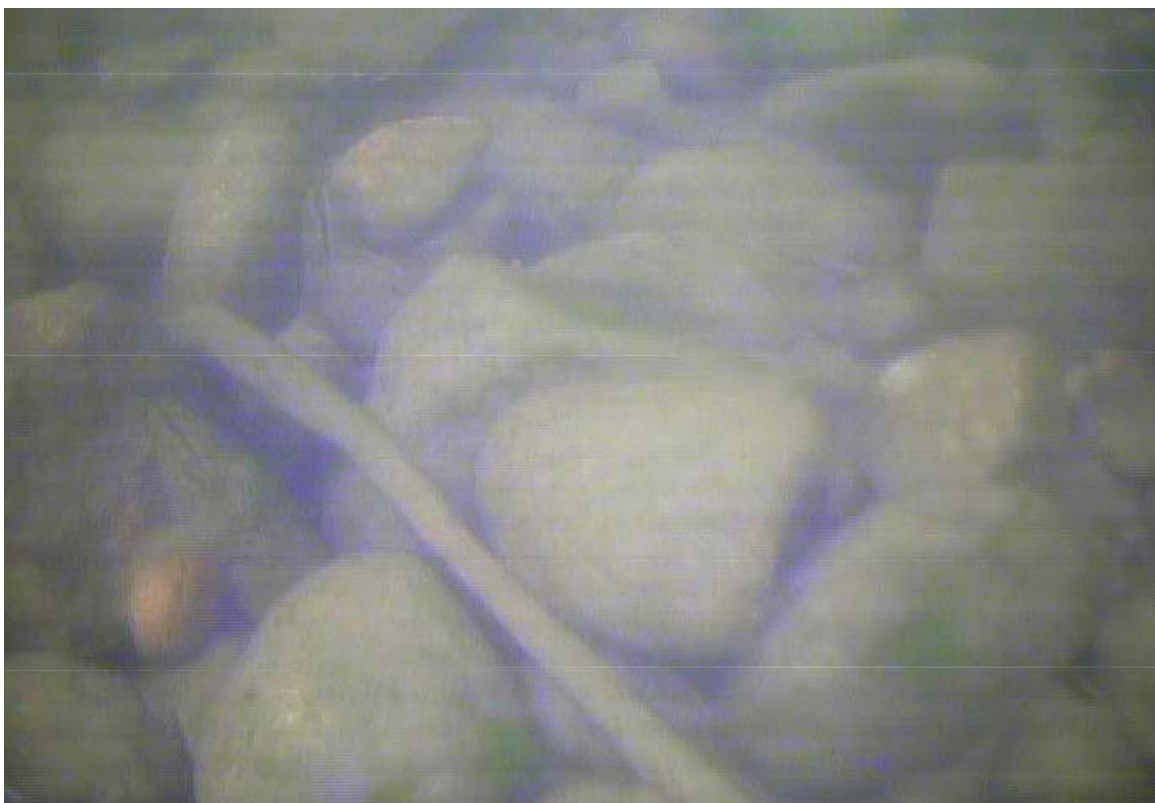
Photo 3: Image of substrate 23 m upstream of end of downstream placed substrate pad. Fines are visible around some of the large stones, but some interstitial spaces remain. Two mussels have colonized the substrate.

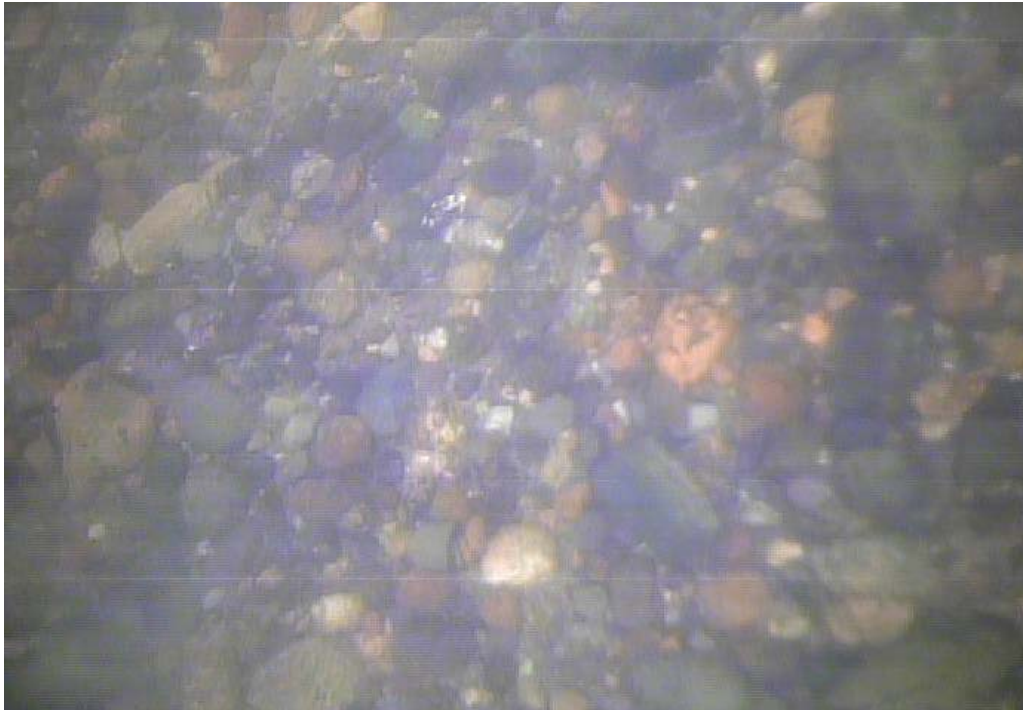
Photo 8: Image of native substrate that does not have a sand drape over the gravel. Photo taken 45 m upstream of lower pad in center of channel.

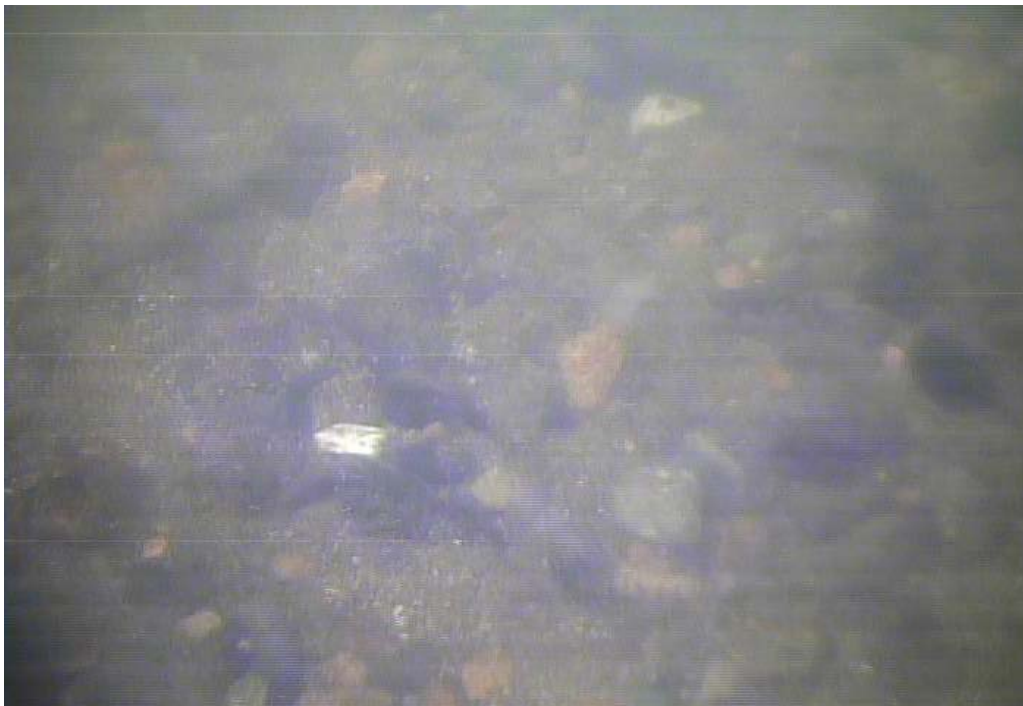
Photo 9: Image of native substrate showing sand drape over gravel. Photo taken just upstream of lower pad in center of channel.

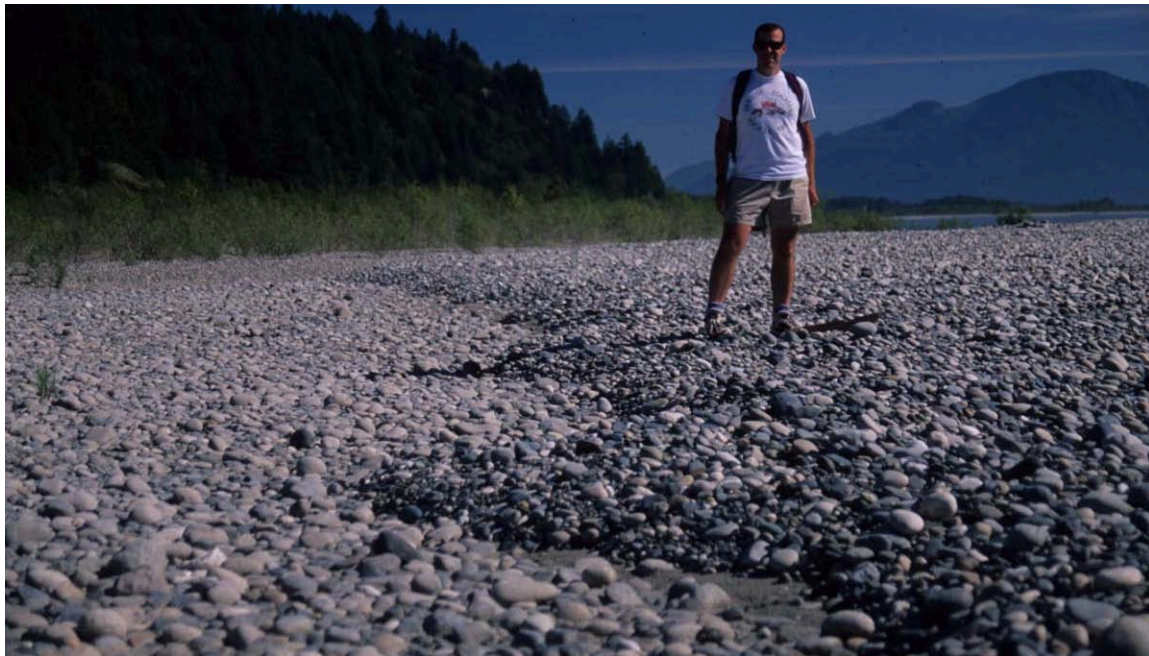
Furthermore, bedload often moves as sheets, such as the gravel sheet shown in Figure 13. The movement of the sheet progresses in a linear fashion from upstream to downstream. Observations from the placed substrate suggest bedload sheets composed of coarse sand and fine gravel may have moved over the lower site and along the left bank edge of the upper site. The movement of a bedload sheet is likely to only proceed once the interstitial spaces are essentially filled and thus pads subject to bedload sheets are apt to fill progressively in a downstream direction.

Figure 13: Photo of a gravel sheet on the Fraser River.
