**Nechako River 2013 Sediment
Transport Investigations**

**Ministry of Forests, Lands and
Natural Resource Operations
4051 18th Avenue
Prince George, BC
V2N 6H2**

**NHC 300252
Final Draft Report
December 31, 2013**

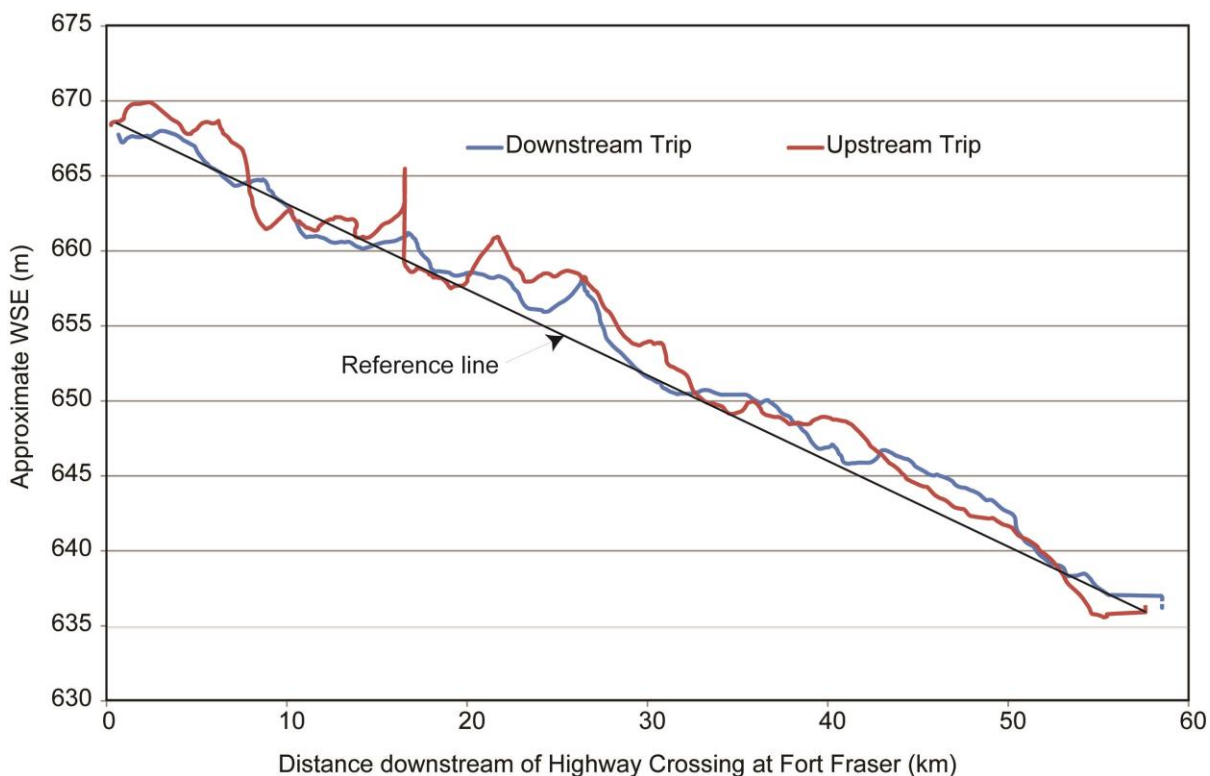
Figure 2: Approximate long profile of Nechako River from Highway Crossing at Fort Fraser to Lower Site downstream of Burrard Street Bridge in Vanderhoof. Upper site is located at the 56 km point.

In summary, the spawning reach at Vanderhoof is located in an area with a marked change in channel gradient (**Figure 2**) that promotes the deposition of sand and gravel sediment that originates from the upstream watershed. Flow regulation and channel confinement have likely increased the deposition of sediment in the reach.

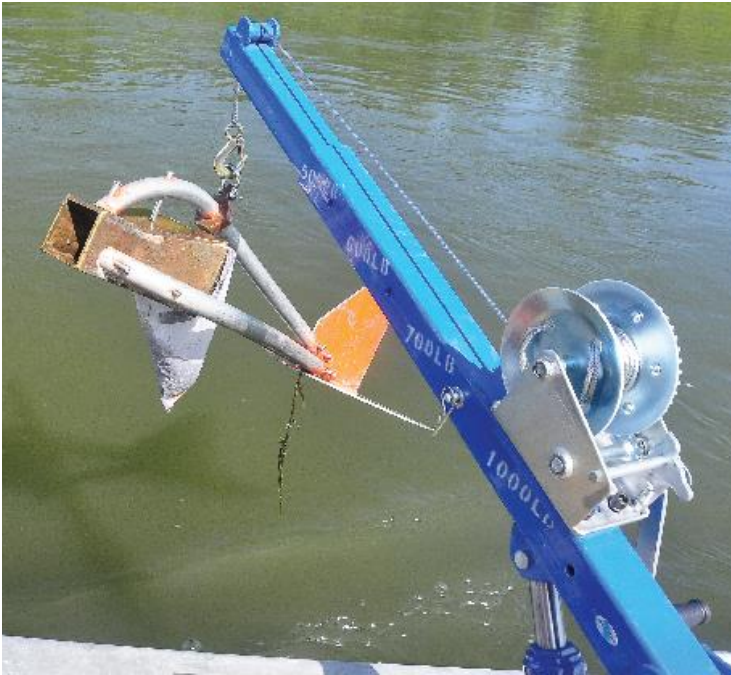
Figure 3: Photo showing the HellySmith sampler and crane mount that were used.

The Hellysmith sampler was relatively easy to use and provided reasonably accurate information about the mobility of the sediment at the sites. The biggest challenge was holding the boat still, especially at the Upper Site where velocities were faster. During subsequent field work a large anchor coupled with a windlass winch would greatly facilitate sampling.

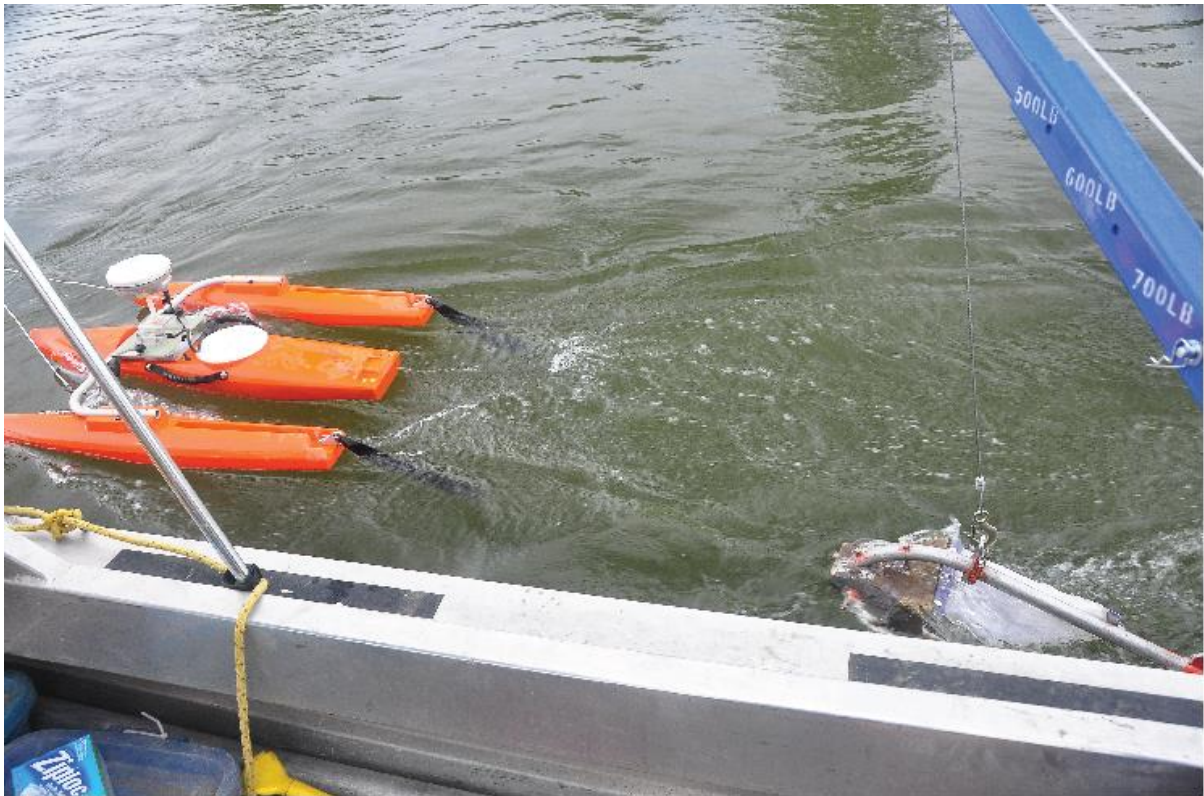
Figure 4: GPS mounted above ADCP that was used to determine velocity and moving bottom conditions.

A RDI Acoustic Doppler Current Profiler (ADCP) (**Figure 4**) was used to monitor if the bed was observed to be moving at each of the sites as well as the mean velocity profile when the samples were being collected. Before or after collecting each set of HellySmith samples the discharge through the channel was also measured. A Real Time Kinetic (RTK) GPS was mounted on the ADCP boat during the August sampling to enable flow measurements during moving bottom conditions.

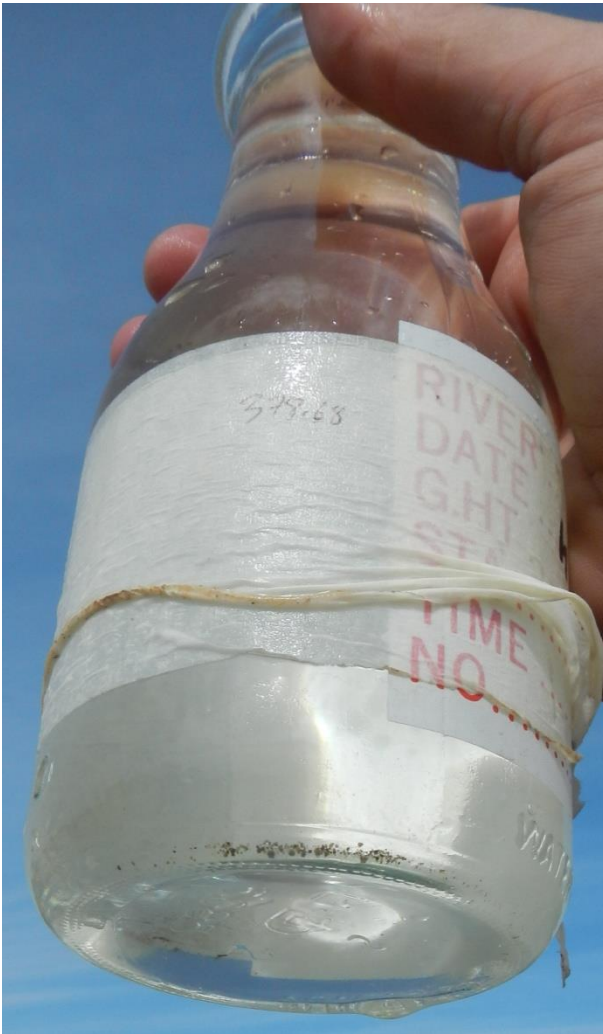
Figure 6: Water Sample from Nechako River Collected in August 2013. Sand grains are clearly visible in otherwise clear water.

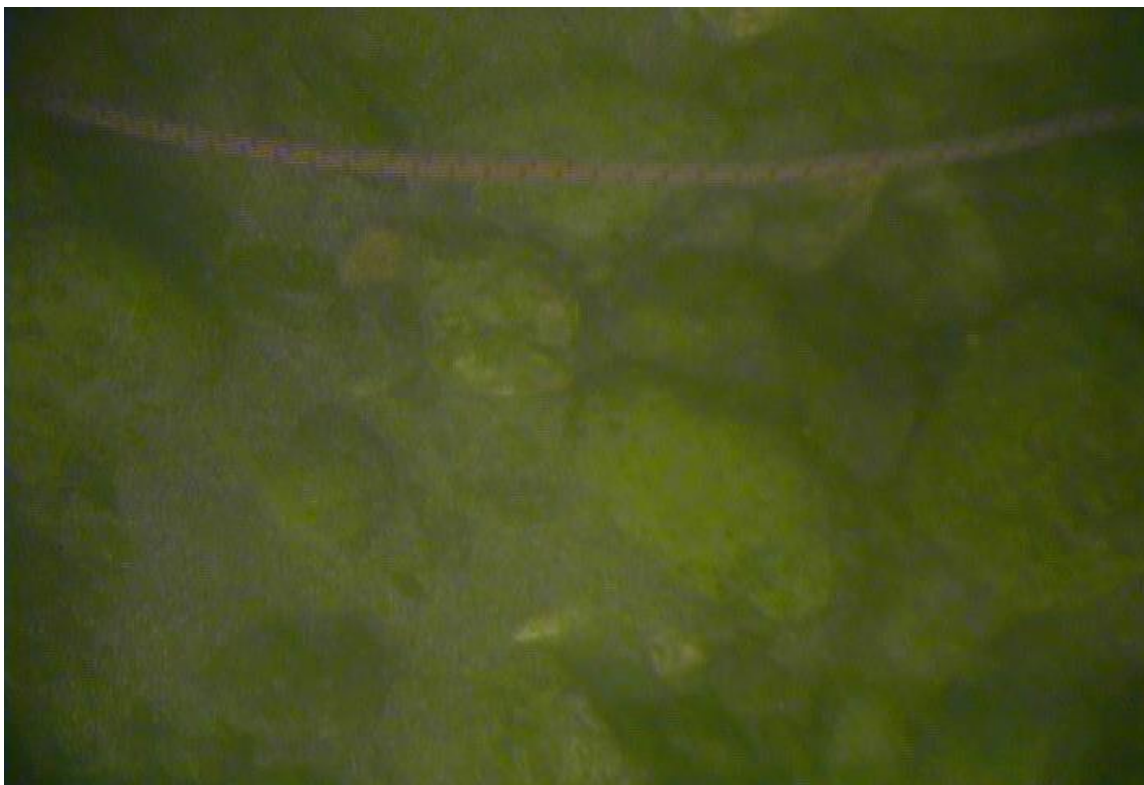
Photo 1: Bed material at US-A during the August trip.

During the August sampling trip moderate transport rates were found along the left bank with a decrease trend across the channel despite high shear stress across the entire channel (**Table 3**). The maximum transport rate found at US-A, the site closest to the left bank, at 6.1 g/m/s (**Photo 1**). Sampling at the Upper Site proved to be the most challenging of all the sites as the high velocities and cobble bed prevented the boat from anchoring securely.

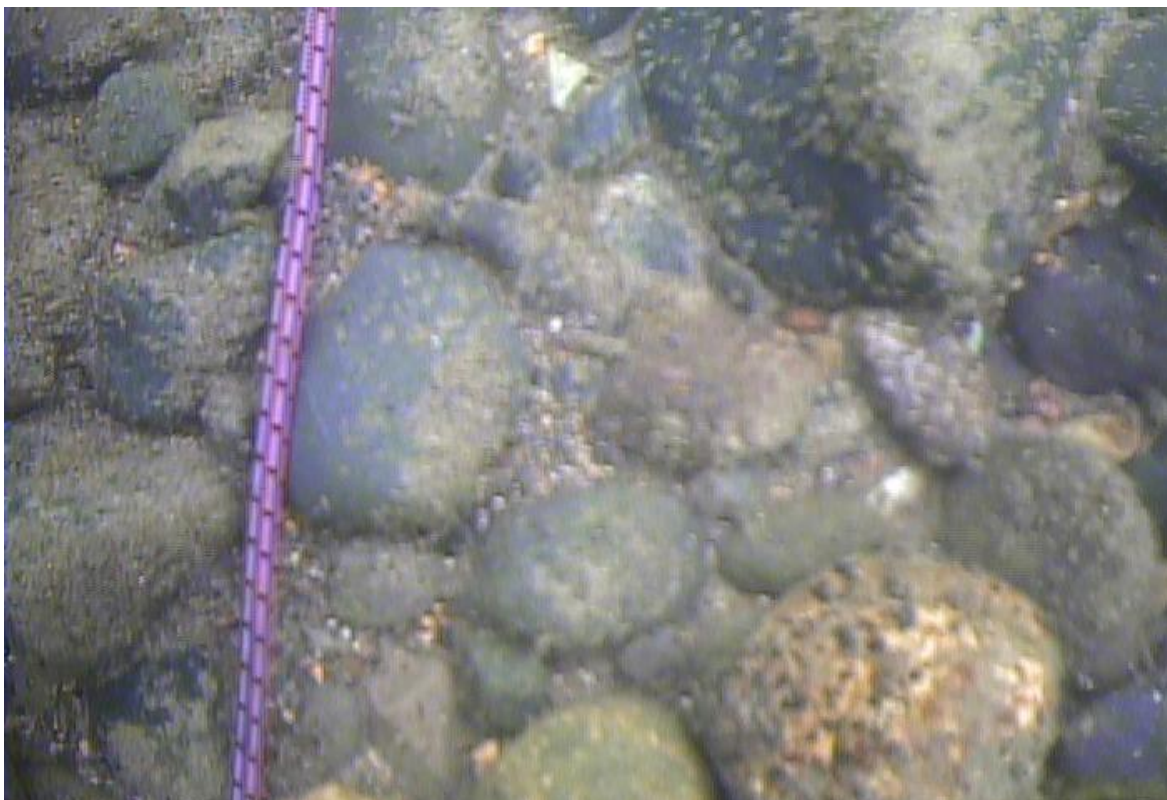
Photo 2: US-C during the October sampling trip.

During the October sampling trip no sediment was captured at any of the stations (**Photo 2**). An additional two stations were added compared to the August trip to ensure that the sampling spatial density was high enough and any discrete areas of transport were not missed.

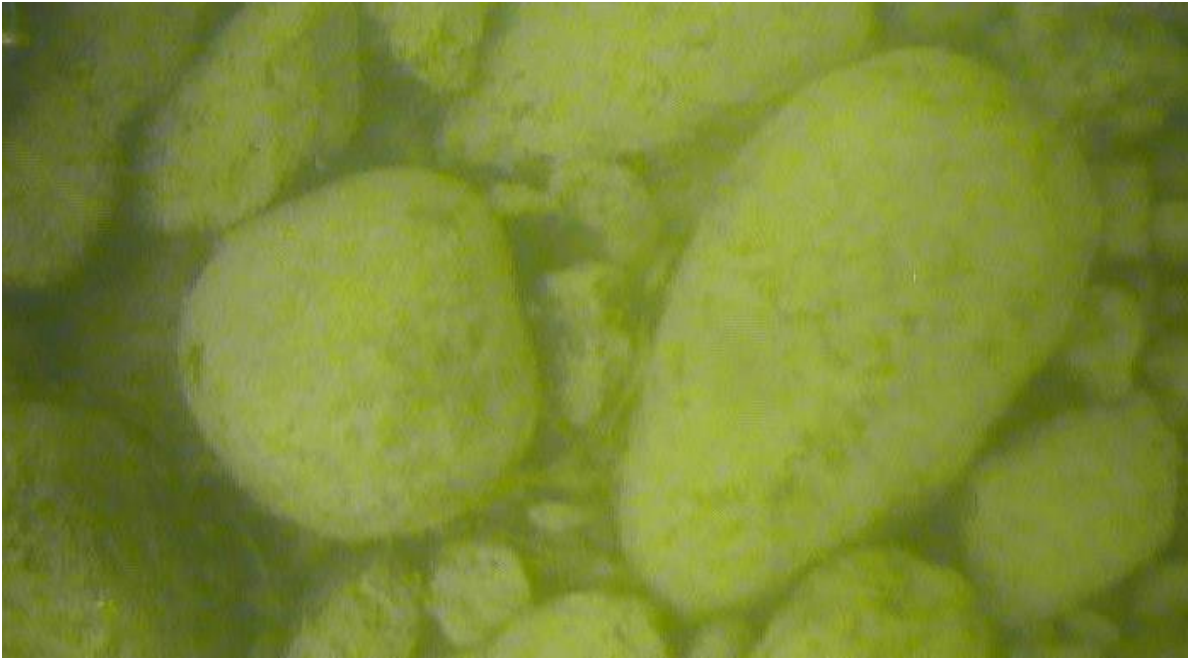
Photo 3: Cobble bed material at site MP-B during the August sampling trip. Filamentous algae are visible growing on placed substrate and there is not sand present.

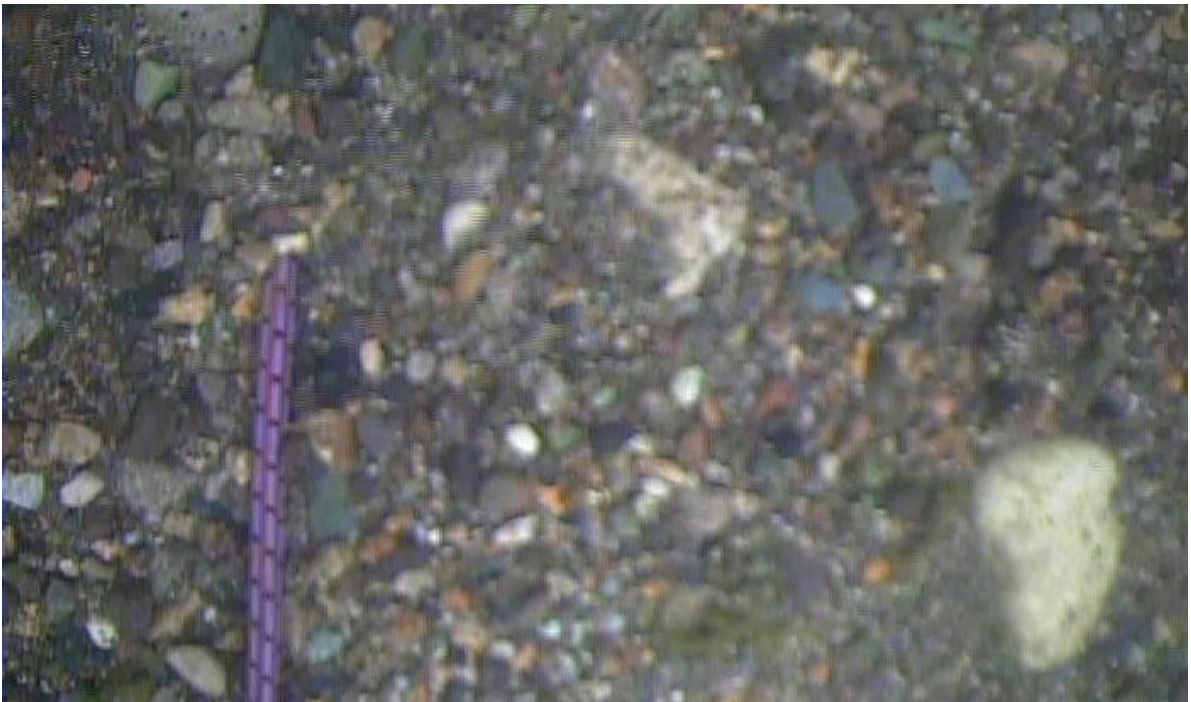
Photo 4: Underwater photo of substrate from Middle Patch Station MP-D from the October sampling trip. The rope has been partially buried by mobile sediment after the camera was placed.

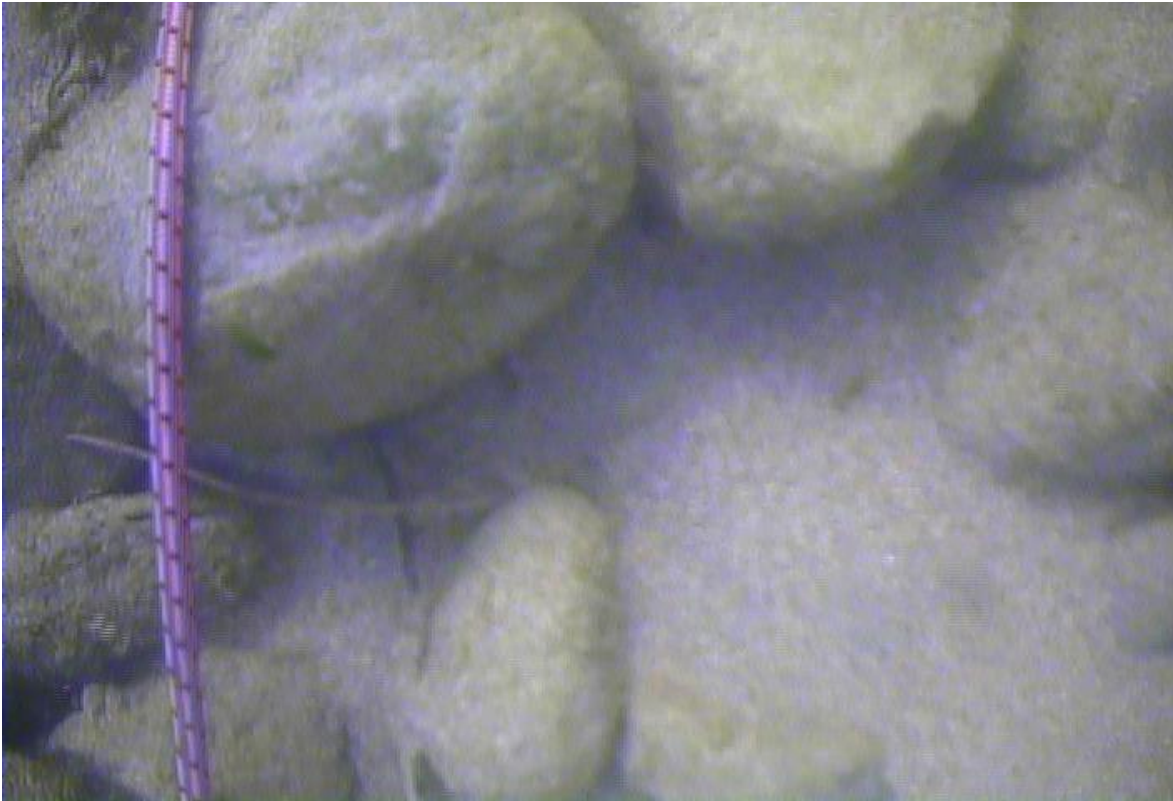
Photo 6: Station LP-G during the October sampling. Coarse patch material with sand deposits in the interstices.

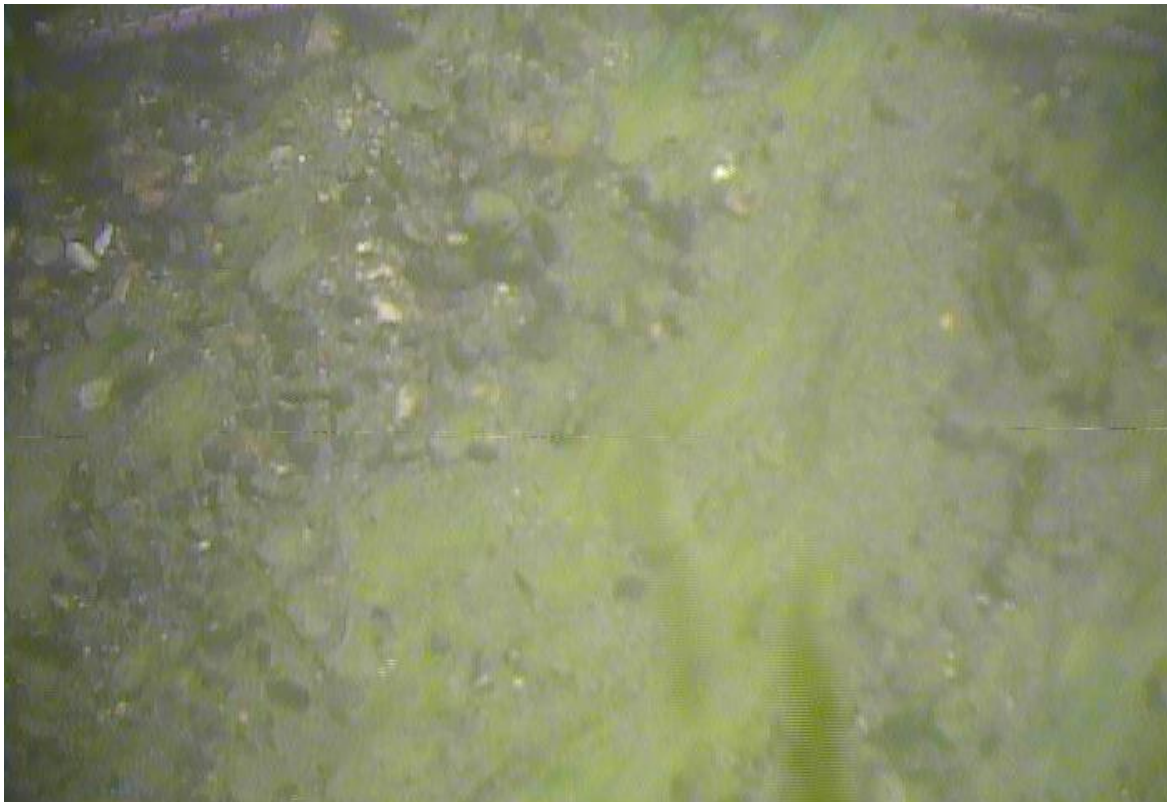
Photo 7: Underwater photo of substrate from LS-E during the August sampling trip.

During the August sampling trip mobile sediment was found at all the stations although it was primarily concentrated in the two stations closest to the right bank (**Photo 7**). Minimal sediment was found to be in transport on the outside of the corner despite having similar bed material and high shear stress (**Table 6**). This site showed considerably more sediment leaving the study site than was coming in as measured at the upper site. This would mean that the study reach would be expected to be degrading. Overall it does not appear this is occurring¹ and it is likely that sediment must be transported from upstream at another time of the year.

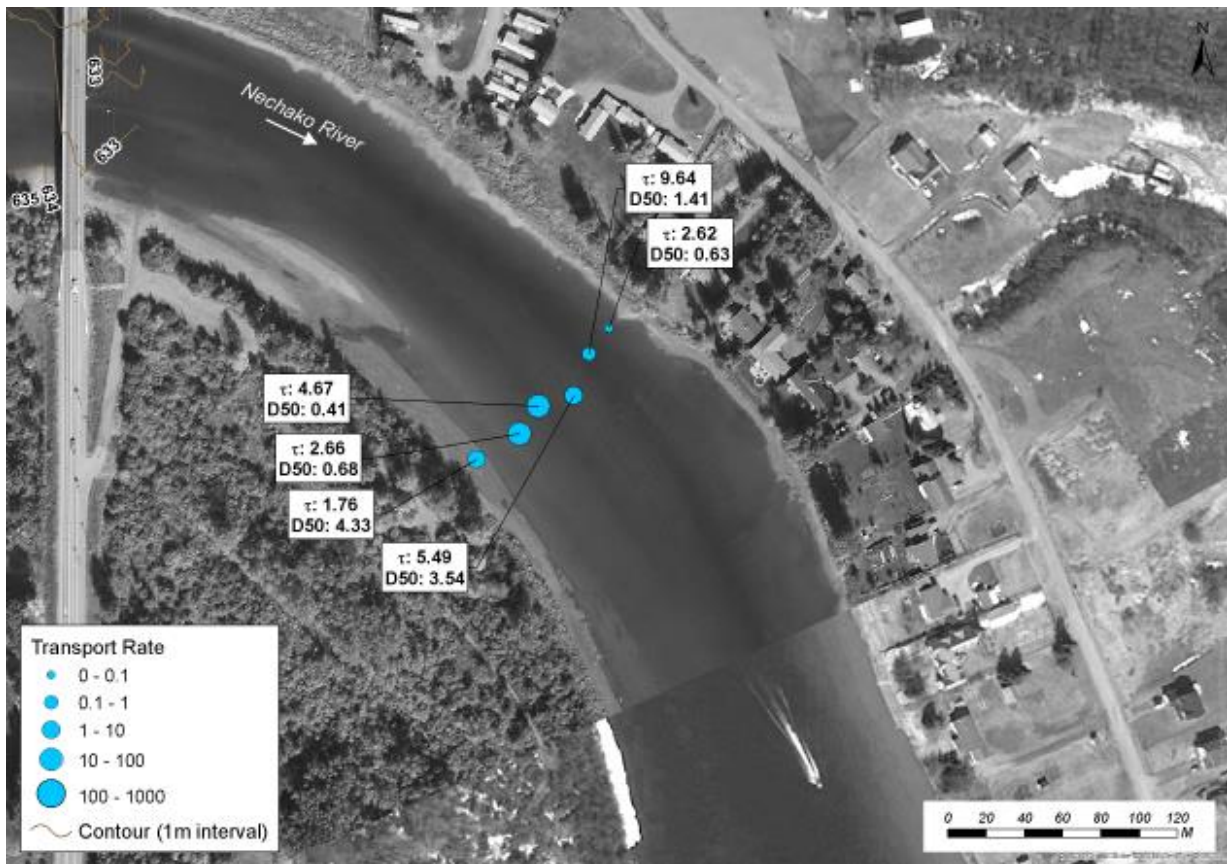
Figure 10: Overview of the sampling sites for the Lower Site. Shear stress (Pa) and D_{50} (mm) are given for each station. Transport rate (g/m/s) is represented by the size of the circle.

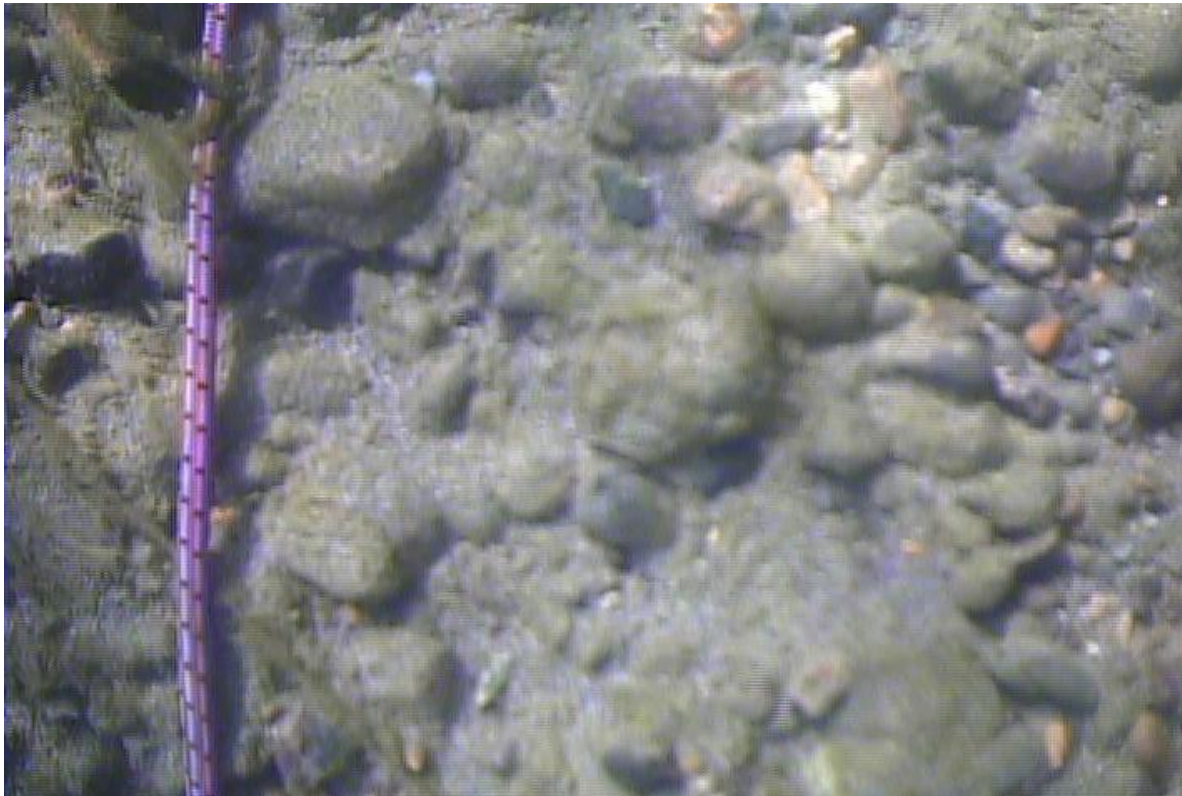
Photo 8: LS-E during the October sampling trip.

During the October sampling trip this was the only site to have significant levels of sediment transport (**Photo 8**). The sites that showed higher transport rates were in the middle of the transect, however, when the lower water levels are taken into consideration, the transport is still occurring along the inside of the corner. Due to the lower water levels the far right station was not accessible.

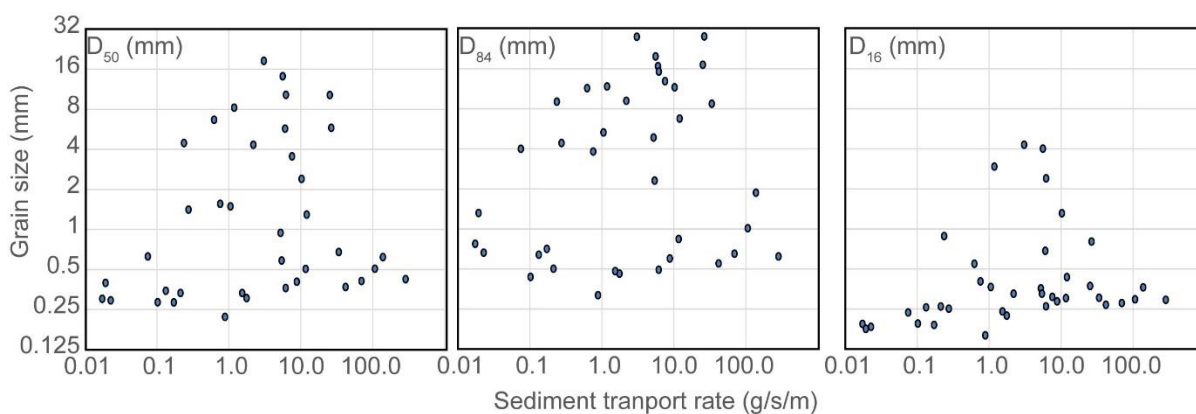
Figure 12: Grain size data for bedload samples as a function of transport rate.

At the site level we saw that transport rates tended to be highest in the middle portion of the channel where the bed was relatively finer and shear velocities were moderate or high. The outside corner of bends typically had low transport rates. In areas of high transport the material being transported was typically coarse sand, while modest rates of transport were either coarse sand or fine gravel (**Figure 12**). At low transport rates the bedload was predominately sand. While a detailed analysis of bed substrate was not completed, the general impression was that very high transport rates occurred when the bed was also coarse sand and the full range of bed grain sizes were mobile. At sites dominated by fine gravel and modest transport rates, the bed was commonly also fine gravel. In contrast, areas with coarse gravel typically had low transport rates or modest transport rates that were dominated by coarse sand. A more detailed analysis using the bed images could be conducted to assess the relation between bed grain size, transport and bedload grain size.

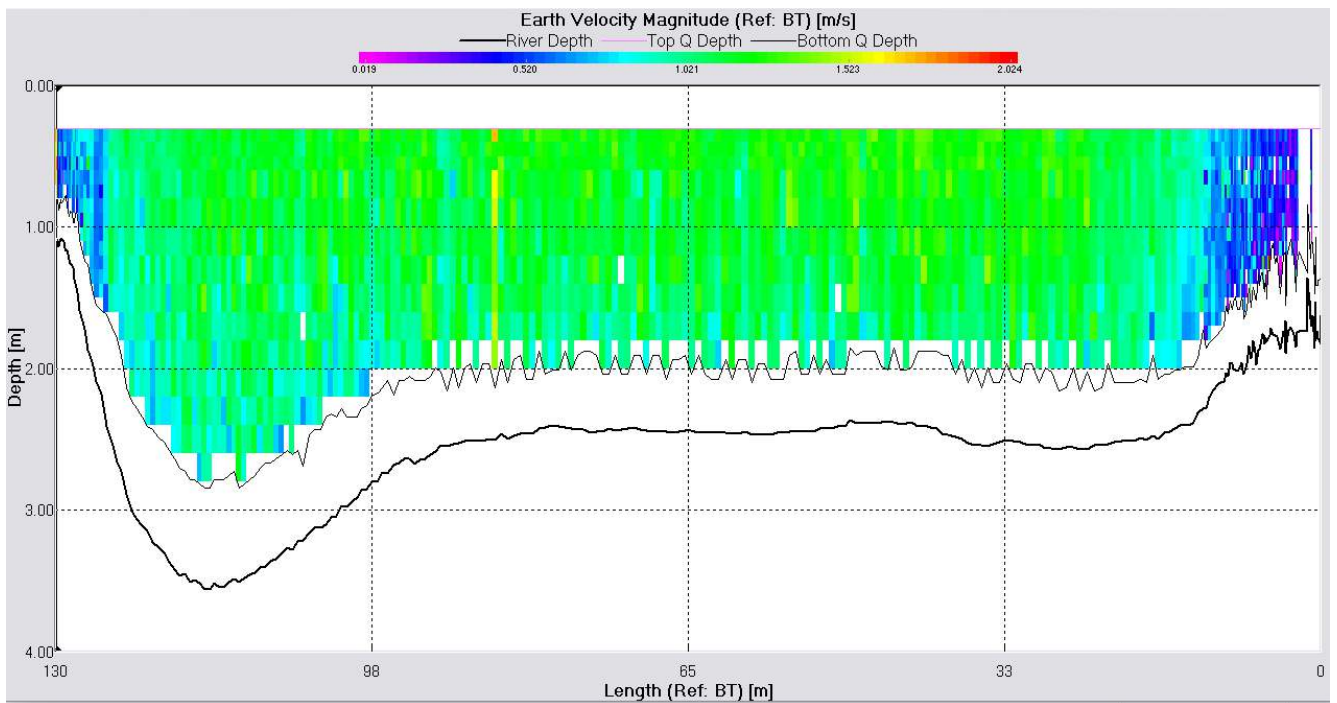
August 2013 discharge transect for the Lower Patch. ($Q = 320\text{m}^3/\text{s}$)

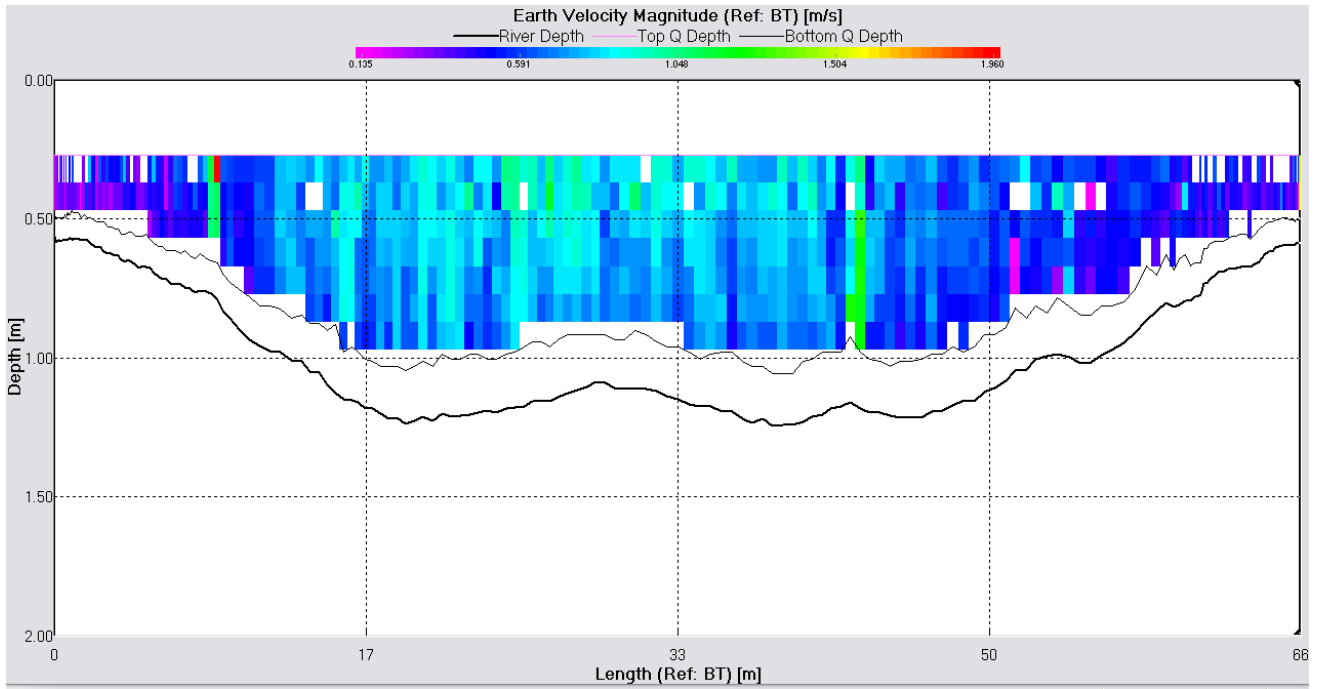
October 2013 discharge transect for the Lower Site. ($Q = 45\text{m}^3/\text{s}$)
