# Nechako River Substrate Monitoring Program 2022 Design and Installation Report

October 20, 2022  
Final Report, Rev. 1

**Ministry of Environment and Climate Change  
Strategy**

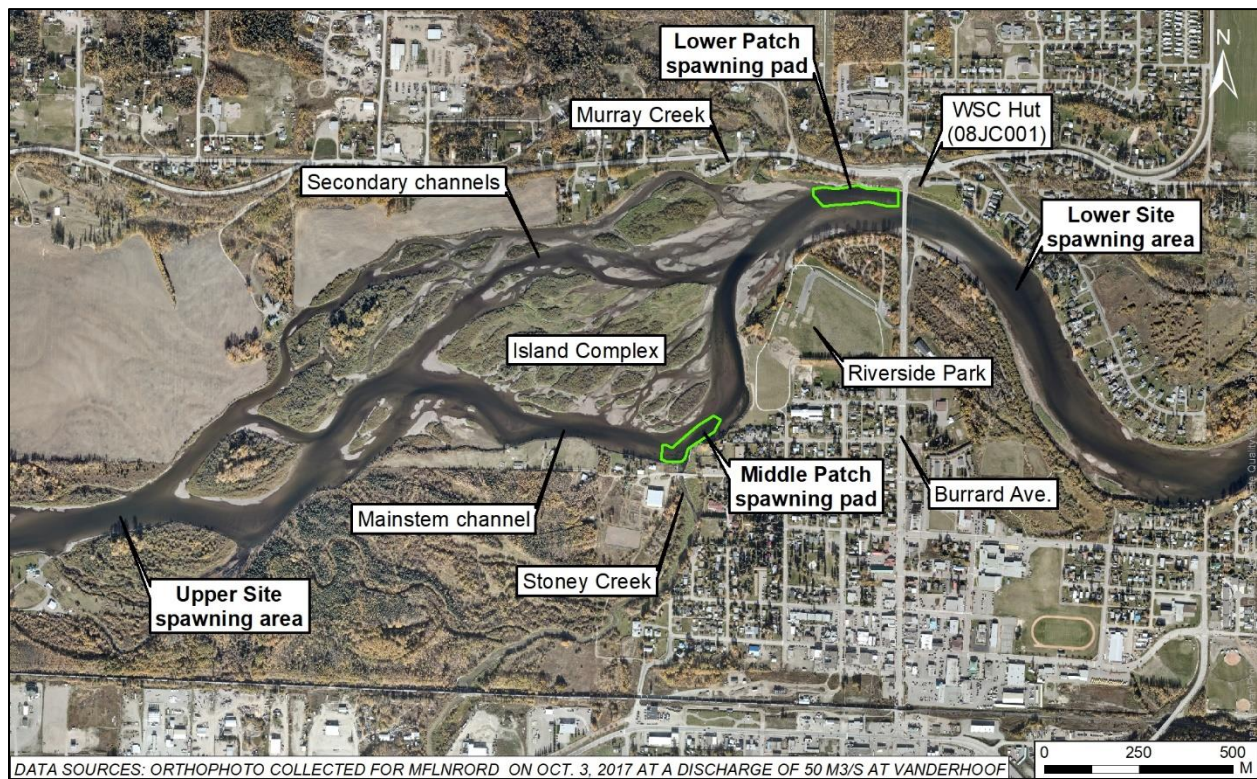
**Figure 1.1 Overview map of the critical White Sturgeon spawning reach on the Nechako River depicting key location references.**

The scope for this project included the design, fabrication, and deployment of three temperature sensor arrays capable of monitoring substrate infilling continuously and remotely. The arrays were deployed within a 100 m radius from the Water Survey of Canada (WSC) Hut (Figure 1.1), where 120 Volt AC

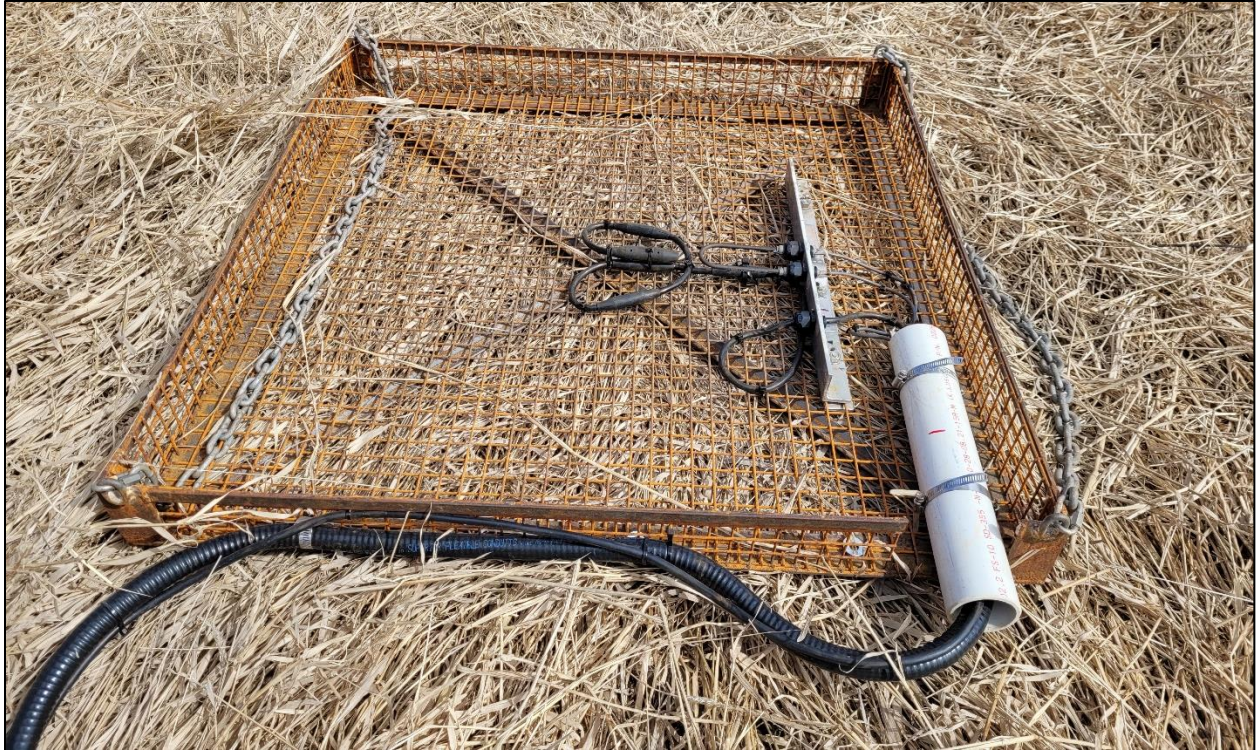
Photo 2.1 Configuration of each sensor array prior to deployment.

Each sensor array was mounted to a 1 m x 1 m x 0.1 m steel frame covered by ½" steel mesh (Photo 2.1). Each array contained one 45 Watt "U-shaped" heating element positioned at the upstream end of the frame, along with an array of five Campbell Scientific (CS225) temperature sensors positioned beneath and downstream of the heating element (Photo 2.2). The sensor arrays and data acquisition system were designed to be powered from a 24 Volt battery bank to allow for the system to be deployed remotely in future projects (i.e., independent of the WSC Hut). Finally, prior to deployment, each frame was filled with a mixture of clean gravels to a thickness of 7-10 cm (Photo 2.3); the grainsize distribution of the gravel mixture, as determined through photo-sieving analysis, is shown in Figure 2.1.

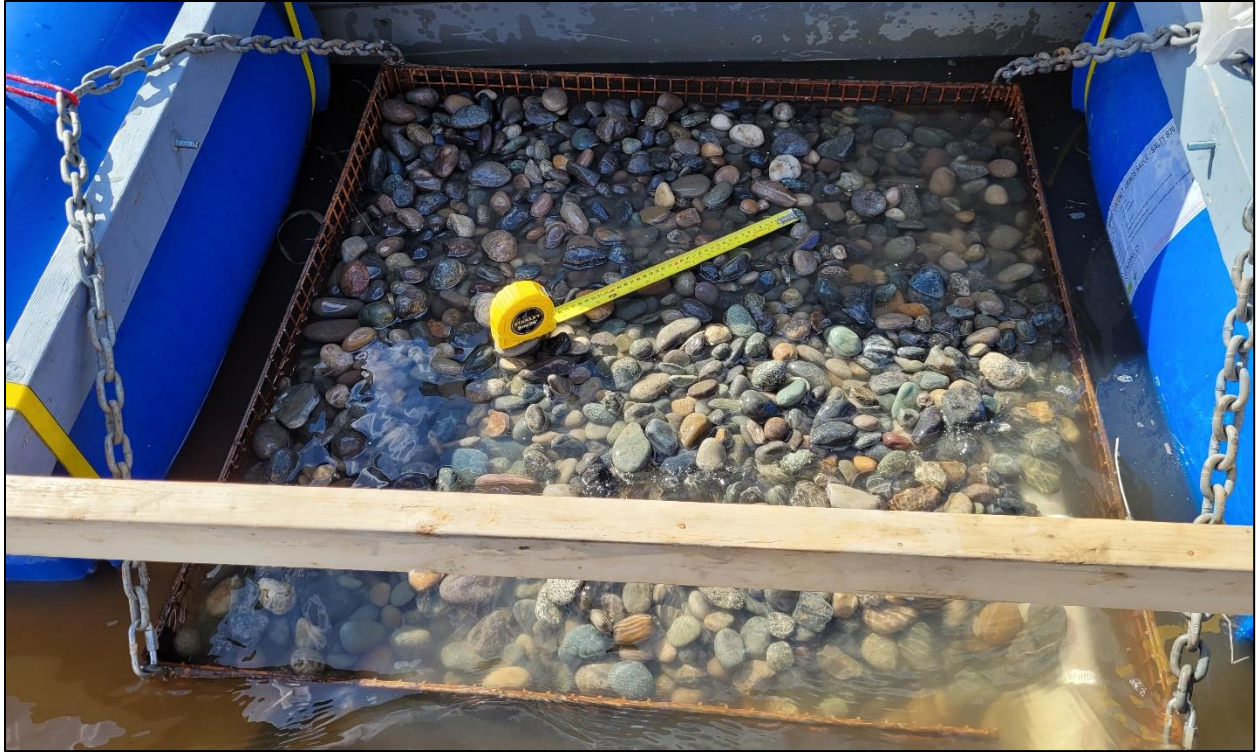
Photo 2.3 Sensor array covered with clean gravel prior to deployment.

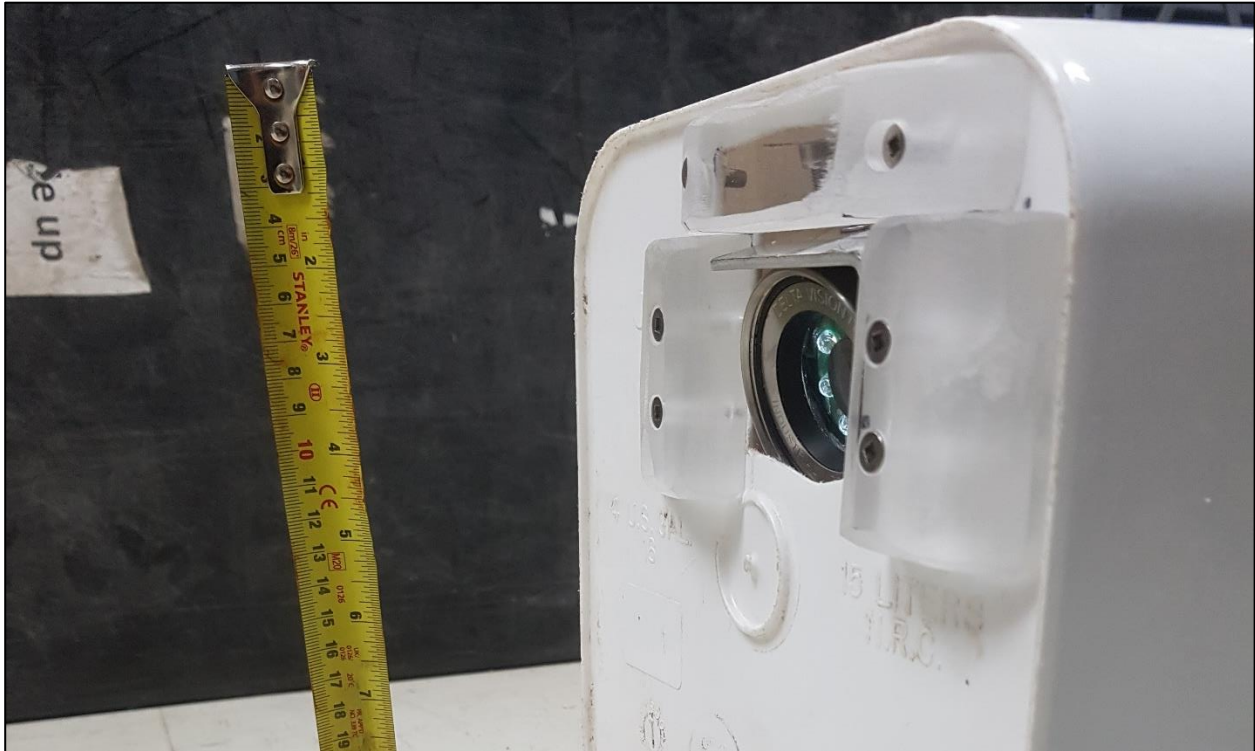
**Photo 2.4** Plastic housing for the underwater camera installed to minimize risk of fouling due to debris accumulation.

As previously mentioned, an underwater camera was provided by the Ministry for use in this project. NHC was tasked with designing a mount for it, ruggedizing cables, developing the image acquisition system, and deploying the camera to visually monitor the riverbed during the 2022 spawning period (and potentially longer). A housing for the camera was made to reduce the potential for debris accumulation and fouling of the lens by fitting two plastic buckets around the lens (Photo 2.4). The underwater camera was connected to a field computer on-site, allowing for remote configuration of the camera and real-time viewing of the underwater imagery.

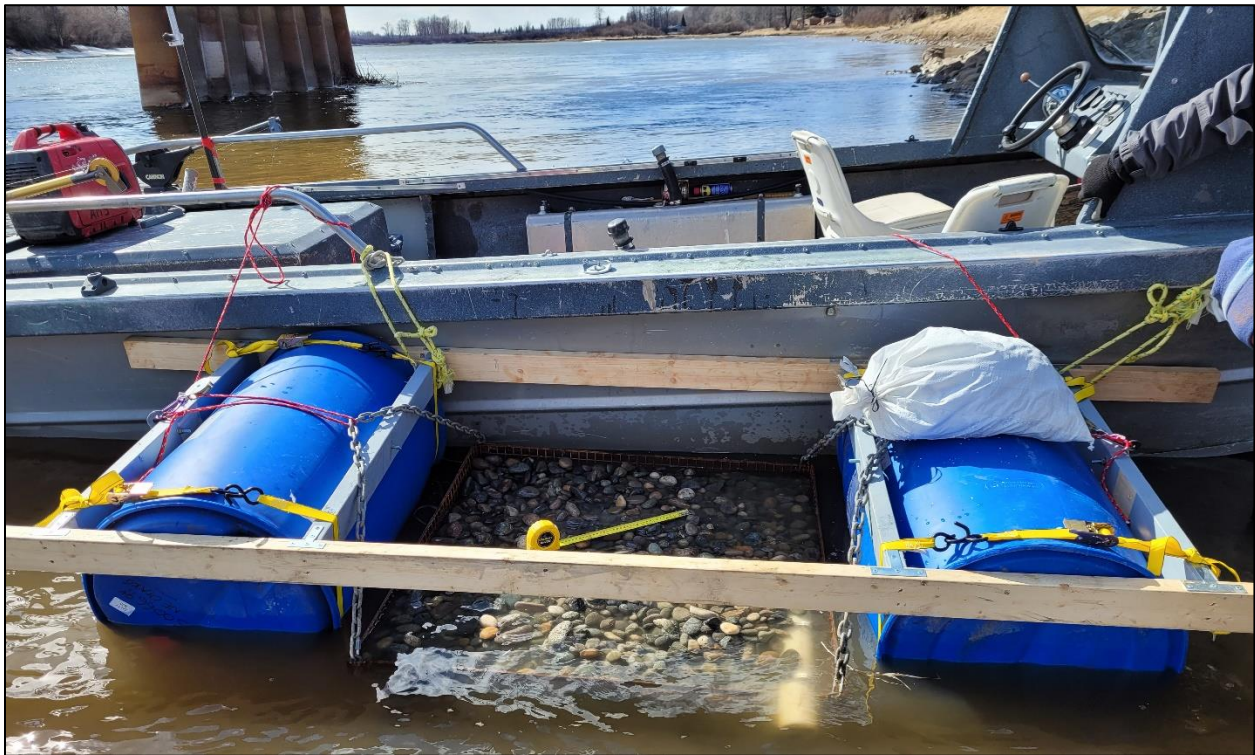
**Photo 3.5** Pontoon system used to lower the sensor arrays onto the riverbed.

The estimated weight of each temperature sensor array was approximately 130 kg (285 lbs) once loaded with clean gravel. To manage this weight safely using a small jetboat, a pontoon system was designed to position and deploy the sensor arrays (Photo 3.5). The sensor arrays were assembled and loaded with clean gravel from the north bank of the river near the WSC Hut, after which the pontoon system was tethered to the boat and ferried offshore to a pre-set anchoring system. Once anchored in place, the sensor arrays were slowly lowered to the bed using a pulley system attached to the pontoon. This method was used to deploy the Inshore Sensor Array (Grid 1377) first on April 12<sup>th</sup>, 2022, followed by the Middle Sensor Array (Grid 1379) and Offshore Sensor Array (Grid 1378) on April 13<sup>th</sup>, 2022.

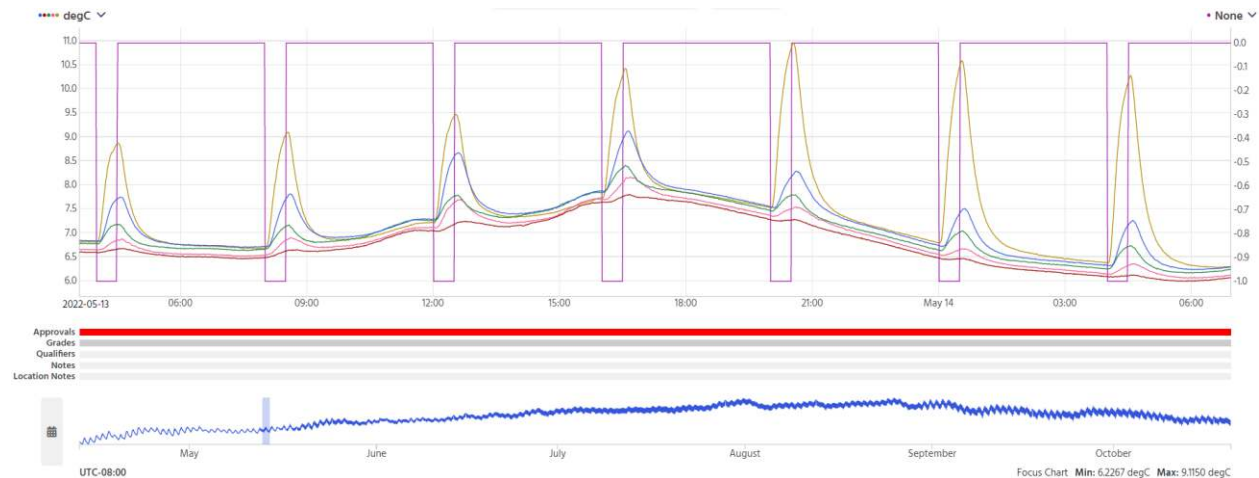
**Figure 4.2 All five sensors on Grid 1377 showing a response to heating after 2022-05-12; Sensor 1 shown in blue, Sensor 2 shown in dark red, Sensor 3 shown in green, Sensor 4 shown in pink, Sensor 5 shown in dark yellow, and Heater shown in purple (0 = OFF, -1 = ON).**

An increased response to heating was initially measured by Sensor 5 on May 9<sup>th</sup>, 2022, approximately 27 days after the sensor array was deployed. The increased heat response can be seen on Figure 4.1 as a sharp rise in temperature detected each time the heater is activated. Sensor 3 began to show an increased heat response shortly after on May 10<sup>th</sup>, followed by Sensor 4 on May 11<sup>th</sup>, and finally Sensors 1 and 2 on May 12<sup>th</sup>, 2022. After May 12<sup>th</sup>, all five sensors on Grid 1377 showed an increased heat response (Figure 4.2), with the greatest magnitude of heating observed for Sensor 5, Sensor 1, Sensor 3, Sensor 4, and Sensor 2, respectively (see Photo 2.2 for sensor arrangement). The increased heat response for all sensors persisted until the end of the initial monitoring period (June 1, 2022).

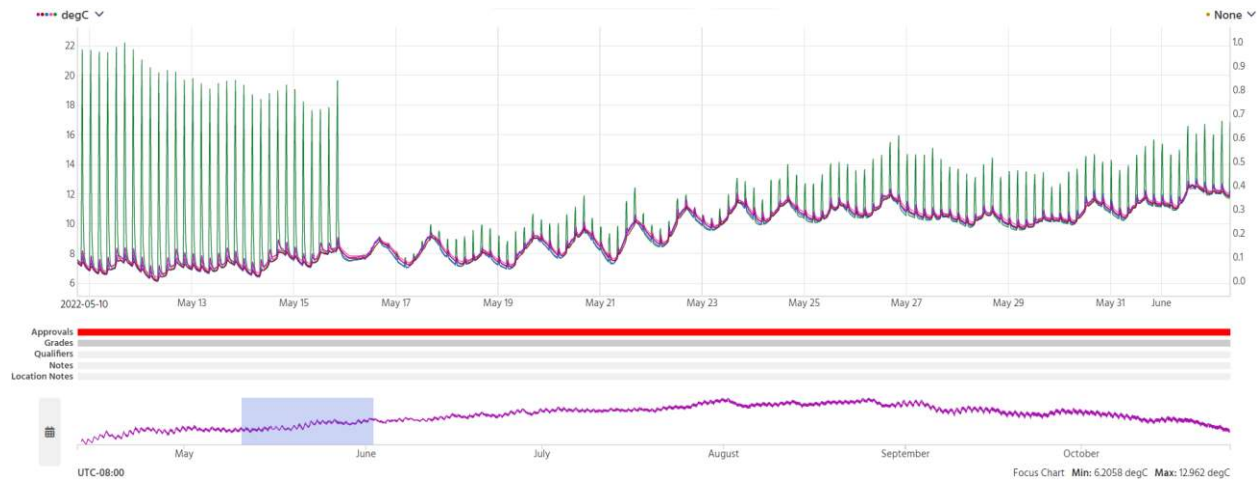
**Figure 4.6** Progressive increase in heat measured by all five sensors on the Offshore Sensor Array (Grid 1378) after the abrupt decrease on May 15-16, 2022; Sensor 1 shown in purple, Sensor 2 shown in red, Sensor 3 shown in blue, Sensor 4 shown in pink, and Sensor 5 shown in green.

00:30 on May 16<sup>th</sup>, 2022 (Figure 4.5). This does not appear to be due to malfunction of the heater, as the magnitude of the measured heat pulses increases progressively once again starting May 17<sup>th</sup>. NHC contacted NWSRI Hatchery Staff as well as Carrier Sekani Tribal Council (CSTC) fisheries to inquire as to whether this grid may have been disturbed accidentally (e.g., anchor, egg mat, etc.); both groups confirmed that they were not working in the area at this time. Furthermore, experimental trials in the NHC physical laboratory completed as part of design development showed that physical disturbance of the grid typically resulted in greater settling of fines, and thus greater heating. Given that the opposite trend was observed (i.e., cooling not heating), it is possible that sediment was winnowed from the grid, resulting in greater interstitial flow (and hence less heating). That said, the measured heat signals from all five sensors progressively increased following the event, suggesting persistent and ongoing sedimentation, but did not reach pre-May 15<sup>th</sup> levels by the end of the monitoring period (Figure 4.6).
