**NECHAKO RIVER WHITE STURGEON
2020 SPAWNING SUBSTRATE RESTORATION AND MONITORING**

FINAL REPORT

15 March 2021

NHC Ref No. 3005659

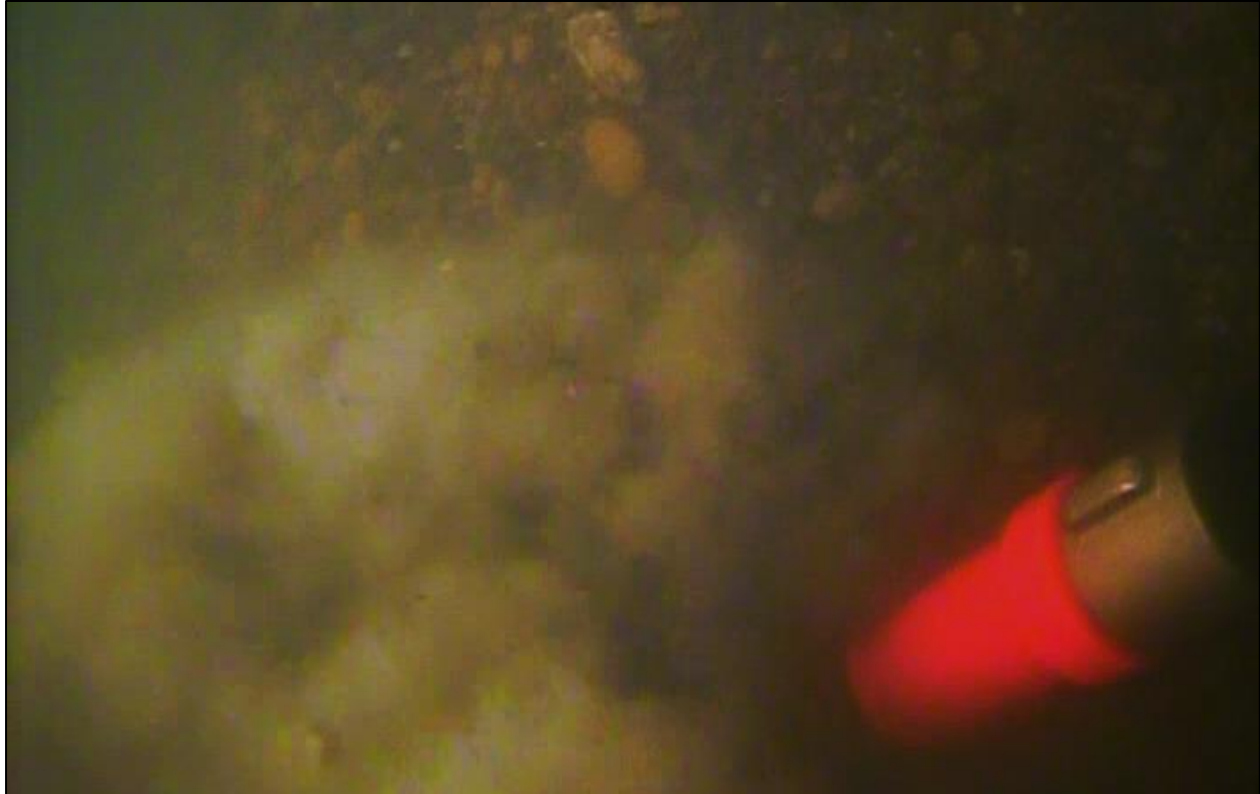
Photo 2.2 Hydraulic jet used for substrate cleaning and embedding sediment traps; image shows jet directed down into substrate, mobilizing the substrate and displacing fines downstream.

Hydraulic jetting (Photo 2.2) was found to be the most effective method for removing fine sediment from within the surficial layer of substrate, where the high pressure nozzle would be positioned approx. 5-10 cm above the bed and directed into the substrate in a sweeping motion. The jet was capable of mobilizing all grainsizes contained within the substrate simultaneously, including gravels and cobbles, which allowed for a complete mixing of the surface and subsurface material. The constant mixing and mobilization of the substrate resulted in a progressive coarsening of surficial material, as fine sediment (silt and sand) would be brought into suspension and transported downstream, while coarser pebbles and gravels would rapidly settle out of suspension and deposit nearby. When applied to an area for a sufficient duration, hydraulic jetting was found to produce a much thicker layer of cleaned gravels (up to approx. 15 cm) containing a comparatively small proportion of sand and silt compared to other substrate treatments.

Hydraulic jetting was conducted from upstream to downstream to prevent redeposition of fines in treated areas. This method was found to produce a hummocky topography (which was subsequently smoothed out by hand) as the jet would cause a progressive lowering of the bed due to the removal of fines from within the subsurface layer, along with an accumulation of sediment downstream. Although this downstream deposition did not prove to be problematic for this study given the relatively small scale of the operation, it may become problematic while cleaning larger areas, as the cleaning process would become increasingly difficult due to the increasing accumulation of fines in the downstream direction.

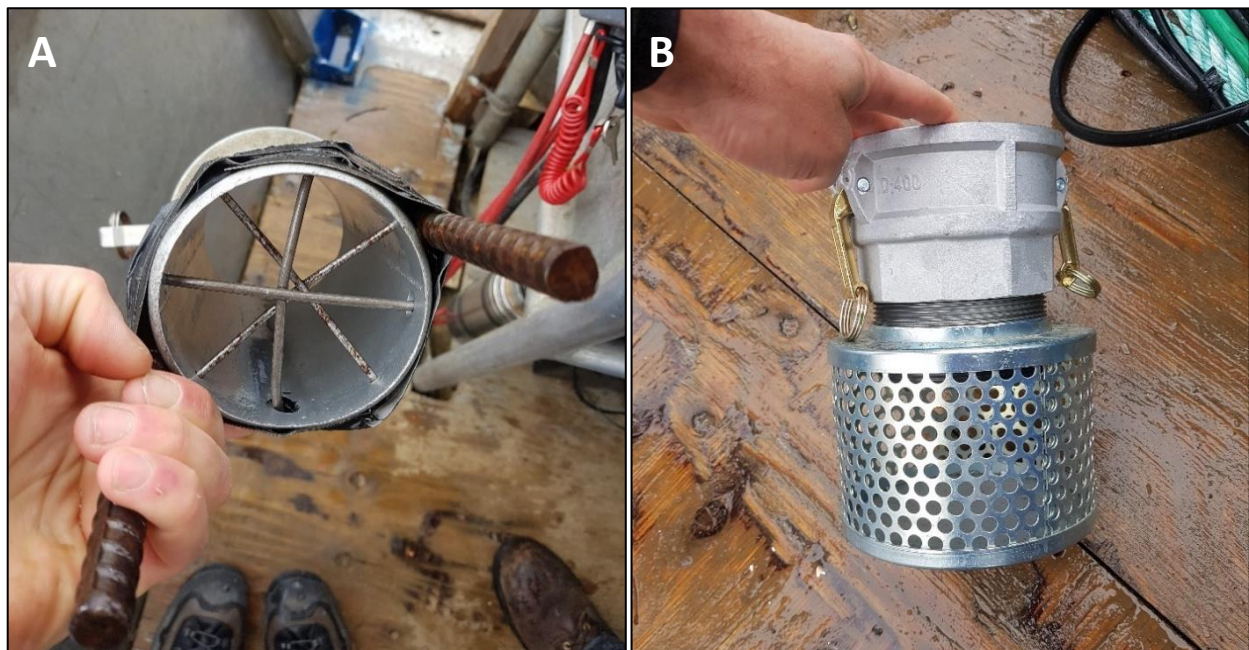
Figure 2.2 Dredge heads used during the cleaning operation; A) cylinder-type dredge head with rebar attachments used to rake the substrate and B) circular screen-type dredge head.

The cylinder-type dredge head shown on Photo 2.2 (A) did not prove to be an effective tool to remove fine sediment from native gravel substrates. The main issue encountered with this type of fitting was that the cylinder would rapidly become clogged due to the wide grain size distribution on the riverbed.

The dredge head with a circular screen shown on Photo 2.2 (B) did not become clogged with sediment like the cylinder-type dredge, mainly because the suction is distributed over a wider area, reducing the amount suction directed towards the bed. However, the reduced amount of suction acting on the bed in turn reduced the effectiveness of the dredge at removing fine sediment from the surficial layer of substrate, and rendered it incapable of removing fine sediment at-depth. In an attempt to increase the efficiency of the dredge, it was then used in combination with mechanical raking. Even in doing so, however, the dredge was only partially effective at removing surficial fines, and largely ineffective at capturing fine sediment brought into suspension.

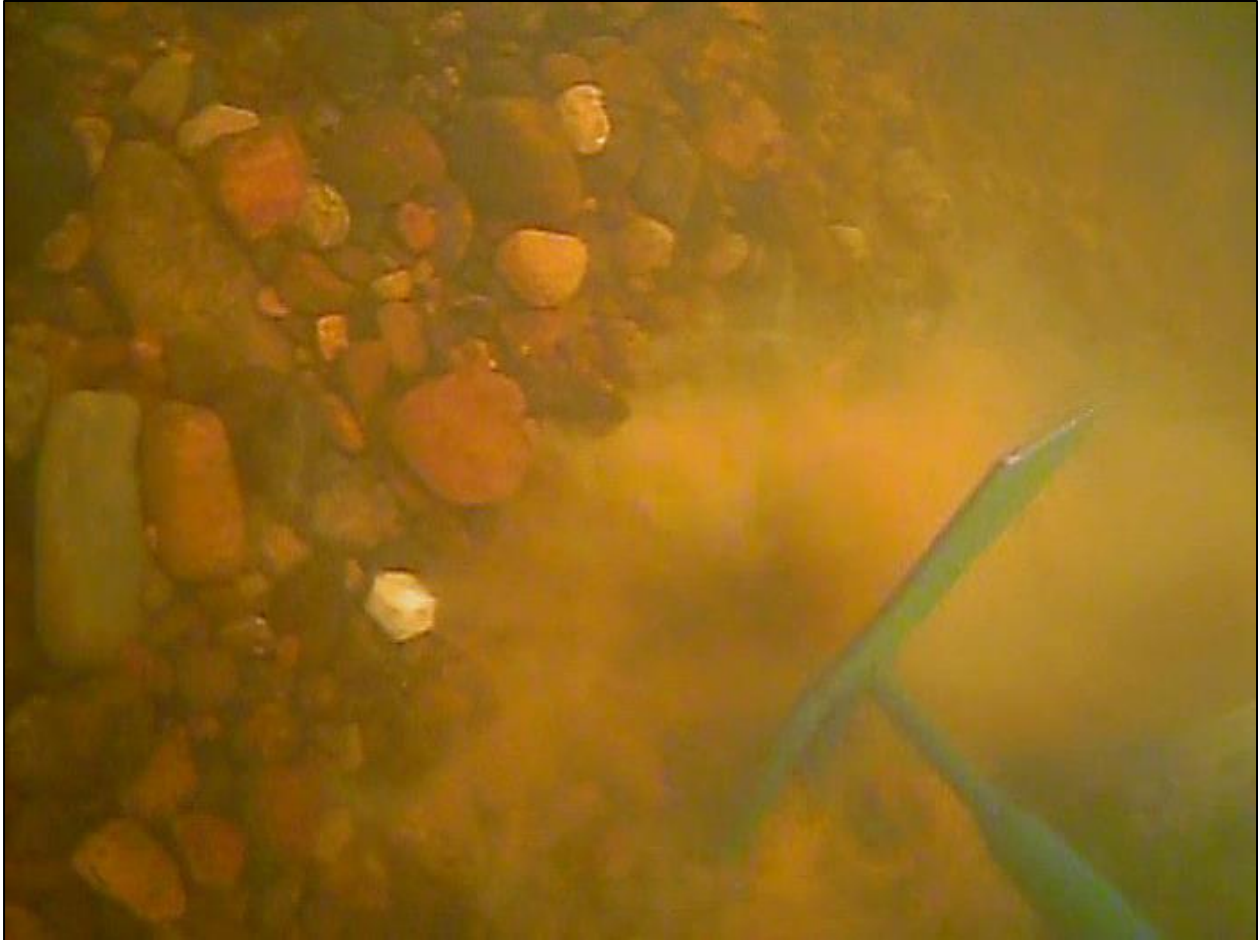
Photo 2.3 Mechanical raking used in combination with the suction dredge to remove infilled fines from the subsurface layers (flow left to right; substrate at top-left of image has been cleaned).

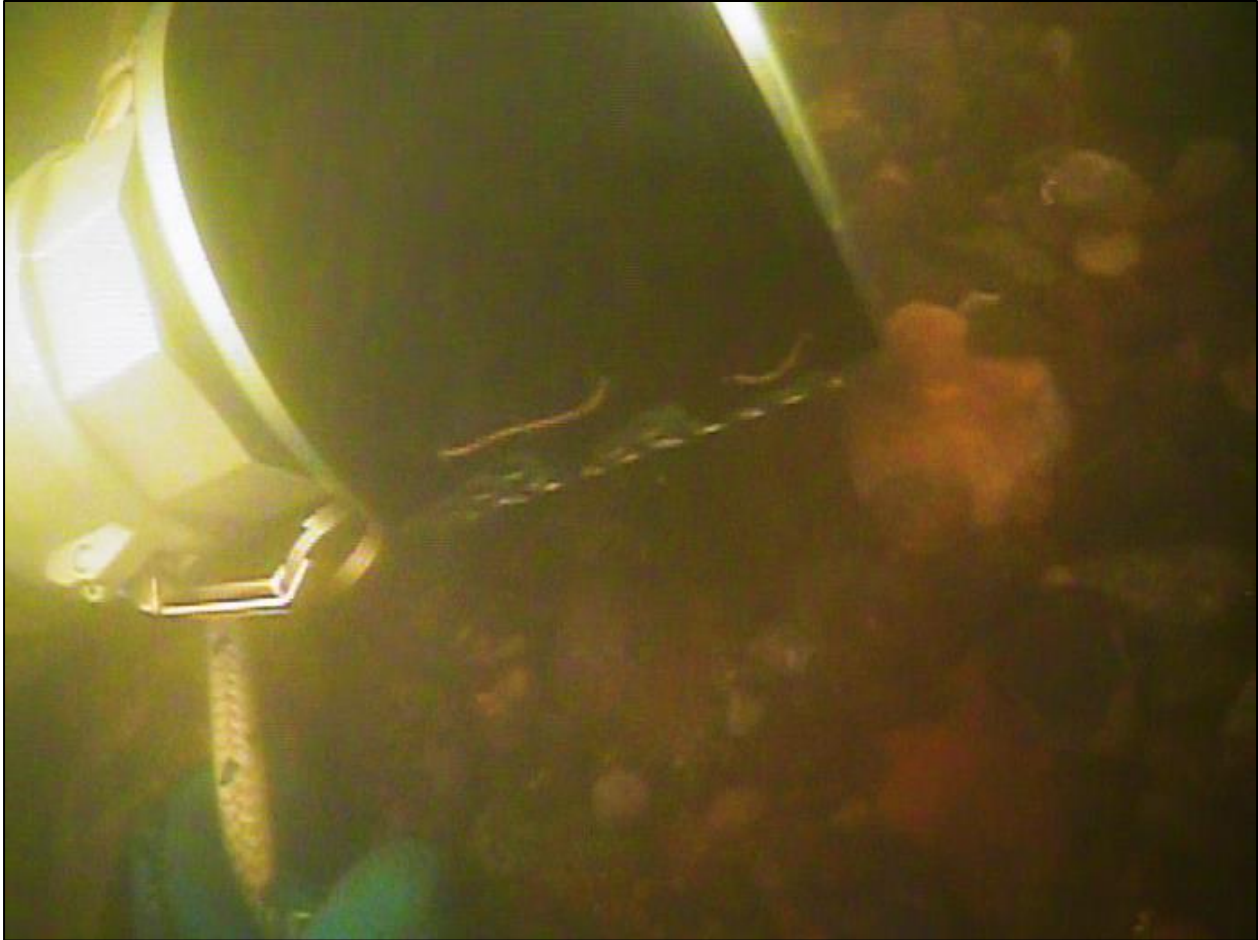
In a second attempt to increase the performance of the circular screen-type dredge head, the top half of the screen was covered to increase the amount of suction directed downwards toward the bed (Photo 3.1). This modification increased the ability of the dredge not only to remove larger grains (sand and granules), but also more sediment. Again, the most effective way of to use this type of dredge head was to combine it with mechanical raking of the surrounding substrate.

Photo 3.1 Suction dredge with circular screen-type dredge head partially covered to increase suction overtop of the substrate at the Middle Patch.

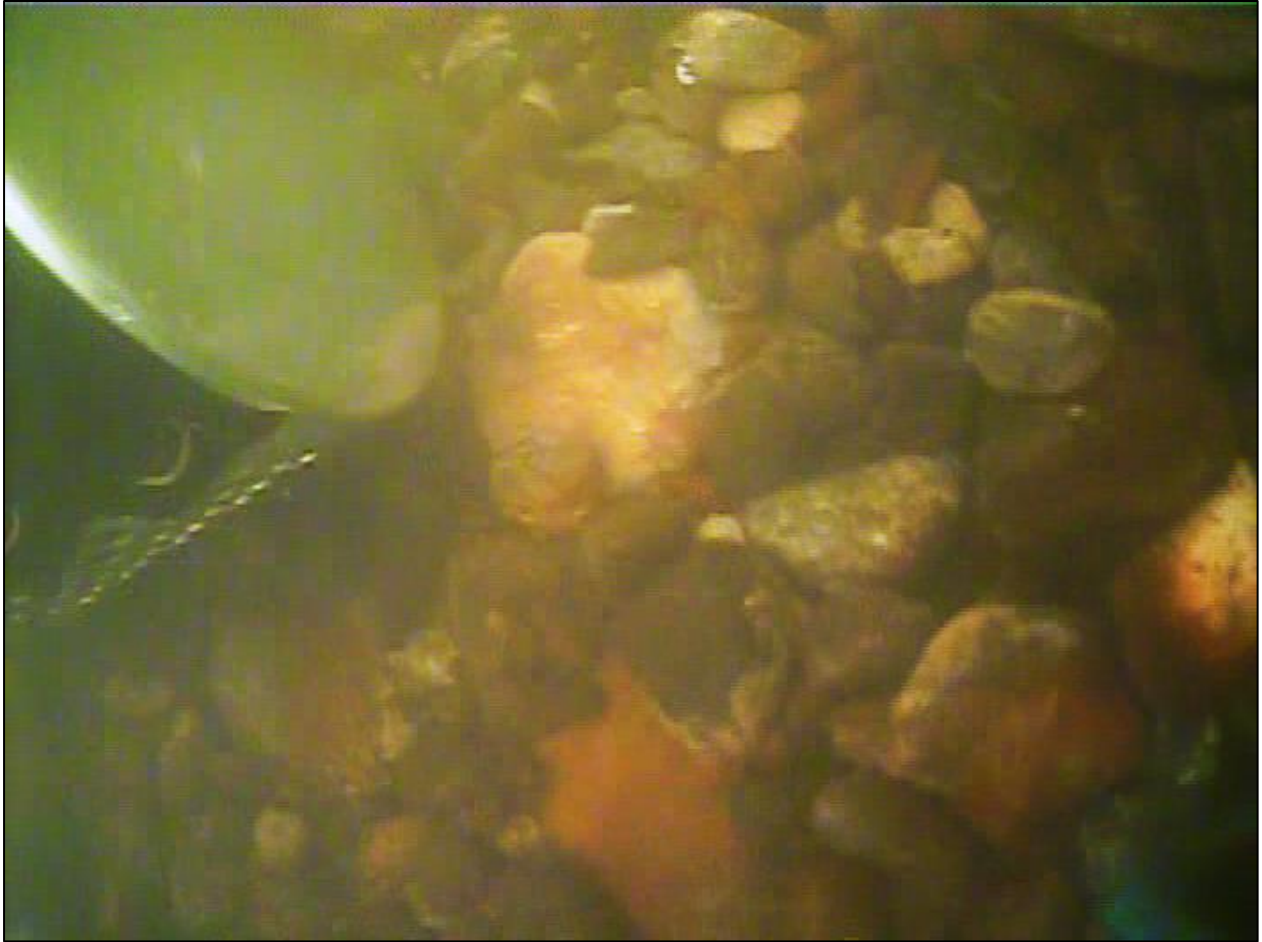
Photo 3.3 Cleaning substrate at the Middle Patch using the modified screen-type dredge (substrate in the image has been cleaned).

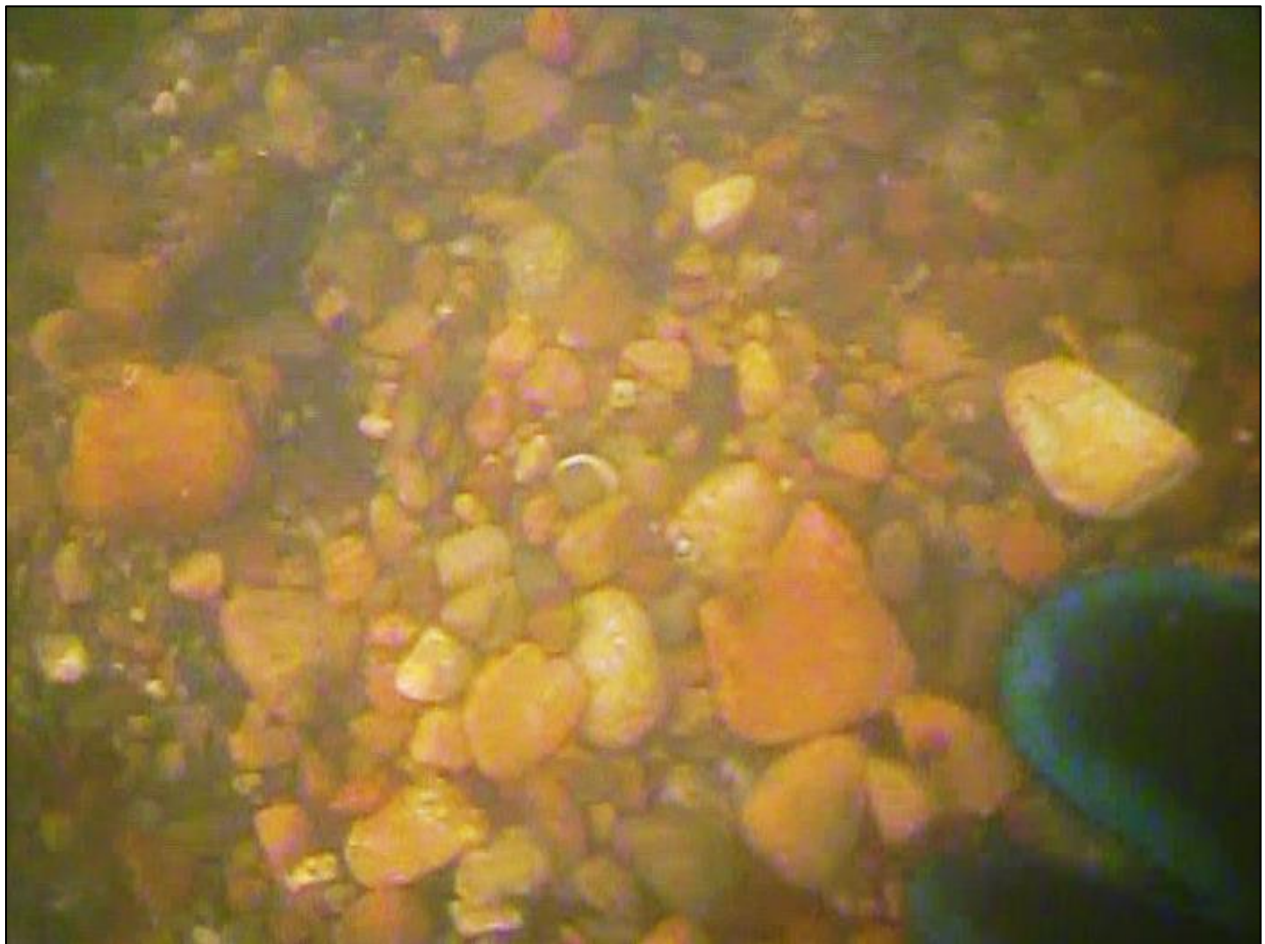
Photo 3.7 Cleaned substrate near the upstream end of the Lower Site treatment area.

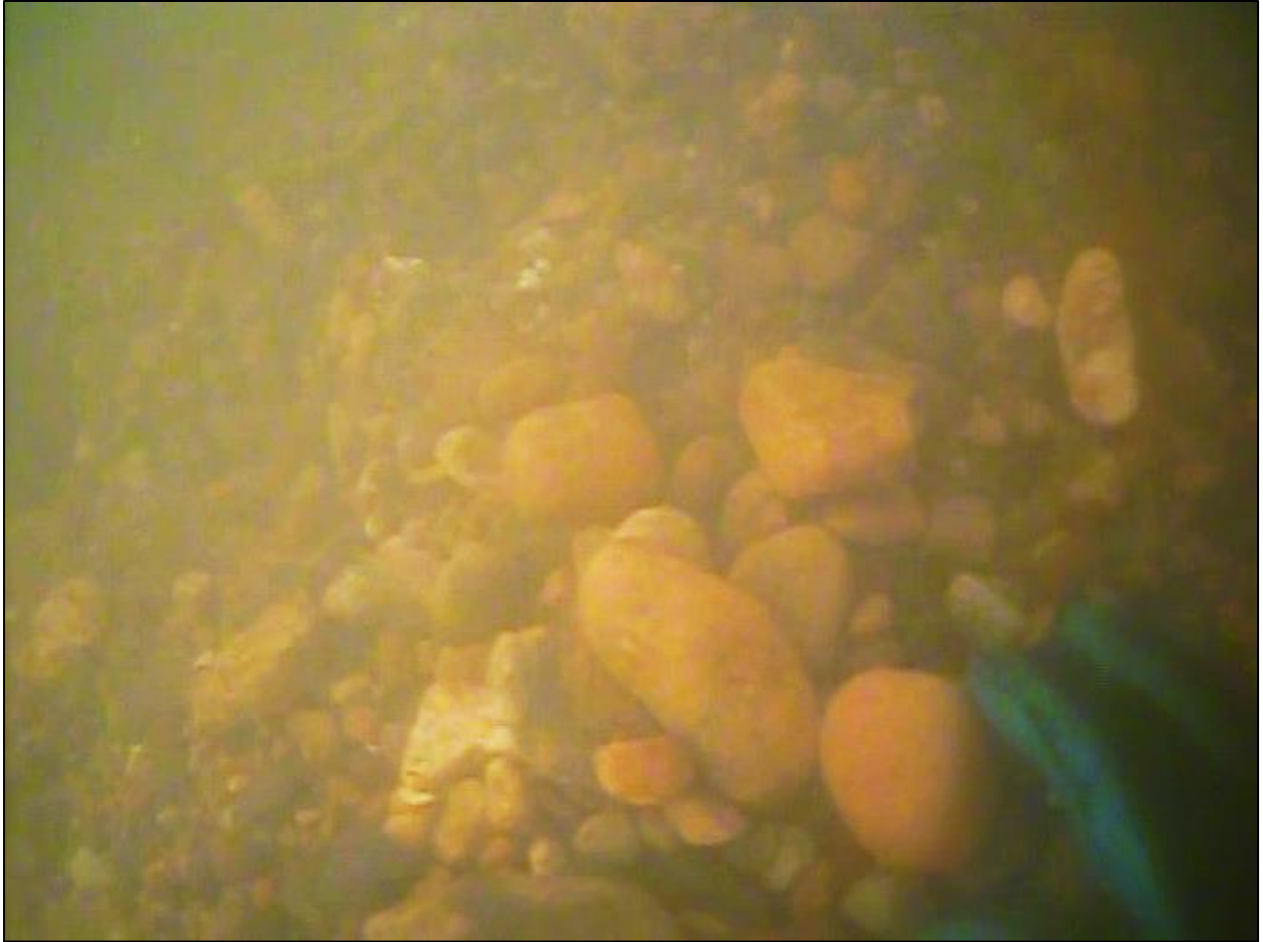
Photo 3.8 Cleaned substrate near the upstream end of the Lower Site treatment area.

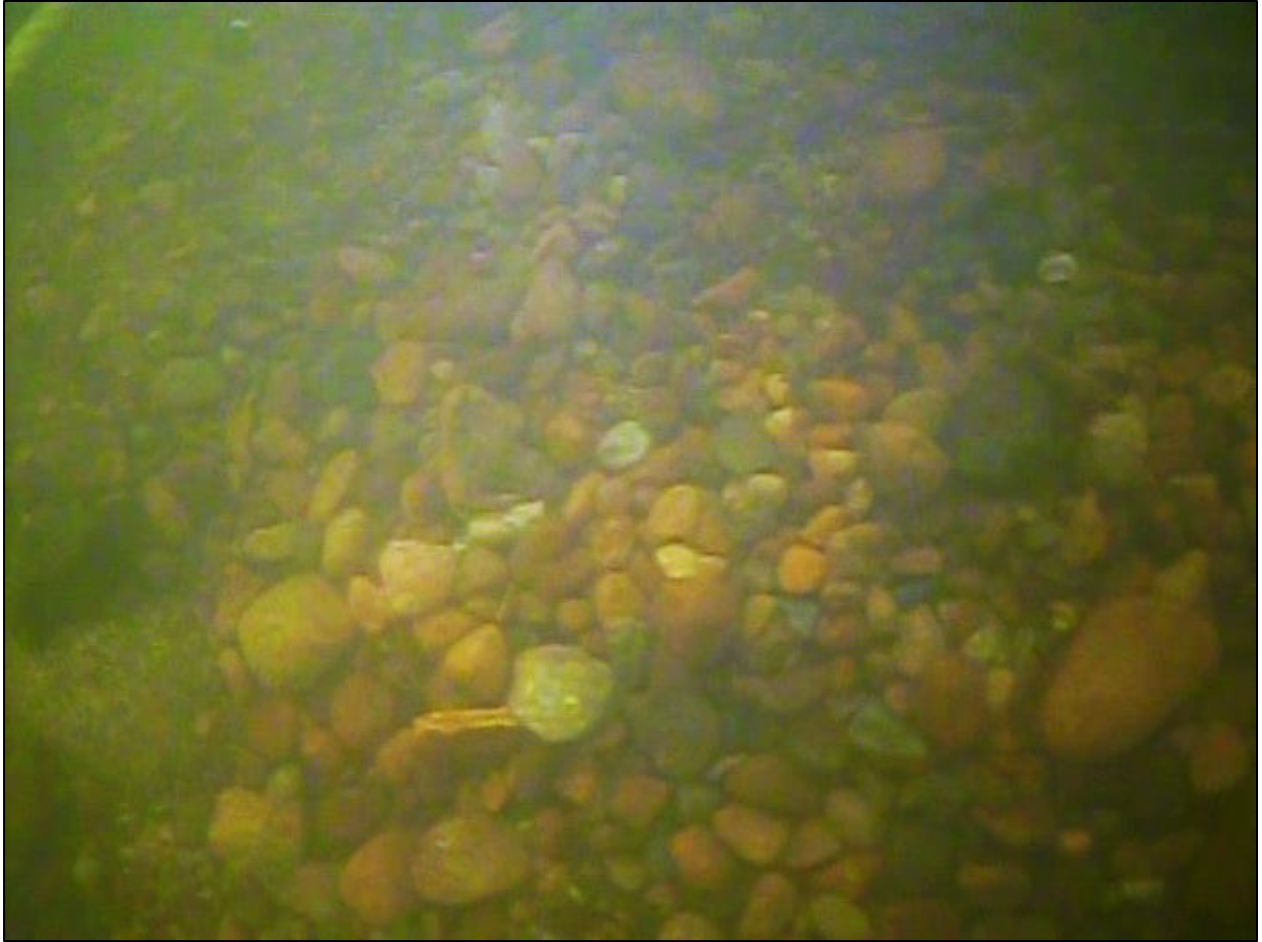
Photo 3.9 Cleaned substrate near the upstream end of the Lower Site treatment area.

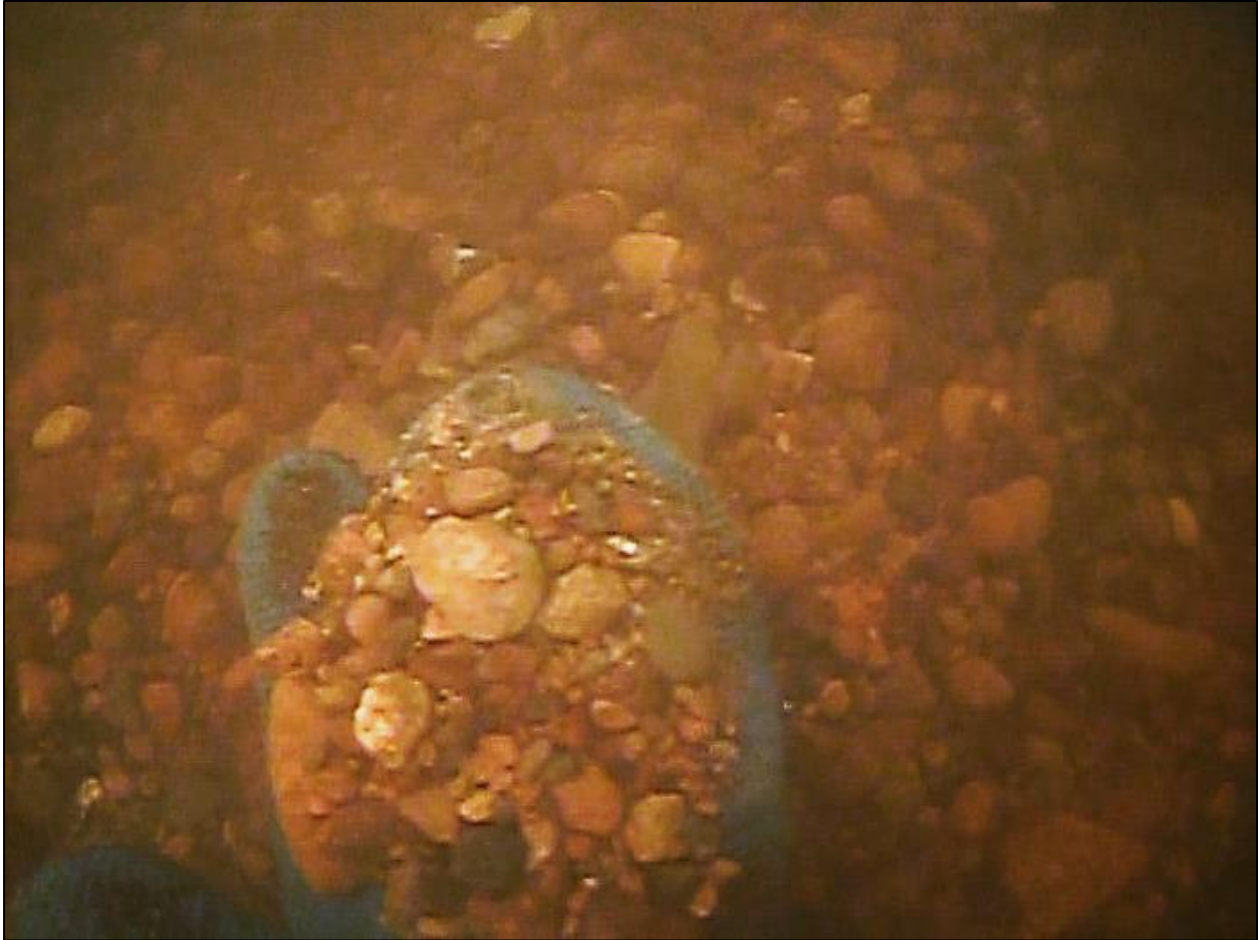
Photo 3.12 Diver showing the composition of the cleaned substrate near the downstream end of the Lower Site treatment area.

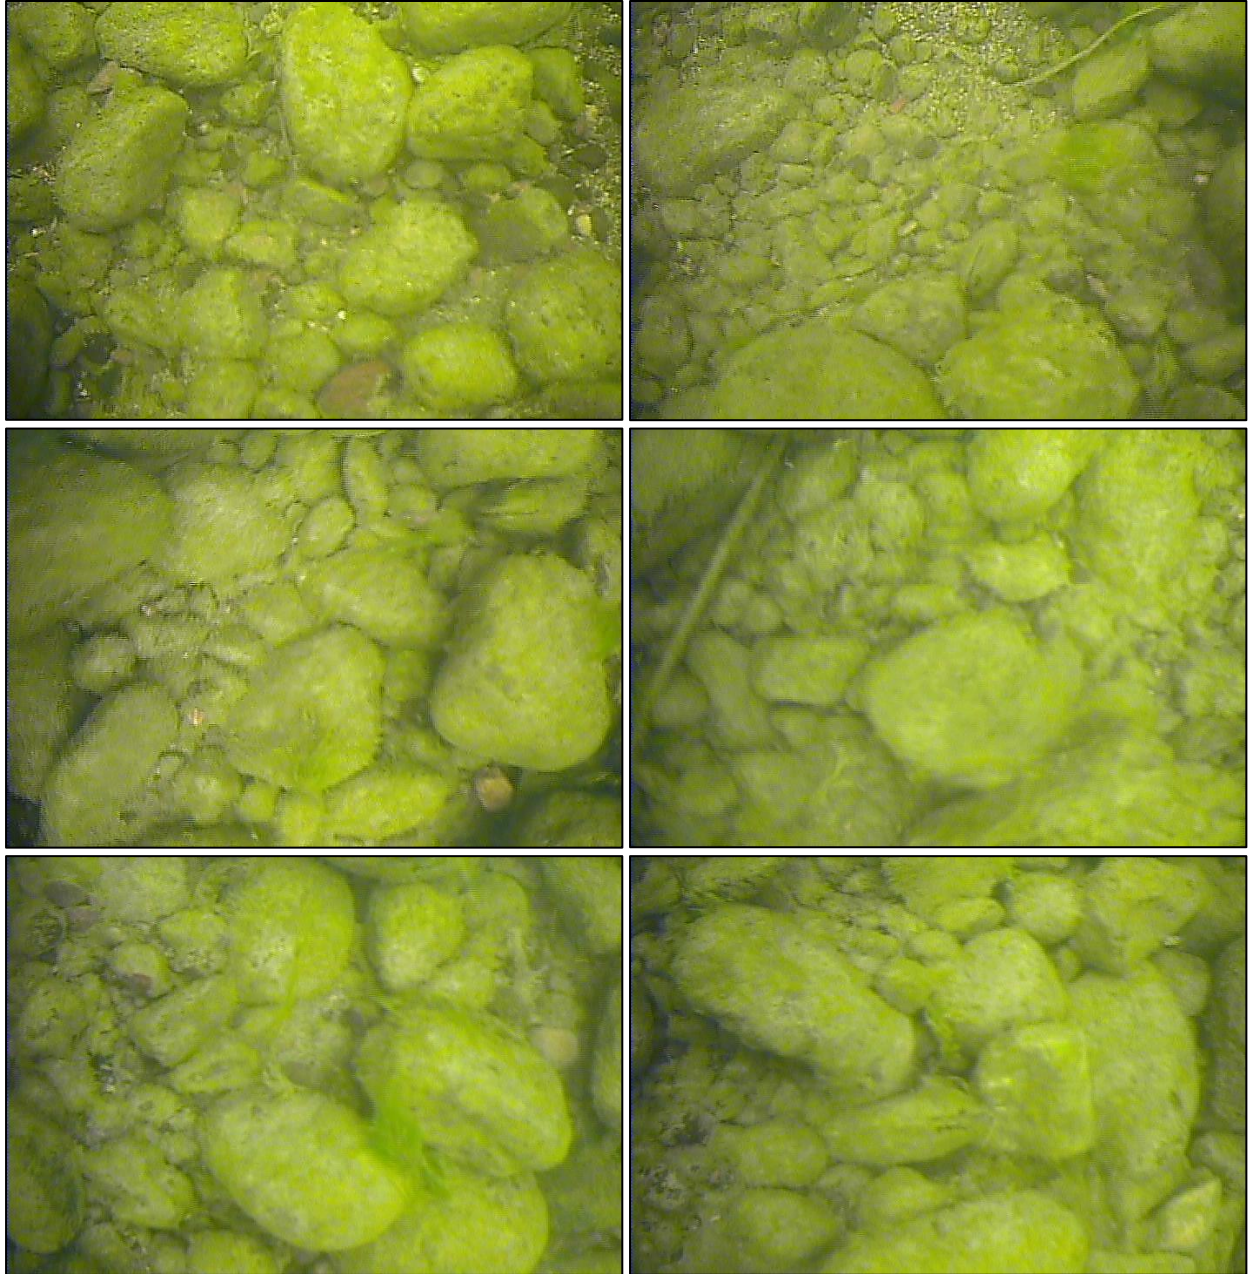
Although the lines of evidence suggest that the condition of the cleaned substrate was at least partially maintained over the monitoring period, it is important to recognize the spatial variability in substrate composition at the Lower Patch site, where deposition of sand often occurs in discrete locations (e.g. behind larger cobbles), producing large differences in substrate composition across small spatial scales. Furthermore, cleaned gravel was not uniformly distributed across the area due to limitations of the cleaning methodology (Section 3.2.2), which resulted in some areas containing a greater proportion of sand and fine gravel than others; due to these caveats, the results of the change detection (without accurate post-operation monitoring sites) should be interpreted with a degree of uncertainty.

Figure 3.5 Substrate photos taken within cleaned area on Lower Patch on June 22, 2020.

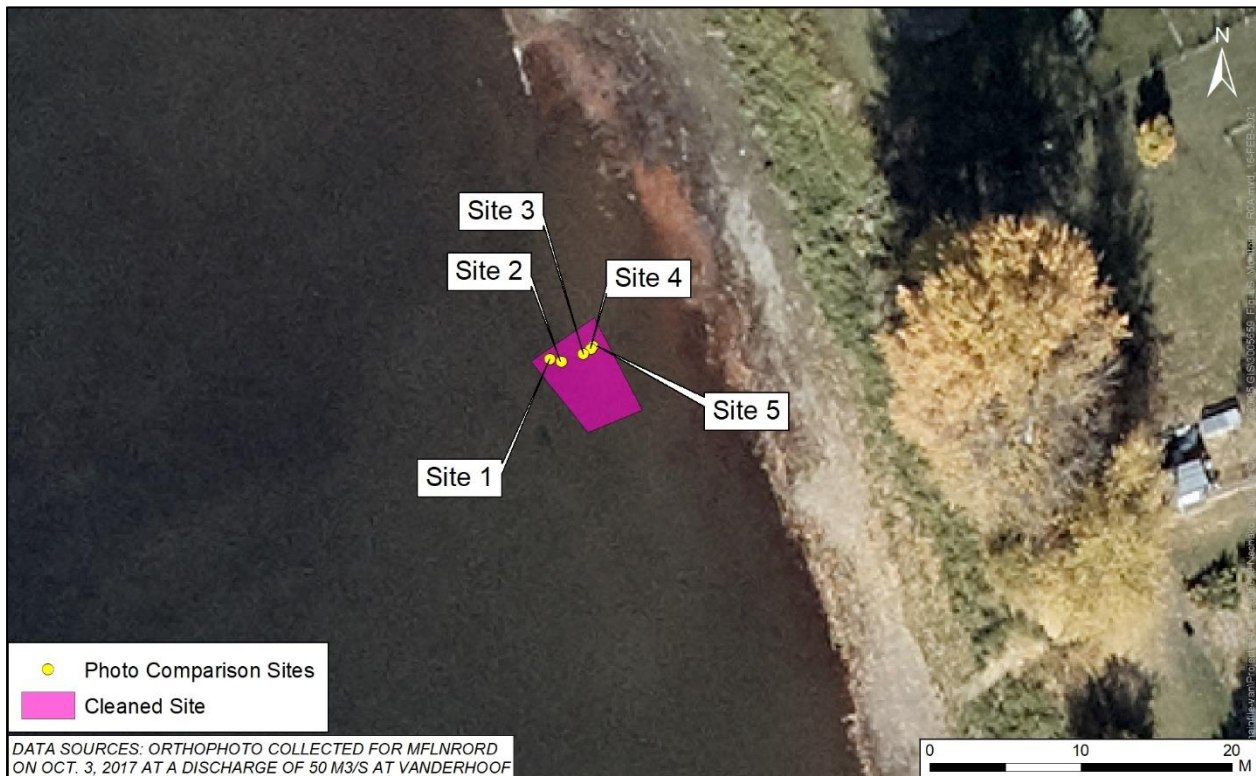
Firstly, it is important to note that the growth of macrophytes within the entire area rendered detailed observations of the underlying substrate difficult. That said, the condition of the cleaned substrate at Sites 1, 2 and 3 appears to have been somewhat maintained over the monitoring period, as the gravels still protrude above the bed and are not embedded in sand; this is particularly the case at Site 3, where a pocket of clean gravel is clearly visible which closely resembles the cleaned substrate. Sites 4 and 5 appear to have undergone greater siltation over this period, as the follow-up imagery taken in late-June shows a general cover of grey material, which is assumed to be very fine sediment. These two sites are located nearer to the bank, where siltation may be greater due to lower flow velocities, further exacerbated by the macrophytes which can reduce near-bed velocity and promote sediment retention.

Figure 3.7 Substrate monitoring sites within the Lower Site treatment area where underwater imagery was collected immediately after cleaning on May 7, 2020 and on June 22, 2020.

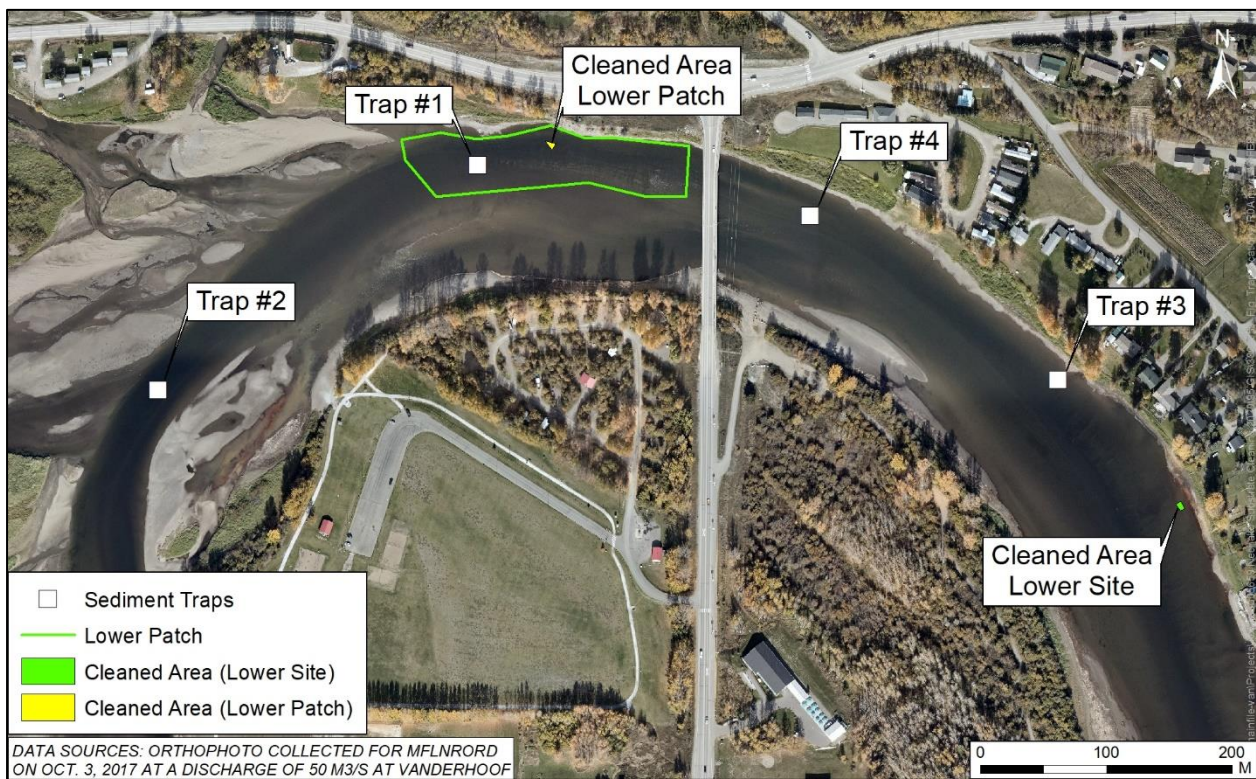
The final locations of the four sediment traps embedded within the spawning reach are shown on Figure 3.8. All traps were found to contain a considerable amount of sediment when retrieved on June 22, 2020, with Traps 1 and 2 containing the greatest amounts (Figure 3.9). The amount contained in Trap 1 is likely to represent the maximum amount of sediment which could be collected by the traps, which is estimated to be approximately 55 kg based on the volume of the sampling bag and the typical mass density of dry sand. Although Trap 2 contained less sediment by weight, it is likely that the sampler was also 100% full (or nearly so), as some sediment loss may have occurred upon retrieval or due to local turbulence and near-bed hydraulics. Interestingly, the least amount of sediment was captured at Trap 3, which was located approximately 140 m directly upstream of the Lower Site cleaning area (both the cleaning area and Trap 3 were located approximately 10-15 m offshore from the north bank) (Figure 3.8).

The composition of the sediment contained within Trap 1 was uniform medium to coarse sand with almost no pebbles or gravels. In comparison, the sediment within Trap 2 contained more organic matter (wood), and consisted primarily of fine to coarse sand with trace granules (up to 3-5 mm), and only a few single gravels (~18 mm). Interestingly, the sediment collected by Trap 3 was noticeably finer than that collected at the other locations, as it was almost entirely composed of fine sand and silt with a relatively limited amount of coarse sand and no pebbles or gravels. Finally, the sediment within Trap 4 was almost entirely sand with no gravel, similar to Trap 1.

Figure 3.8 Final locations of the four sediment traps embedded within the spawning reach in 2020.

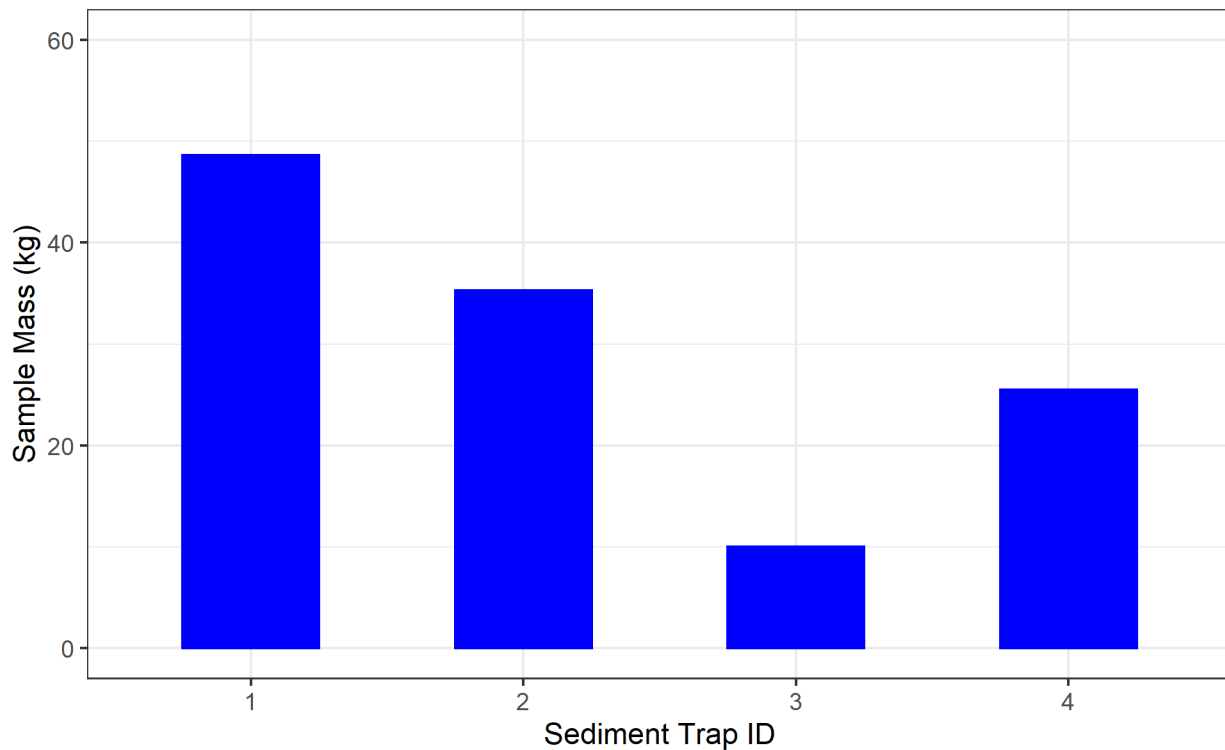
Figure 3.9 Dry weight of sediment contained within the four sediment traps installed in 2020.

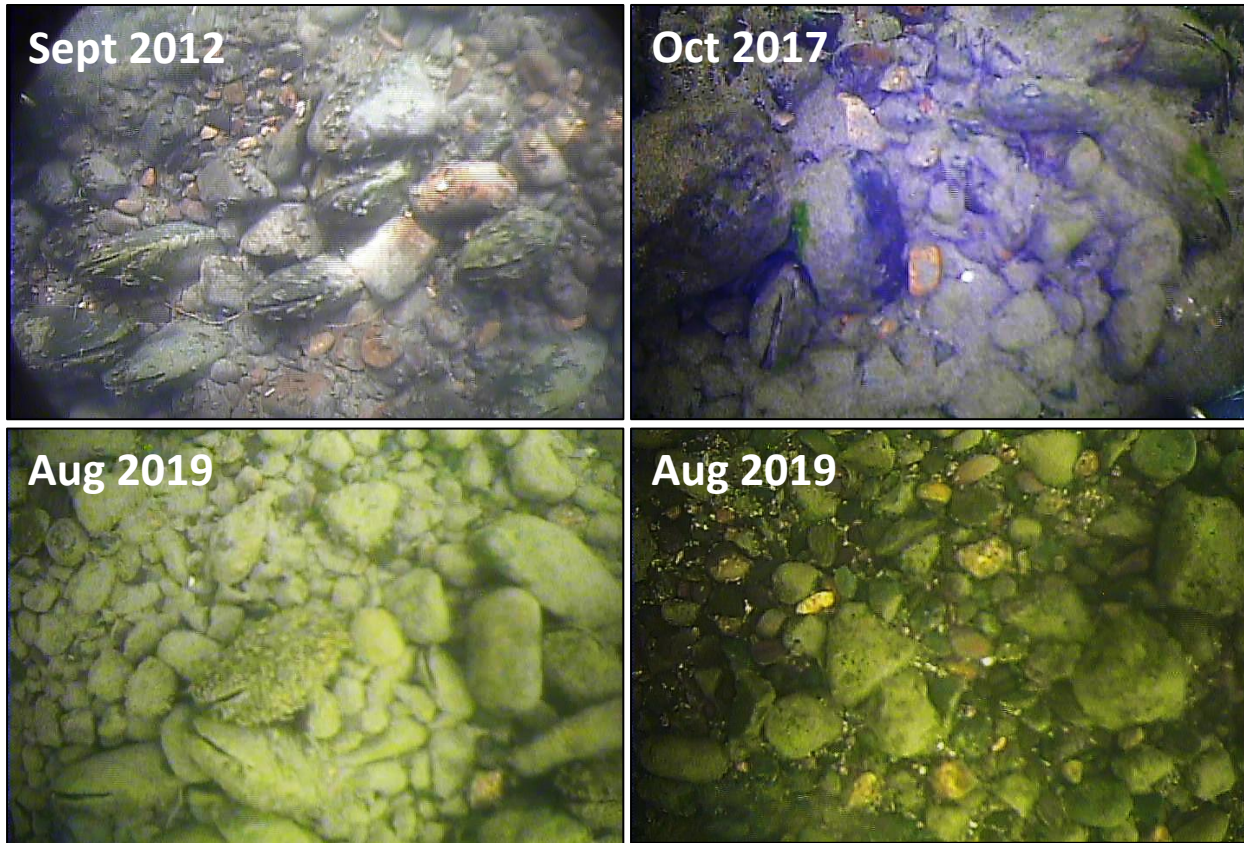
Figure 4.2 Comparison of substrate photos at “Site 1” labelled on Figure 4.1.

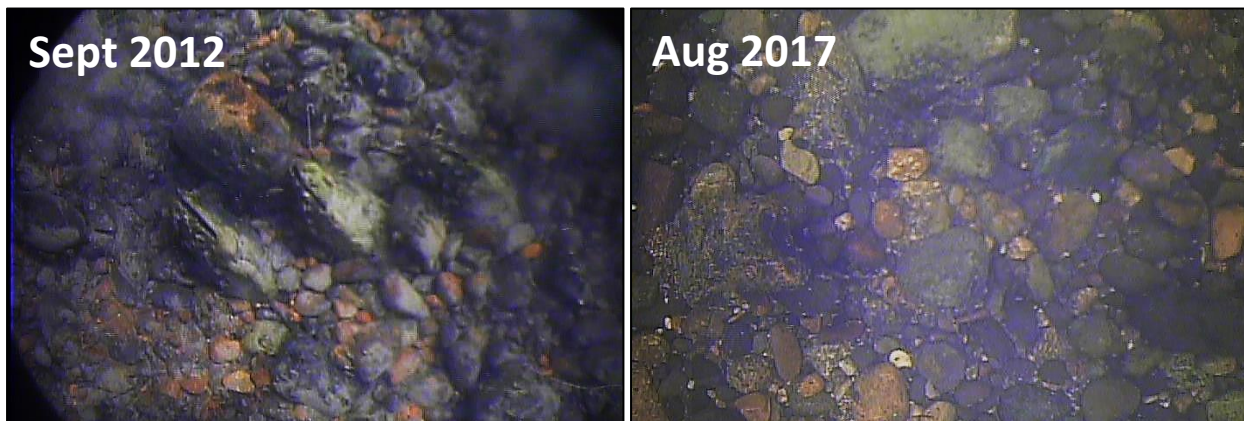
Figure 4.3 Comparison of substrate photos at “Site 2” labelled on Figure 4.1.

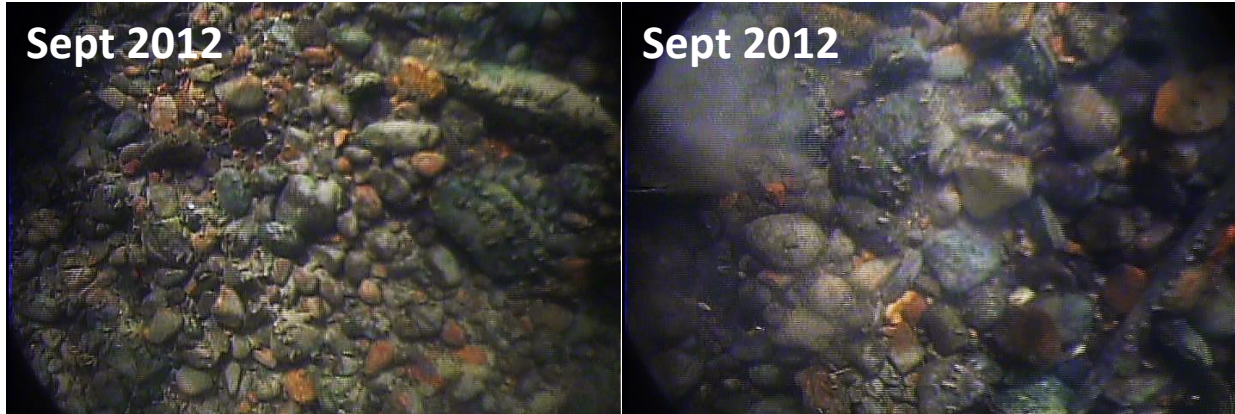
Figure 4.4 Substrate photos at "Site 3" labelled on Figure 4.1.

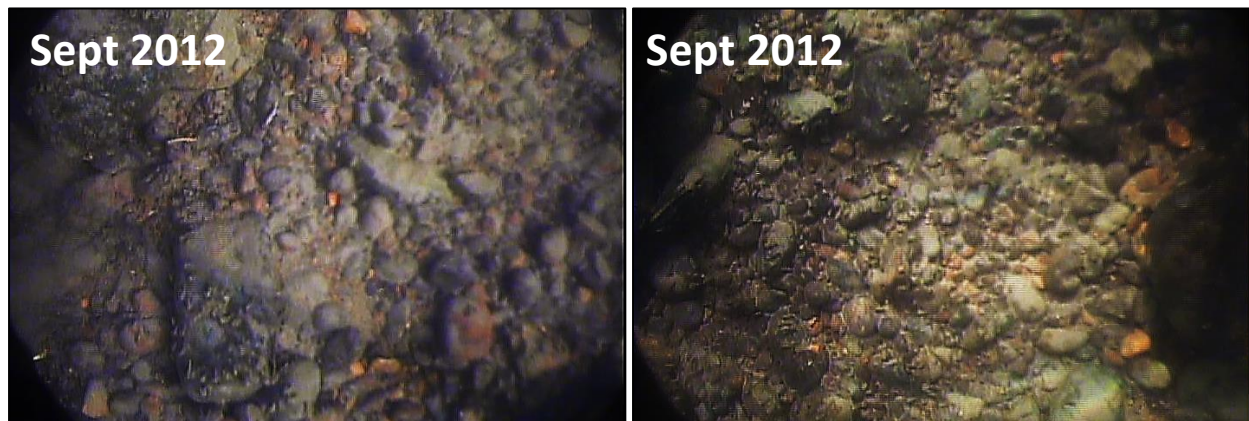
Figure 4.5 Substrate photos at "Site 4" labelled on Figure 4.1.

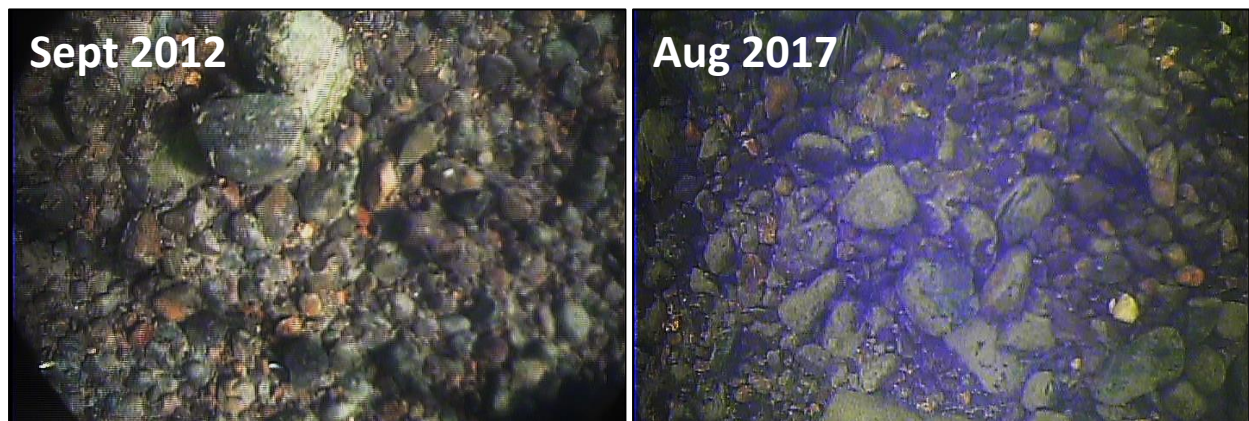
Figure 4.6 Comparison of substrate photos at "Site 5" labelled on Figure 4.1.
