**Nechako Sturgeon Spawning Gravel
September 2012 Substrate Assessment**

**Ministry of Forests, Lands and
Natural Resource Operations
4051 18th Avenue
Prince George, BC
V2N 6H2**

**NHC 300115
Final Report
February 27, 2013**

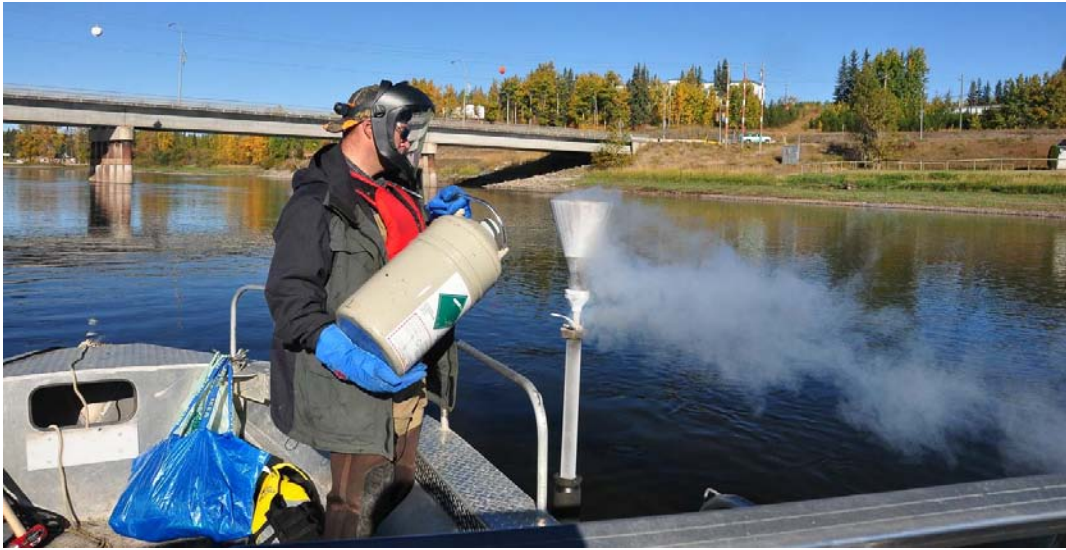
Photo 1: Liquid nitrogen being poured into the funnel that leads into a 20 mm diameter pipe that has an outlet 10-30 cm above the bottom of the core.

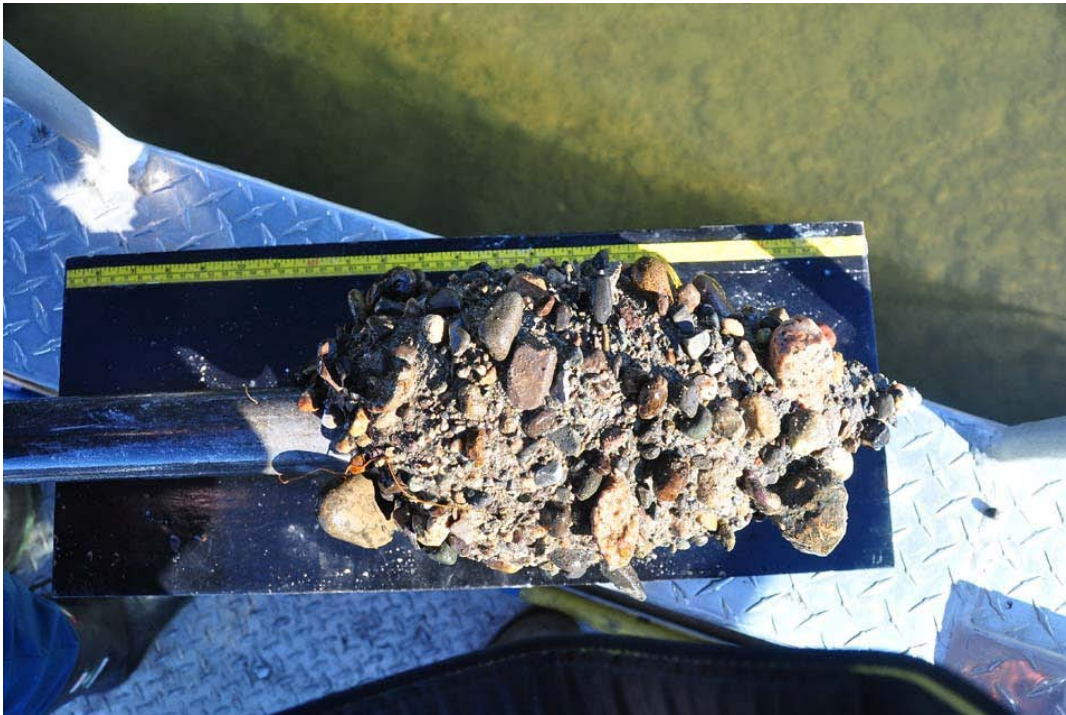
Photo 2: Freeze core # 9 from the Lower Site.

Freeze cores 8 through 11 demonstrate that the subsurface sediment is generally gravel with a large fraction of fines (Map 4 and Table 2). The oxidation visible in Core 8 suggests that the substrate at this site is relatively stable and relatively little vertical exchange of the bed material occurs with the gravel.

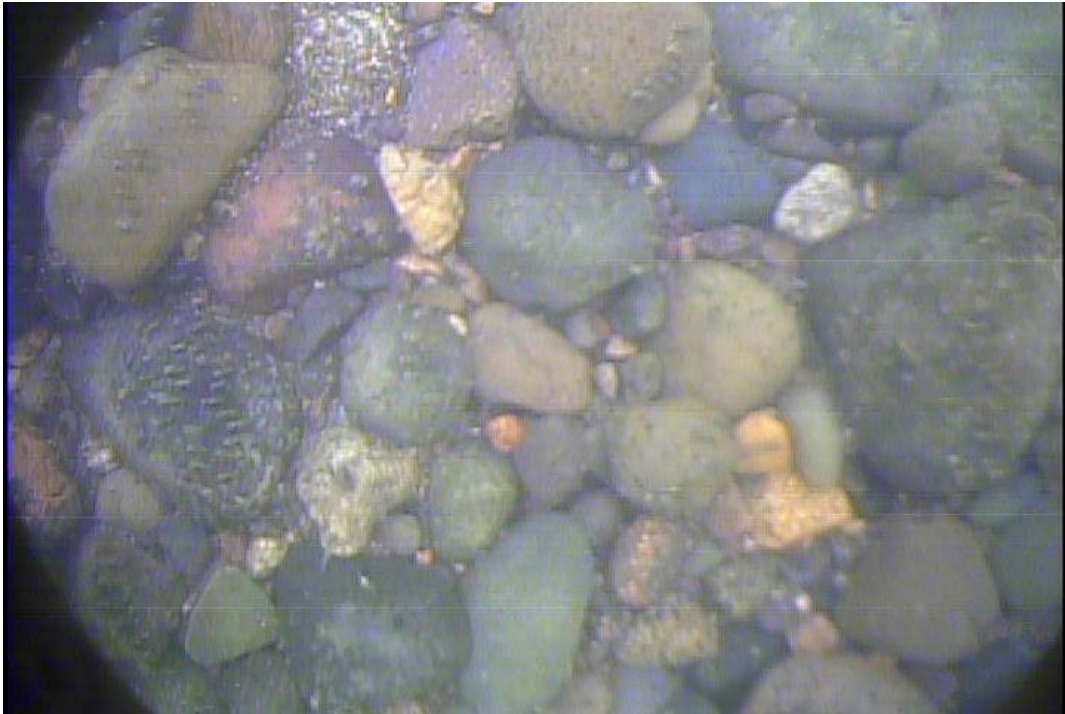
Photo 3 and Photo 4 are example images of the river bed from the Upper Site. They both illustrate cobble substrate that is mostly clear of sand. In general the underwater photos show that the bed is predominantly covered by cobbles (Map 1) and that cobbles with less than 10 % sand is the dominant substrate type (Figure 3). Along the left side of the channel the bed has noticeably more fine sediment between the grains than along the right side of the channel. This is likely due to the hydraulics associated with the site (see Figure 2).

Photo 3: Underwater photo of substrate from Upper Site.

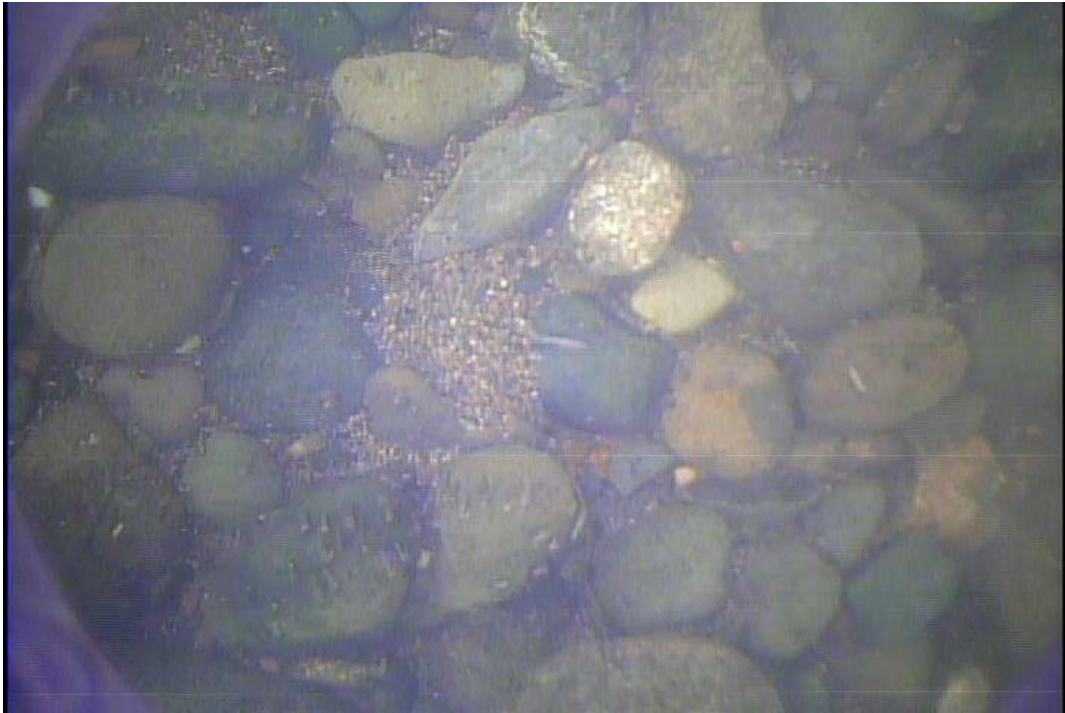
Photo 4: Underwater photo of substrate from Upper Site.

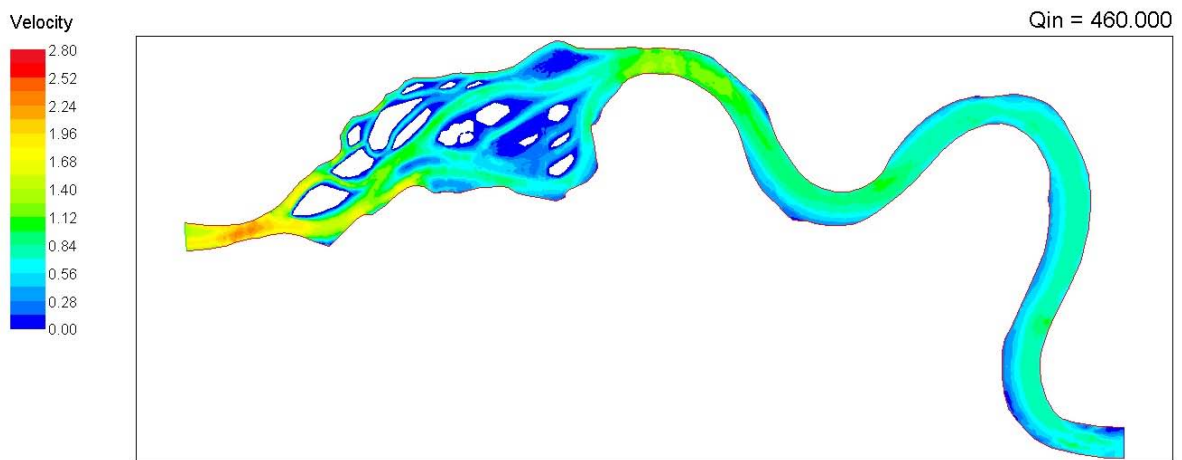
Figure 2: Figure illustrating velocity pattern at all four sites based on River2D model run (Northwest Hydraulic Consultants Ltd., 2008).

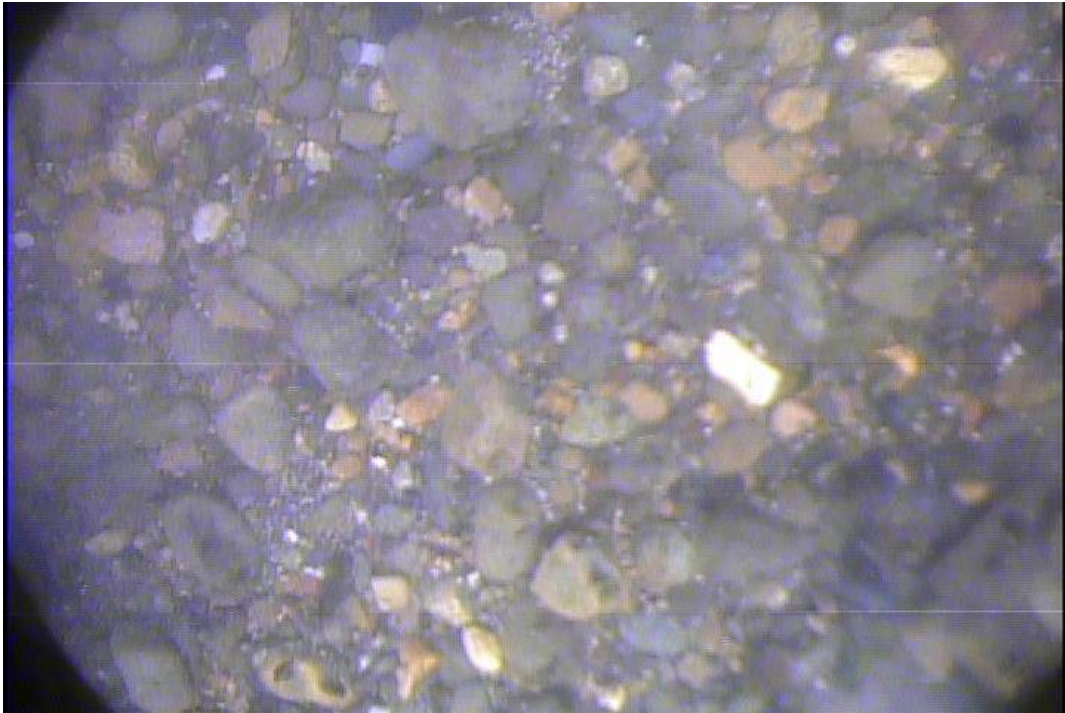
Photo 6: Underwater photo of substrate from Middle Patch.

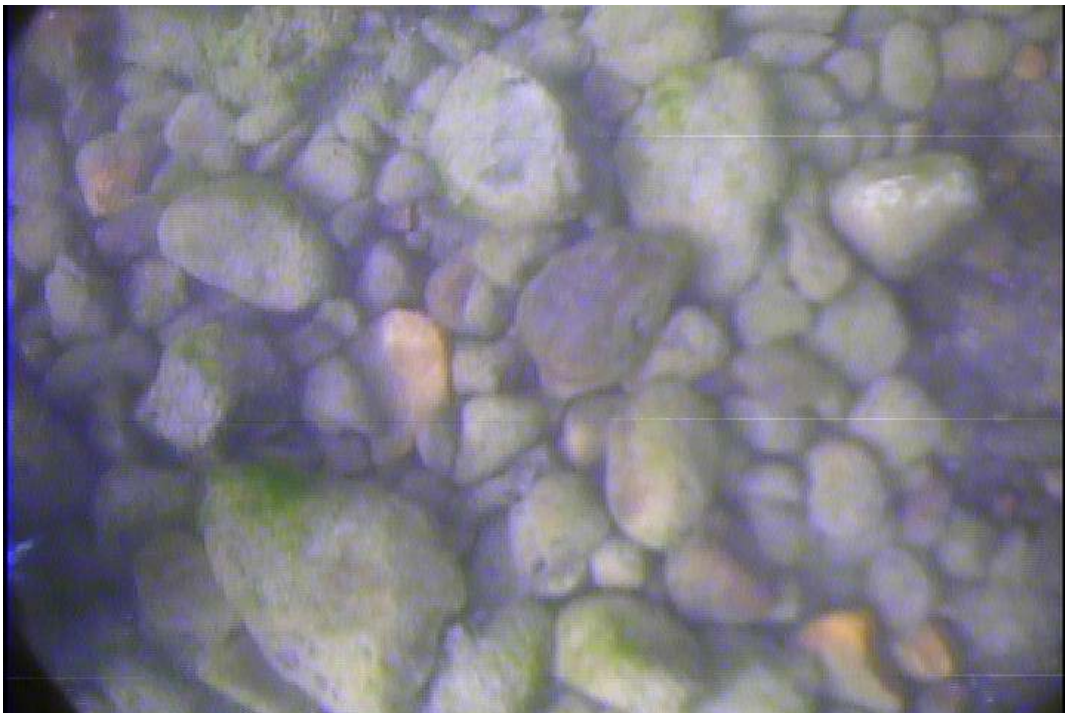
Photo 7: Underwater photo of substrate from Middle Patch.

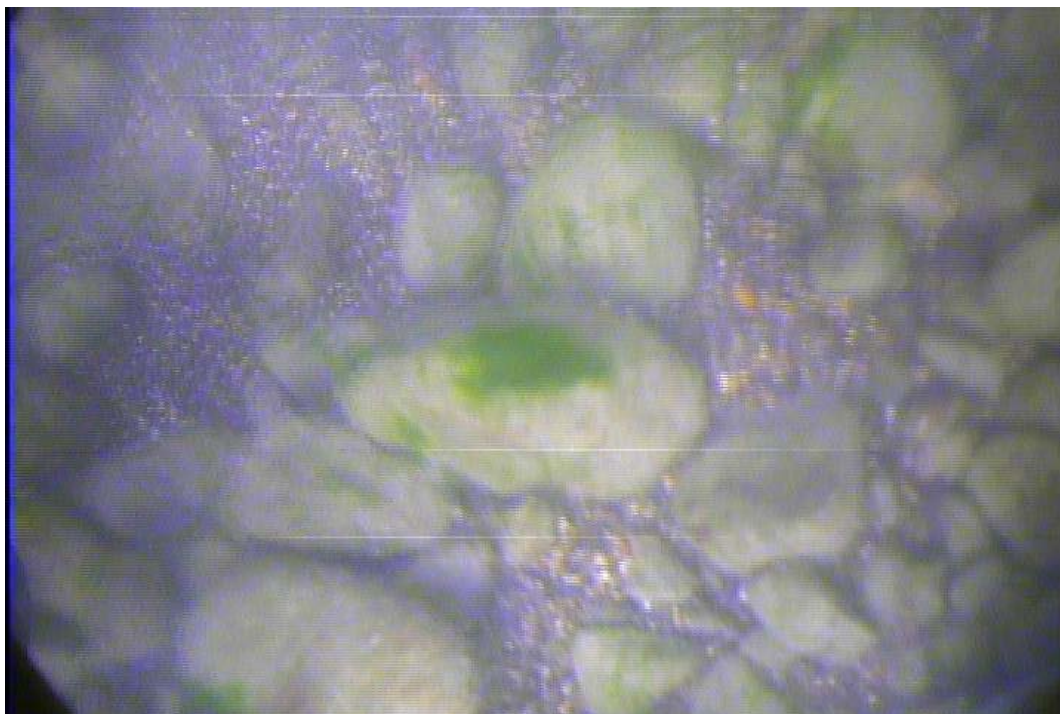
Photo 8: Underwater photo of cobble substrate from Middle Patch showing thick algae growth on larger stones and clean gravel/sand.

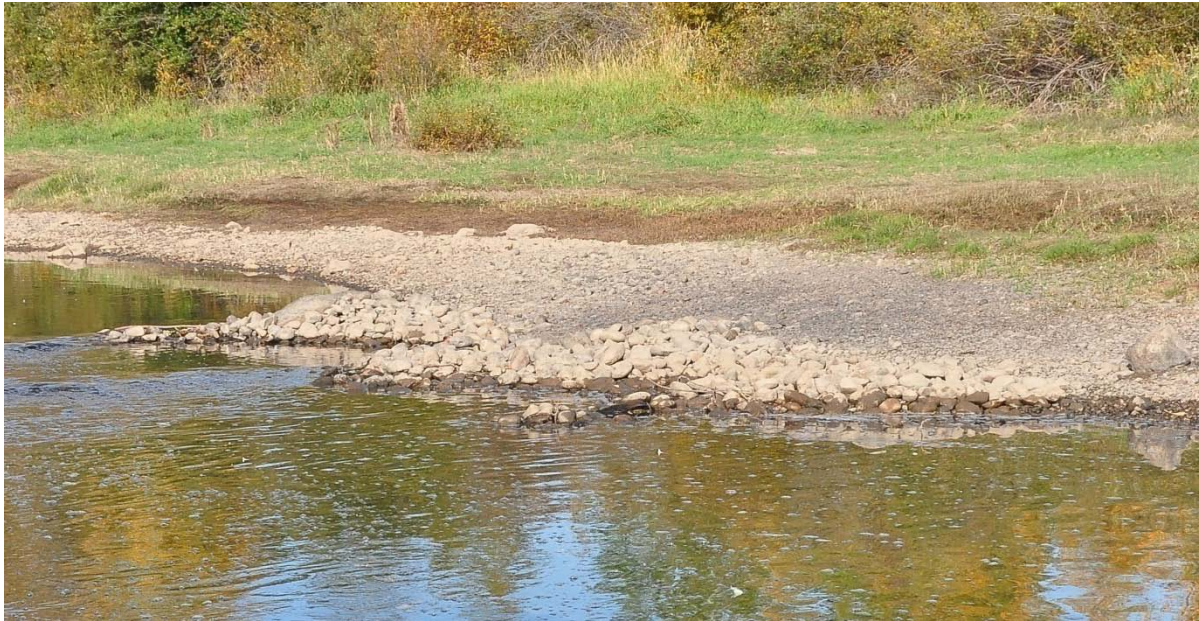
Photo 9: Placed substrate that is emerged out of the water is visible near the river bank while native gravels can be seen along the edge of the river bank. Photo from Lower Patch on left bank.

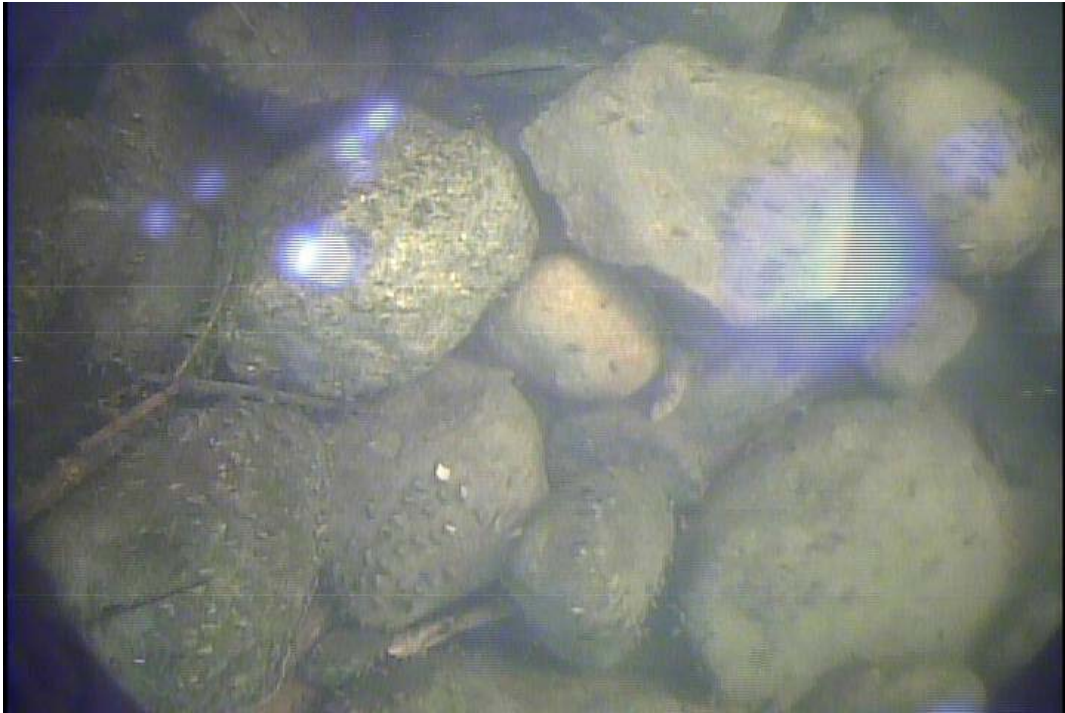
Photo 11 and Photo 12 are two representative underwater photos from the Lower Patch that show high quality substrate that is free of fines. In contrast, Photo 13 shows a patch of placed substrate infilled with fine gravel and sand. During 2012 much more high quality substrate like that shown in Photo 11 and Photo 12 was observed compared to 2011. This observation suggests that either the 2011 sampling did not cover the areas of cleaner substrate (due to the deeper waters and lower quality underwater images) or fine substrate was flushed out by the 2012 freshet. . Map 3 illustrates the sampling results from the underwater images and shows that the deeper areas along the left bank commonly have less than 10 % sand while the shallow areas on the inside bend of the river were generally infilled with fines. This pattern is typical of river meanders as bedload often moves along the inside edge of bends, and the higher velocities on the outside of the bend keep mobile sediments moving.

Photo 12: Underwater photo of substrate from Lower Patch.

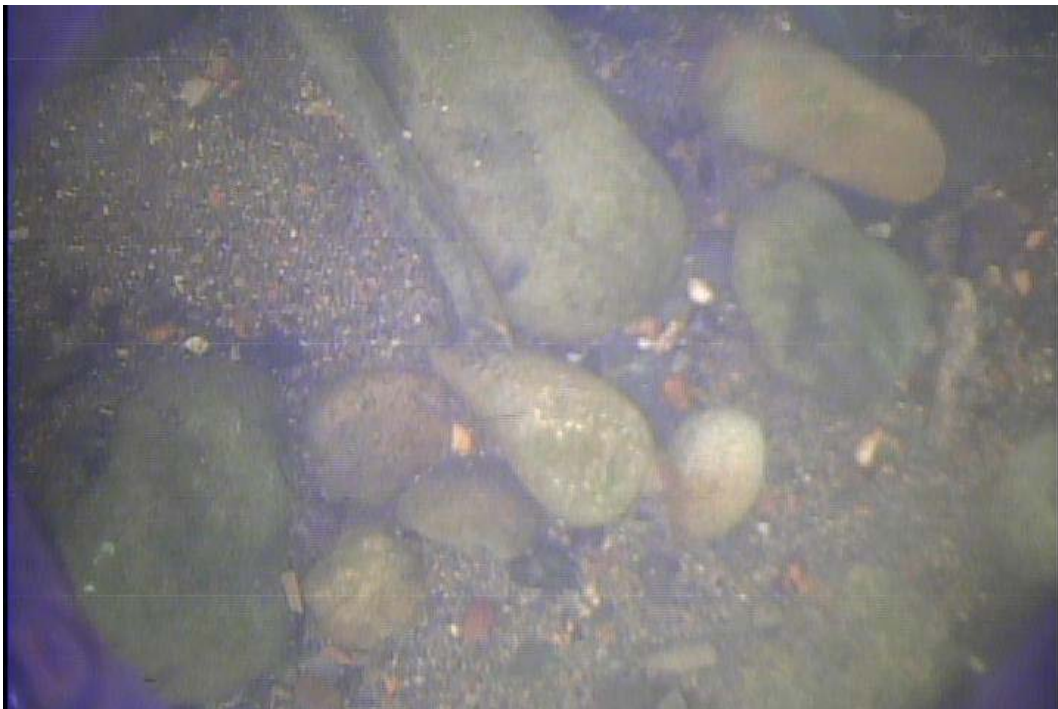
Photo 13: Underwater photo of substrate from Lower Patch showing placed substrate infilled with fine gravel and sand.

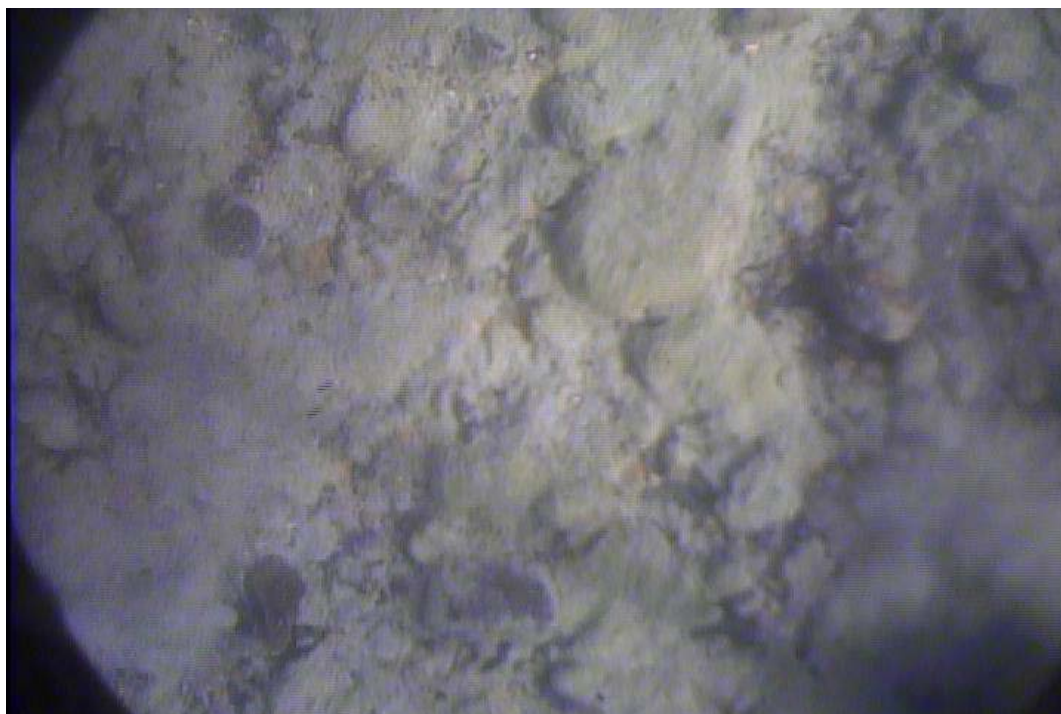
Photo 14 and Photo 15 are example images from the Lower Site. They both illustrate a coarse gravel substrate. Photo 14 illustrates a patch of substrate with a relatively thick fine sand/silt blanket indicative of a relatively inactive area. In contrast, Photo 15 lacks the silt layer and shows a patch of substrate with a number of mussels and reasonably dense macroinvertebrate growth. In general the underwater photos show that the bed is predominantly covered by gravel (Map 4) and that gravels with less than 10 % sand is the dominant substrate type (Figure 3). Of the four sampling areas, the Lower Site had the finest substrate and the most sand. The right side of the channel was generally finer and shallower and generally composed of gravel infilled with sand. In some areas, especially around Core 10, sand moving along the bed in strips could be seen (Photo 16). In the same area it was observed that there were lots of mussels on the right side of the channel where the substrate was more stable, compared to the left side of the channel where the bed was more mobile.

Photo 14: Underwater photo of substrate from Lower Site.

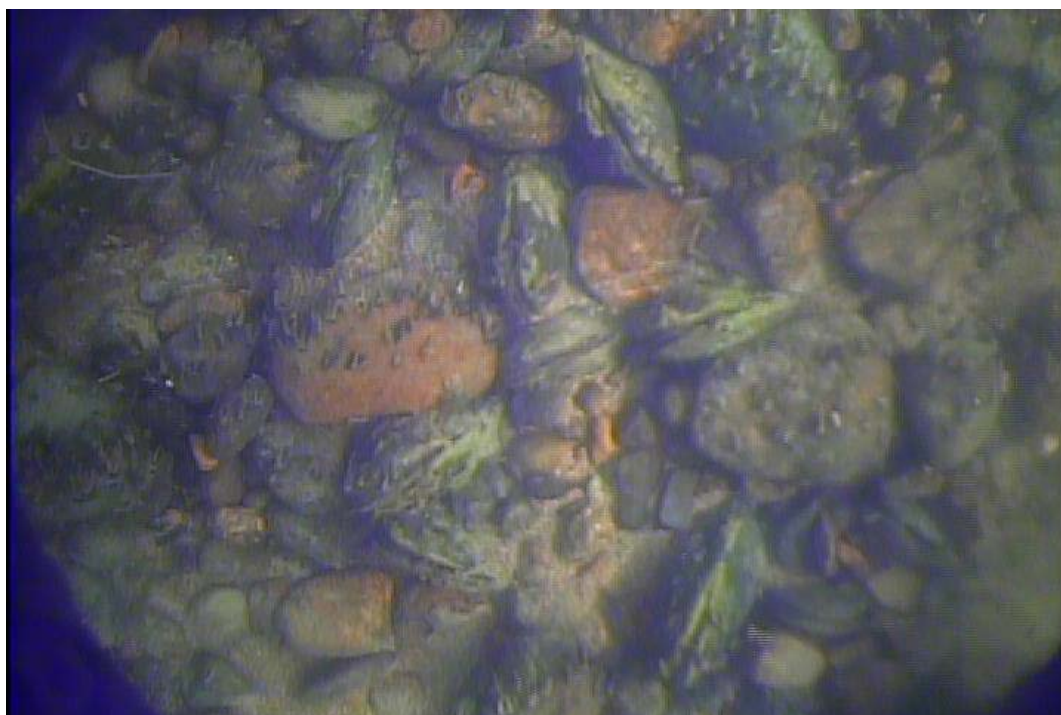
Photo 15: Underwater photo of substrate from Lower Site.

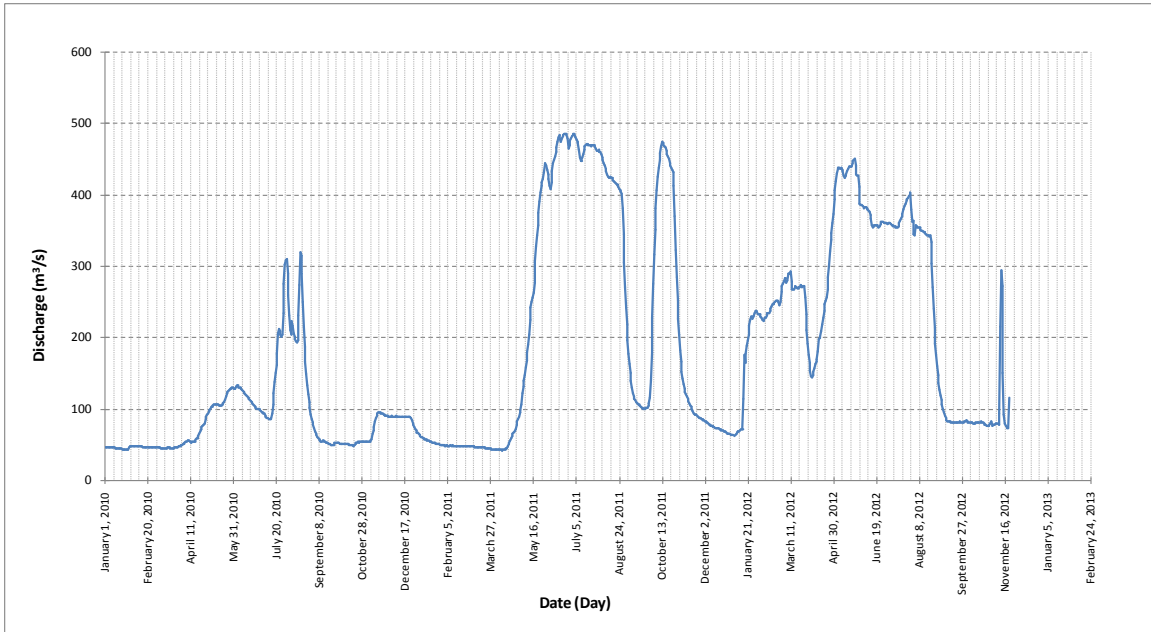
The 2011 freshet had a peak discharge about $500 \text{ m}^3/\text{s}$ and lasted for about three months while the 2012 freshet peaked at $450 \text{ m}^3/\text{s}$ and had sustained flows above $350 \text{ m}^3/\text{s}$ for about 3 months (Figure 4). Based on daily data from 1962-2005, the 2011 flood peak had a return interval between 2 and 5 years and the 2012 freshet peaked at a 2 year return interval. In both cases the duration of the freshets were exceptionally long. Despite the relatively high flows the placed substrate did not move. Images of the substrate coupled with the 2008 River2D modelling (Northwest Hydraulic Consultants Ltd., 2008) suggest that the placed material will remain stable during most, if not all, flood events.

Figure 4: Discharge data from WSC 08JC001 gauge.
